What Home Inspectors Need to Know About

Slate Roofs

Fabrication and Installation

By Joe Jenkins

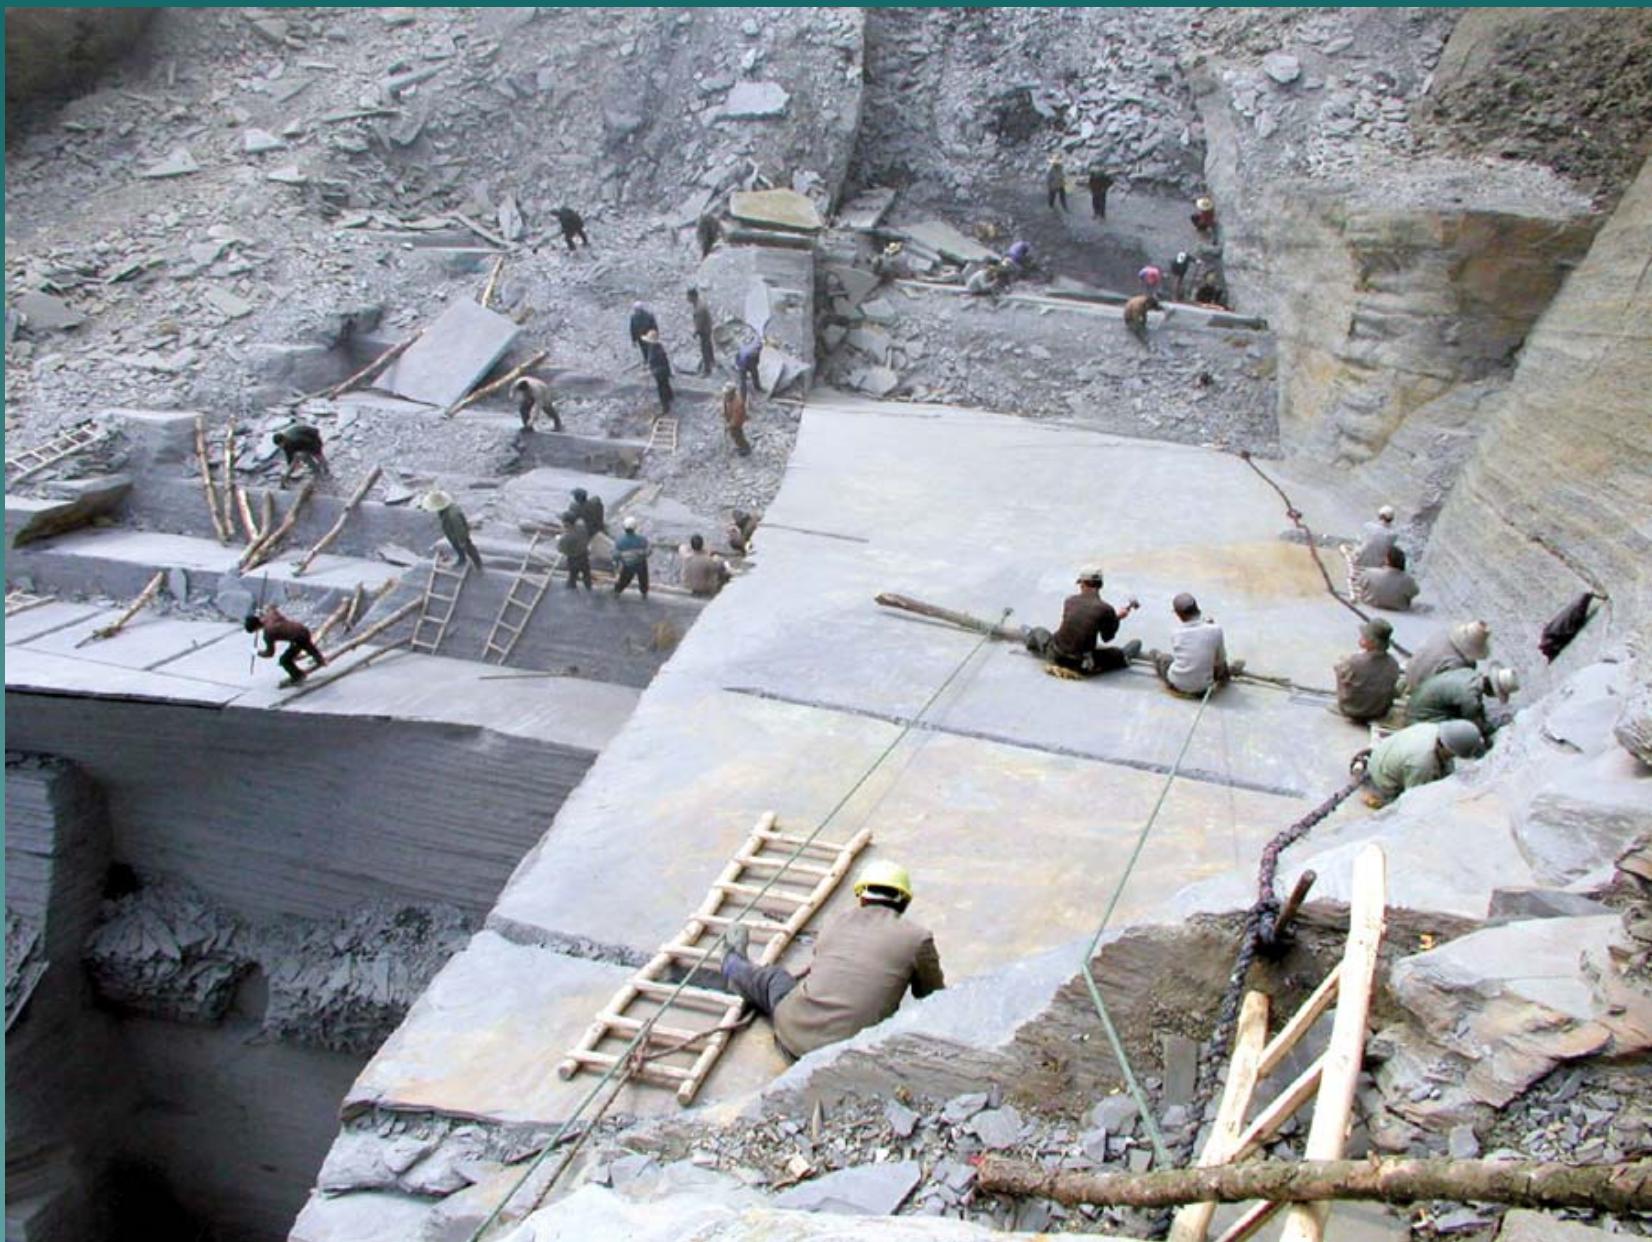
This is a Chinese slate quarry.

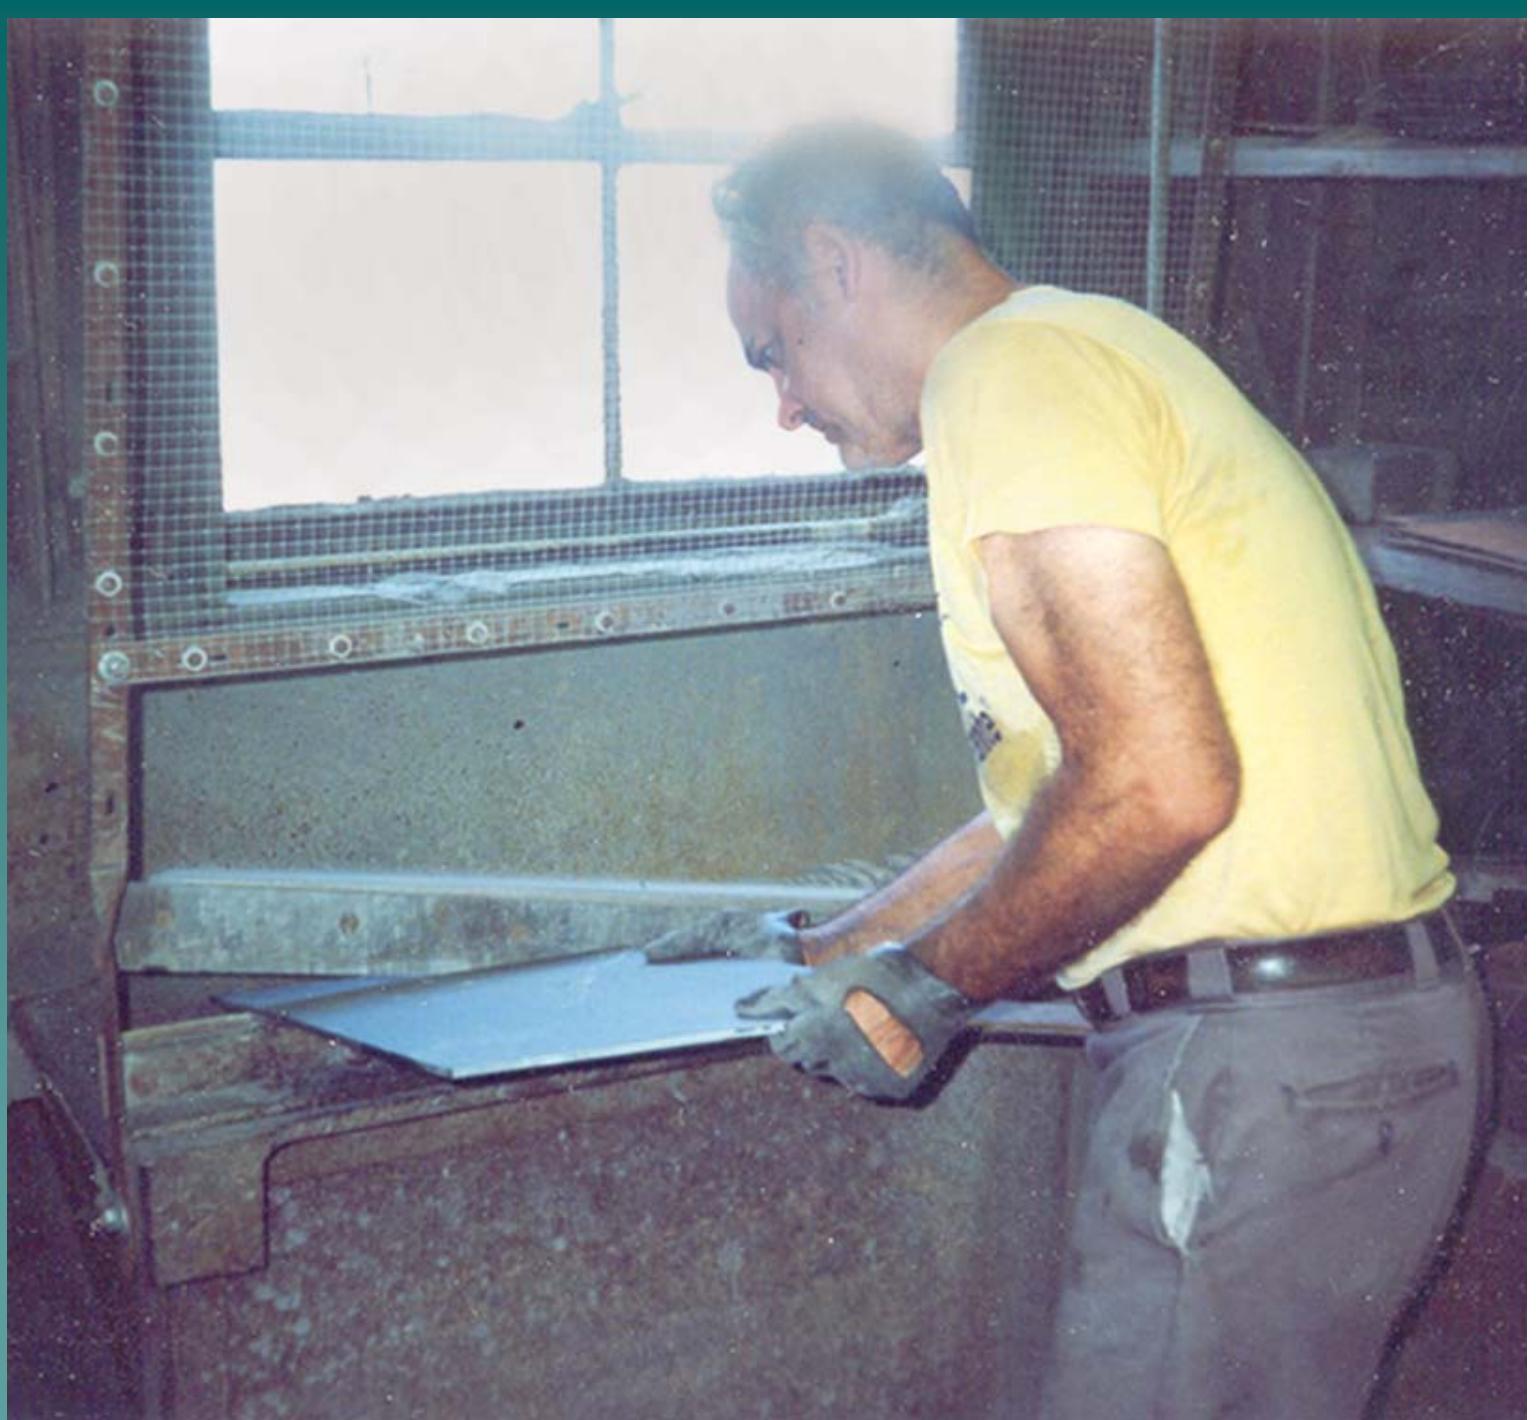
The edges
are trimmed
square
using a
trimming
machine.

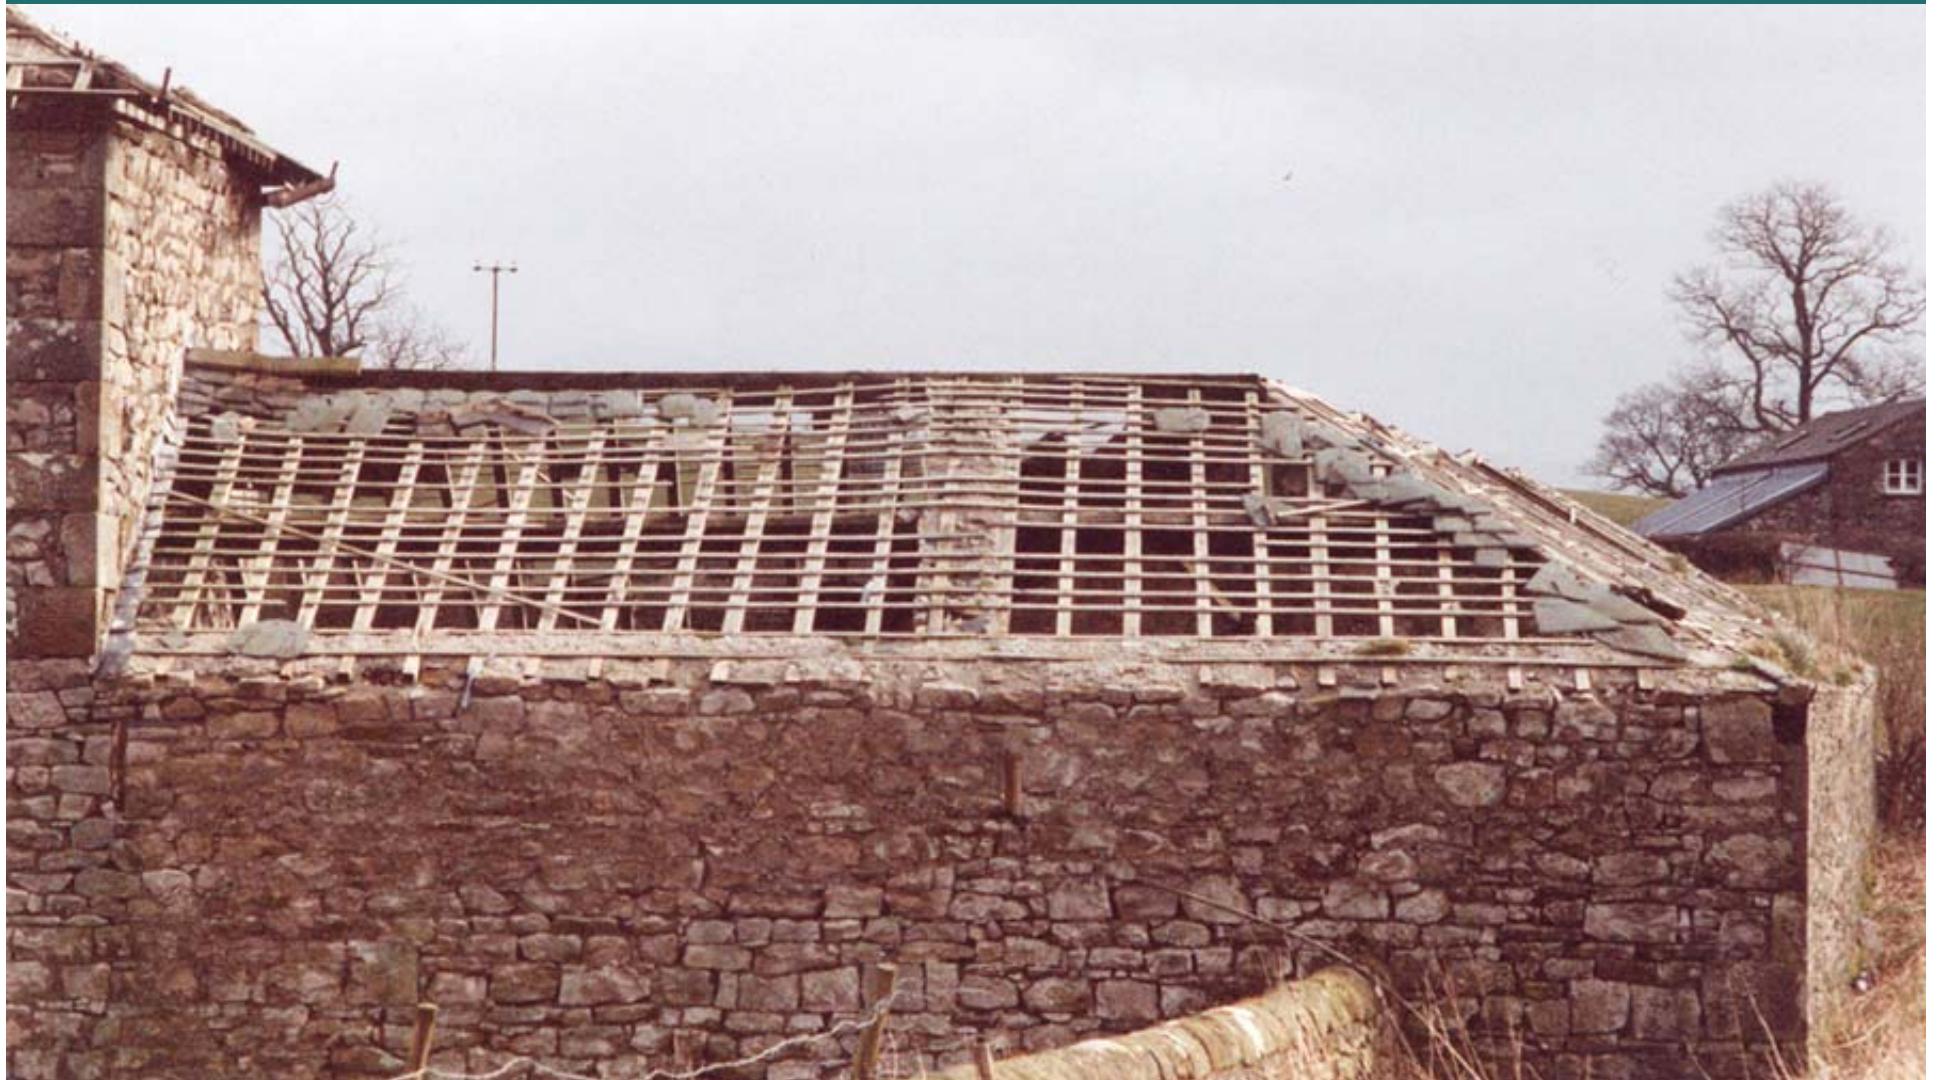
This is what's left of a very old UK pegged slate roof showing the lath. No felt underlayment was used at that time.

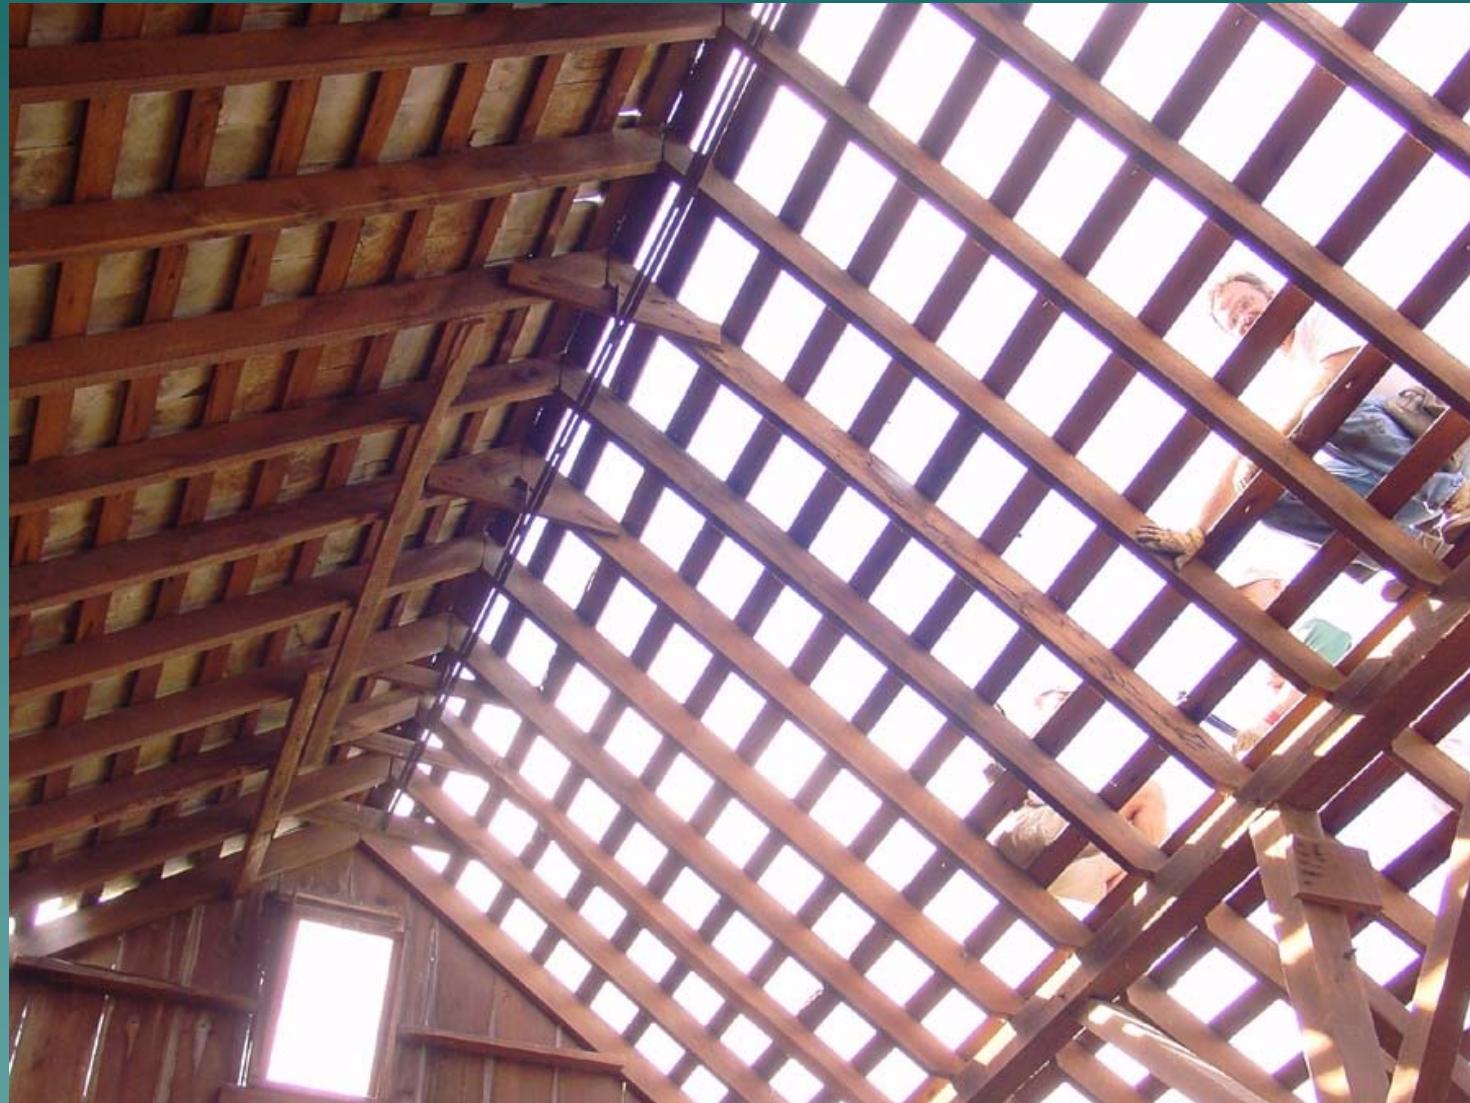
Underlayment, such as felt paper, is not necessary on slate roofs. Barns, for example, traditionally don't use underlays.

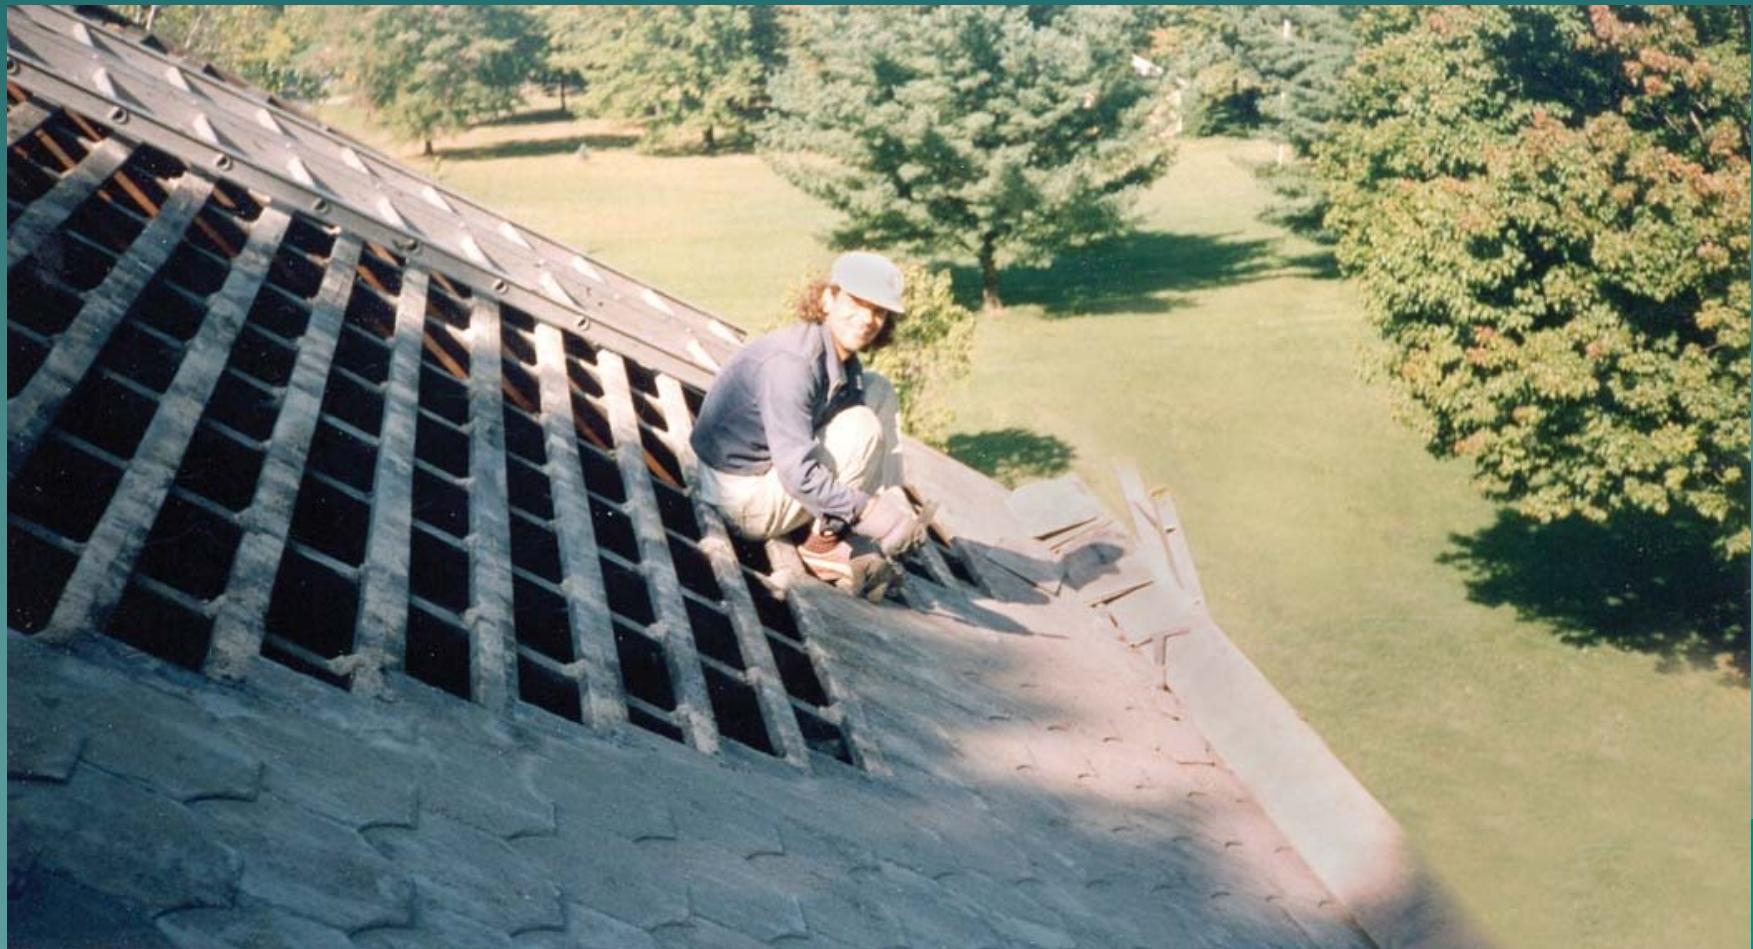
This is a 100-year-old residential slate roof, on hardwood lath,
with no underlayment and no leaks.
The slate is being removed for recycling (salvage).

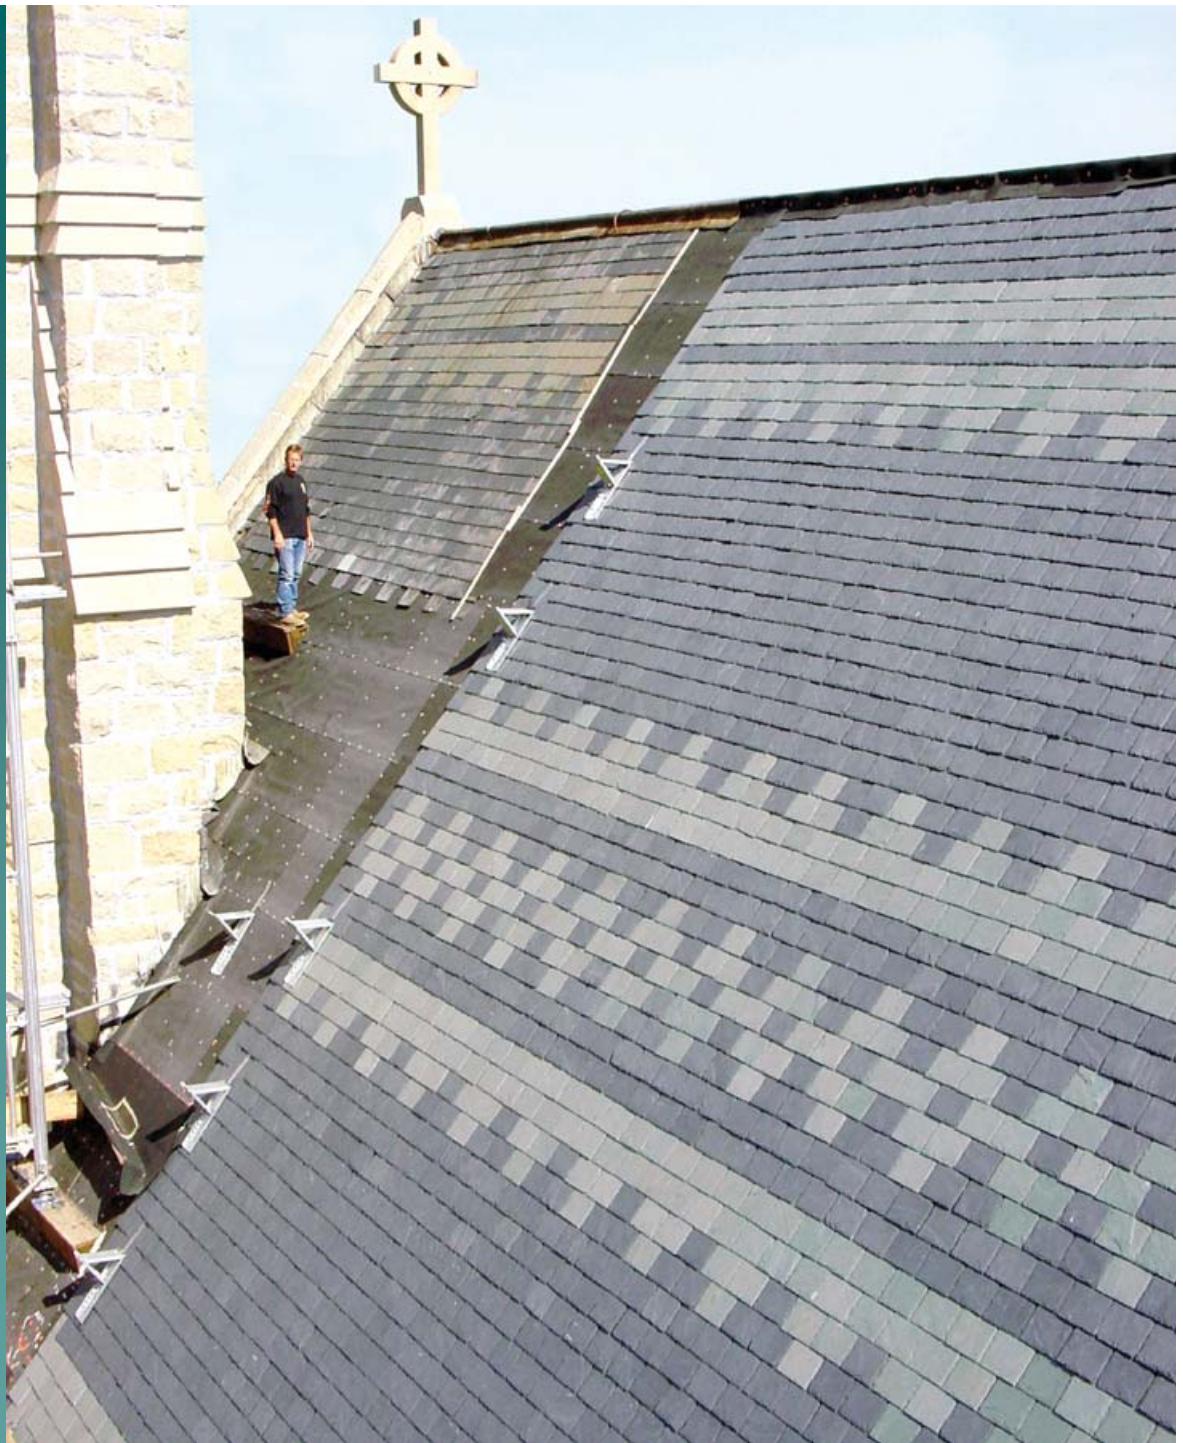
When this 120 year old cathedral roof was reslated, it was found to have no underlayment under the original slates.

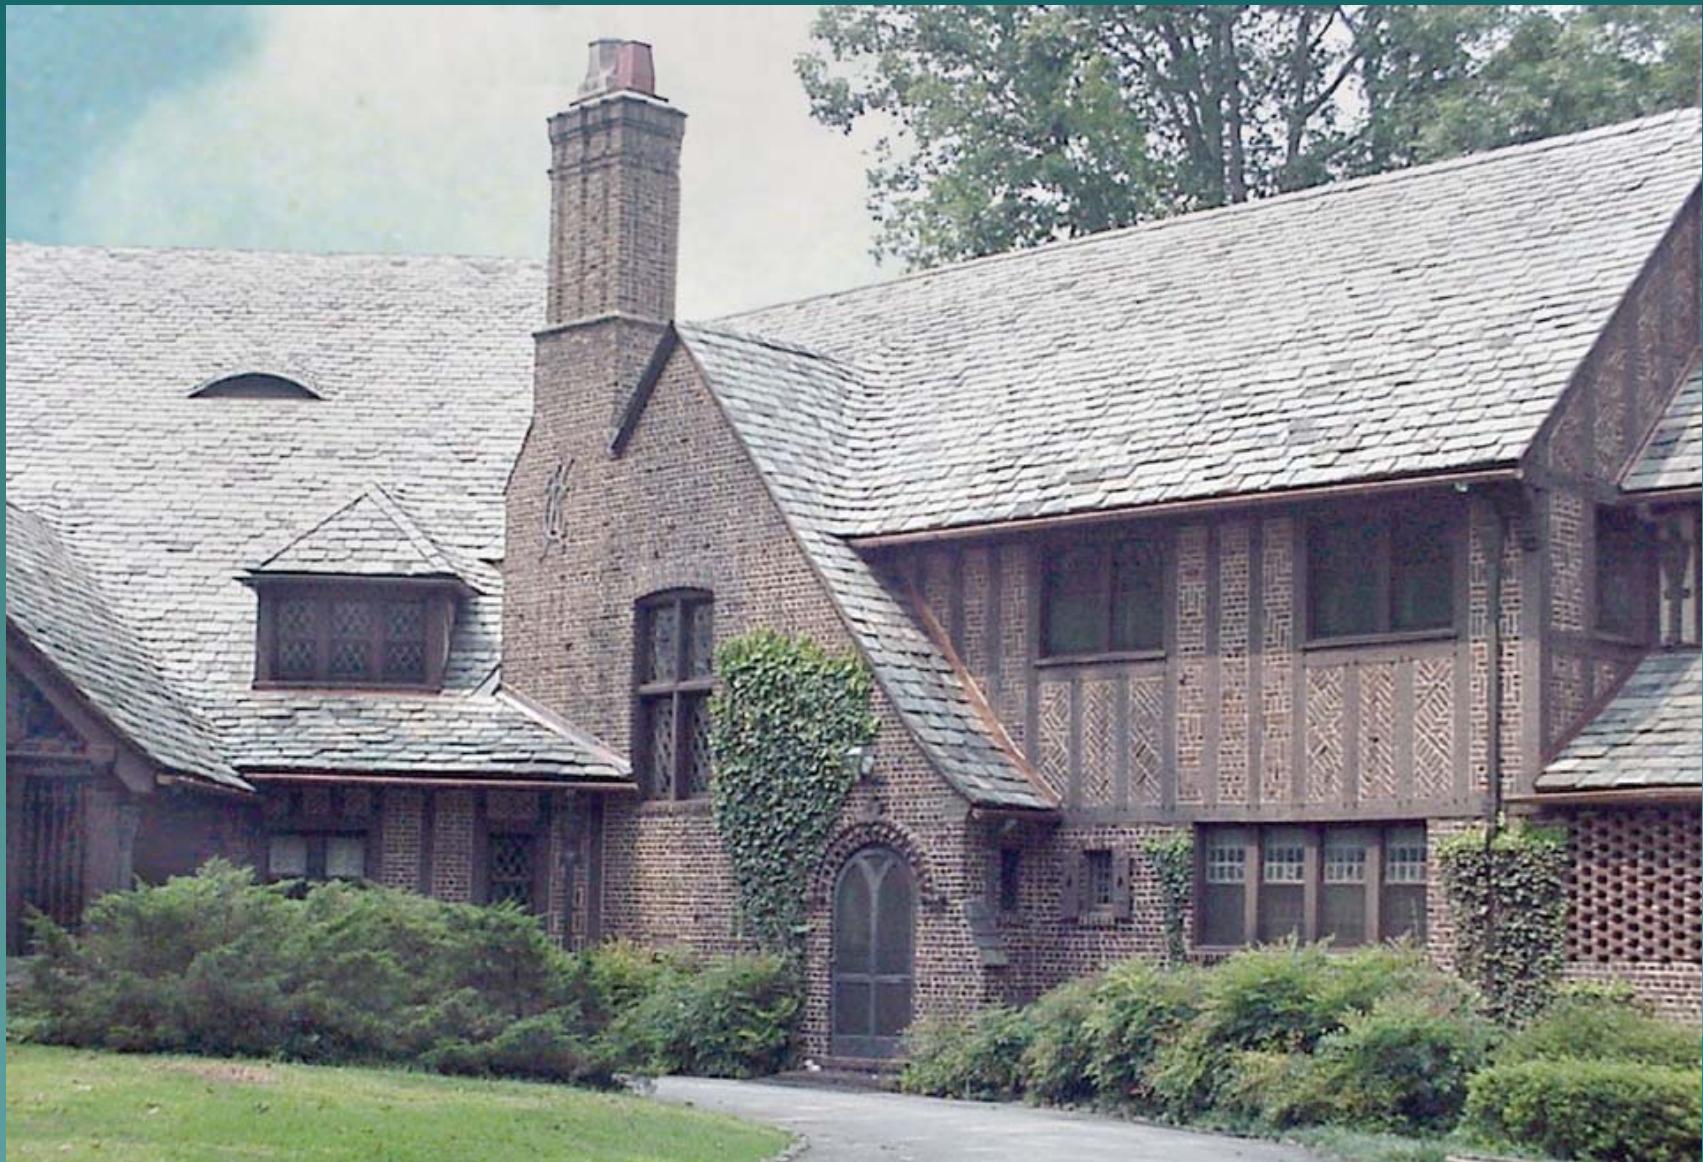
This re-roofing job was successfully completed.

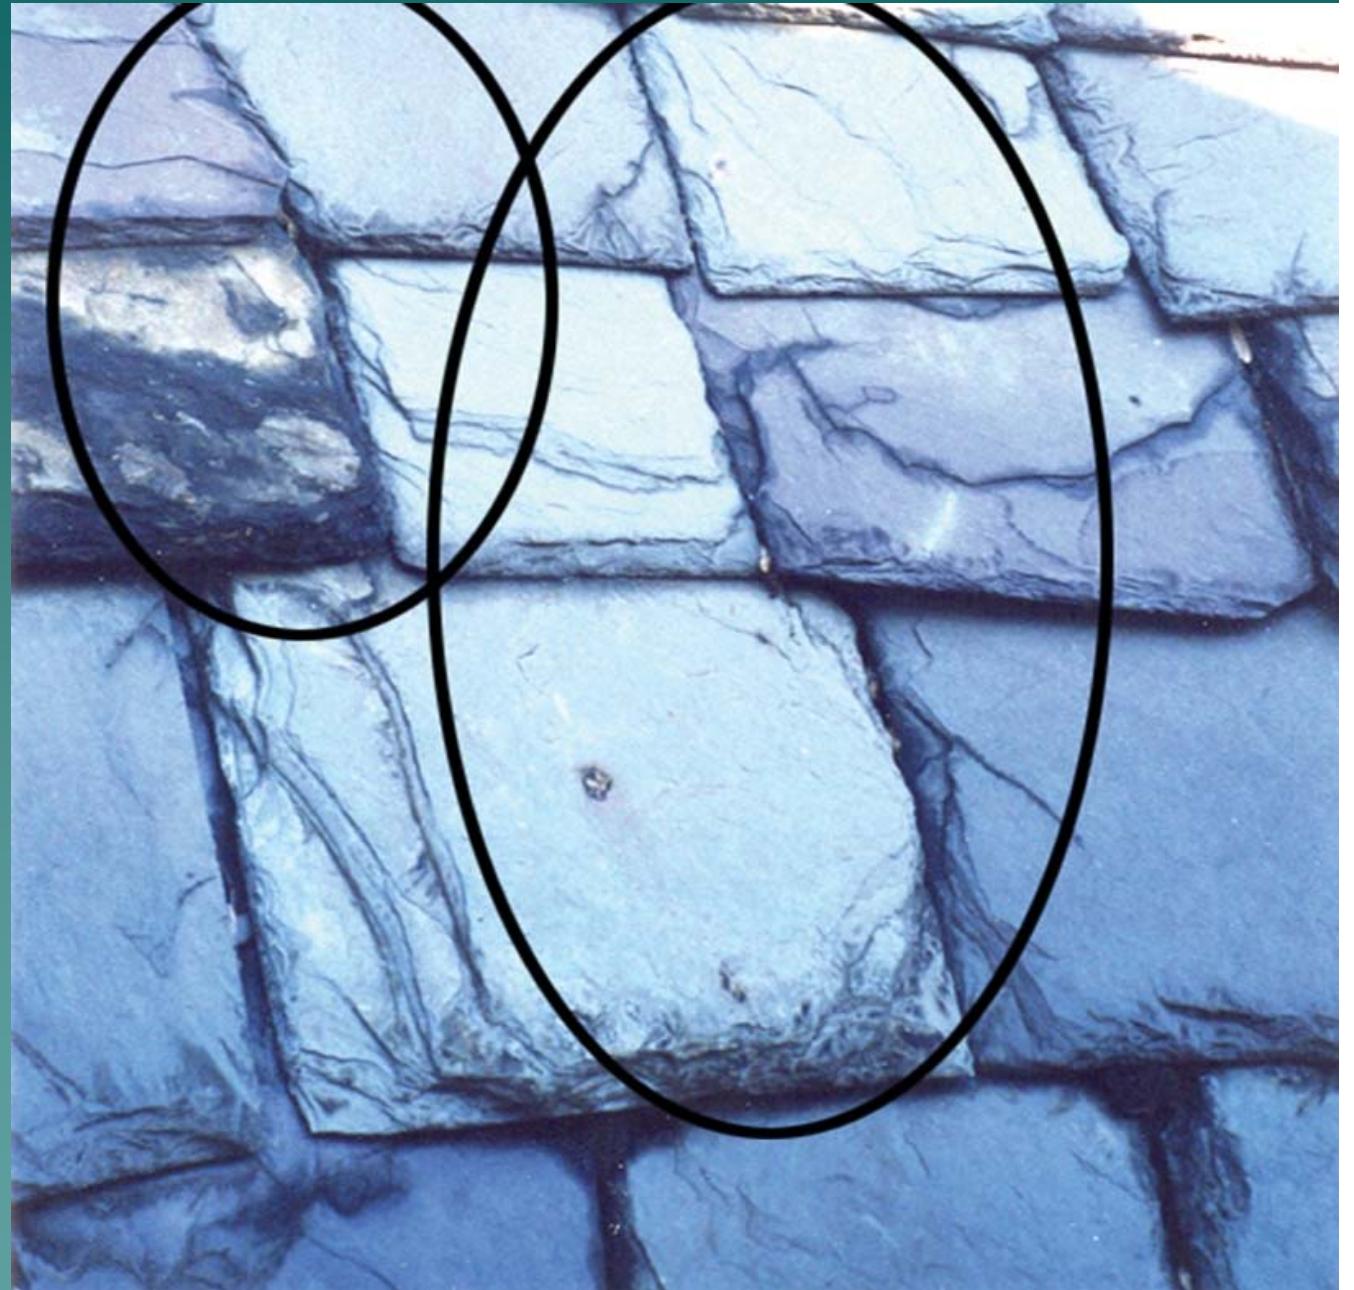
Lateral overlaps or “sidelaps” are also important. These shown here are inadequate or nonexistent.

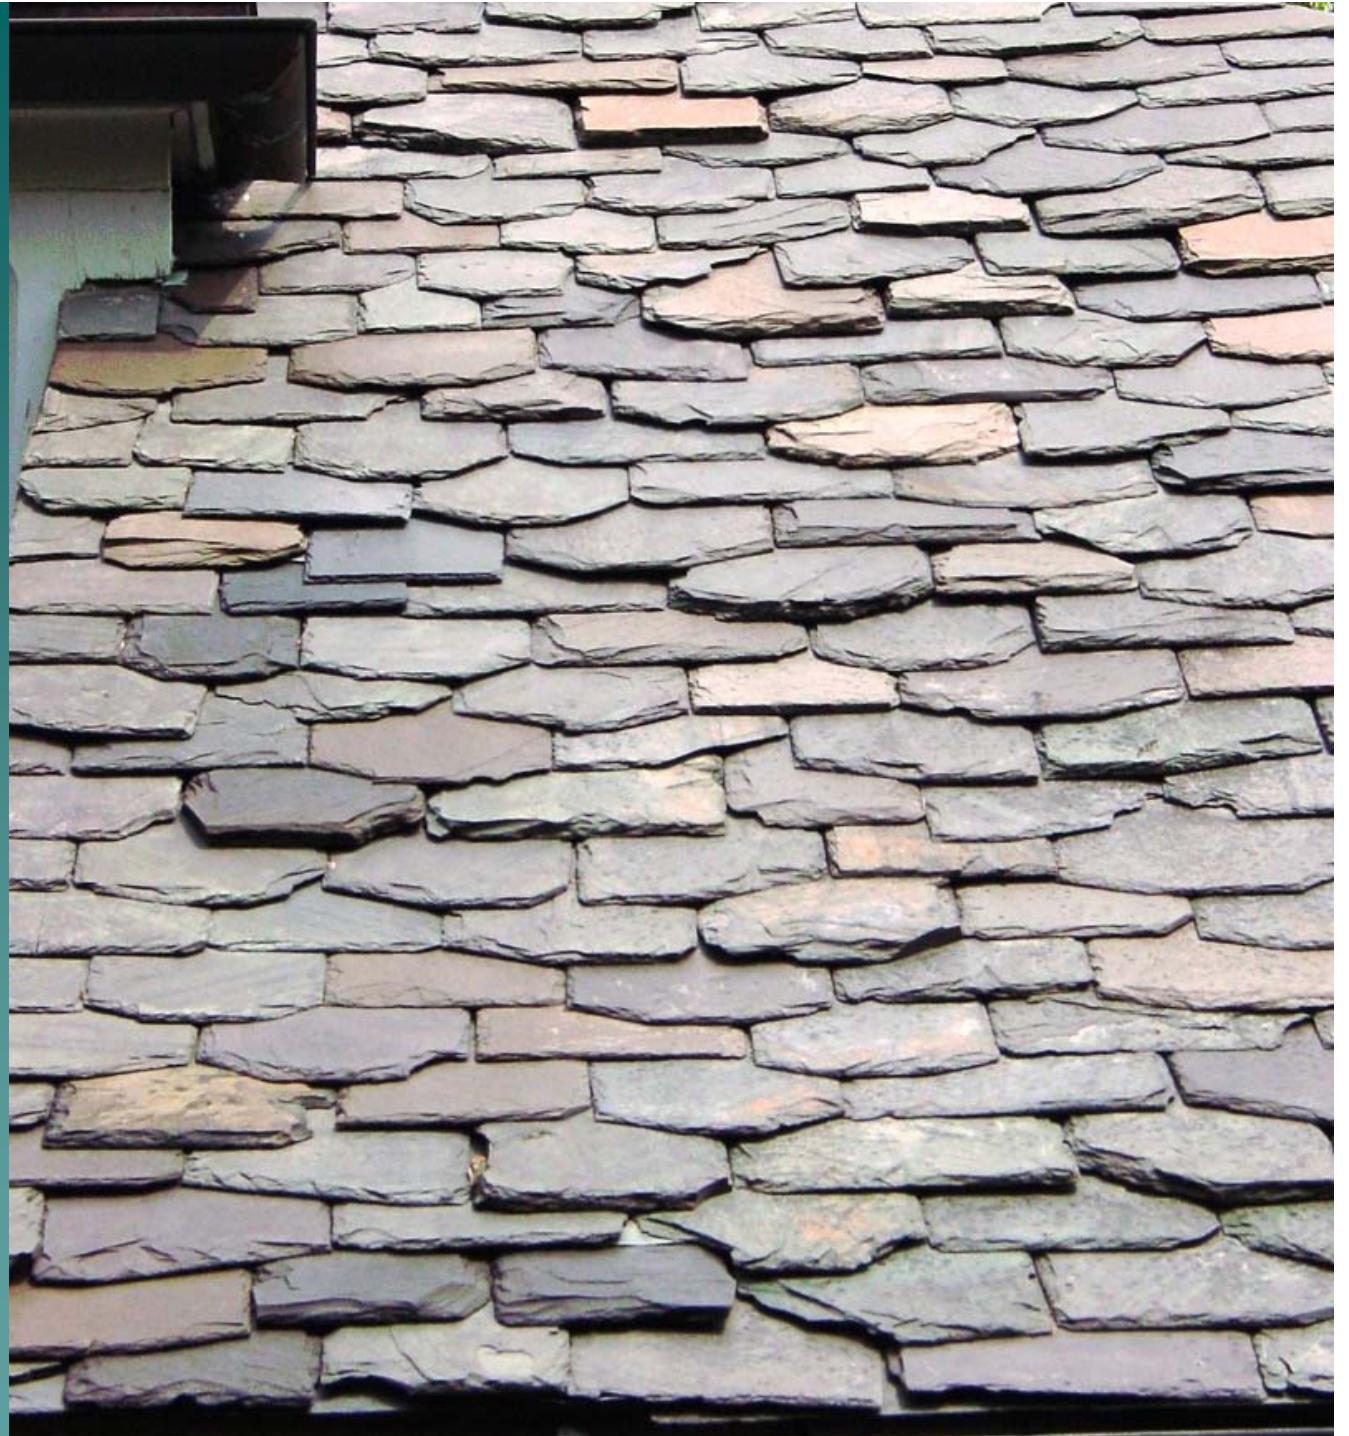
Slate is versatile and can be installed in many styles, as long as proper headlaps and sidelaps are maintained. This is a “ragged butt” style.

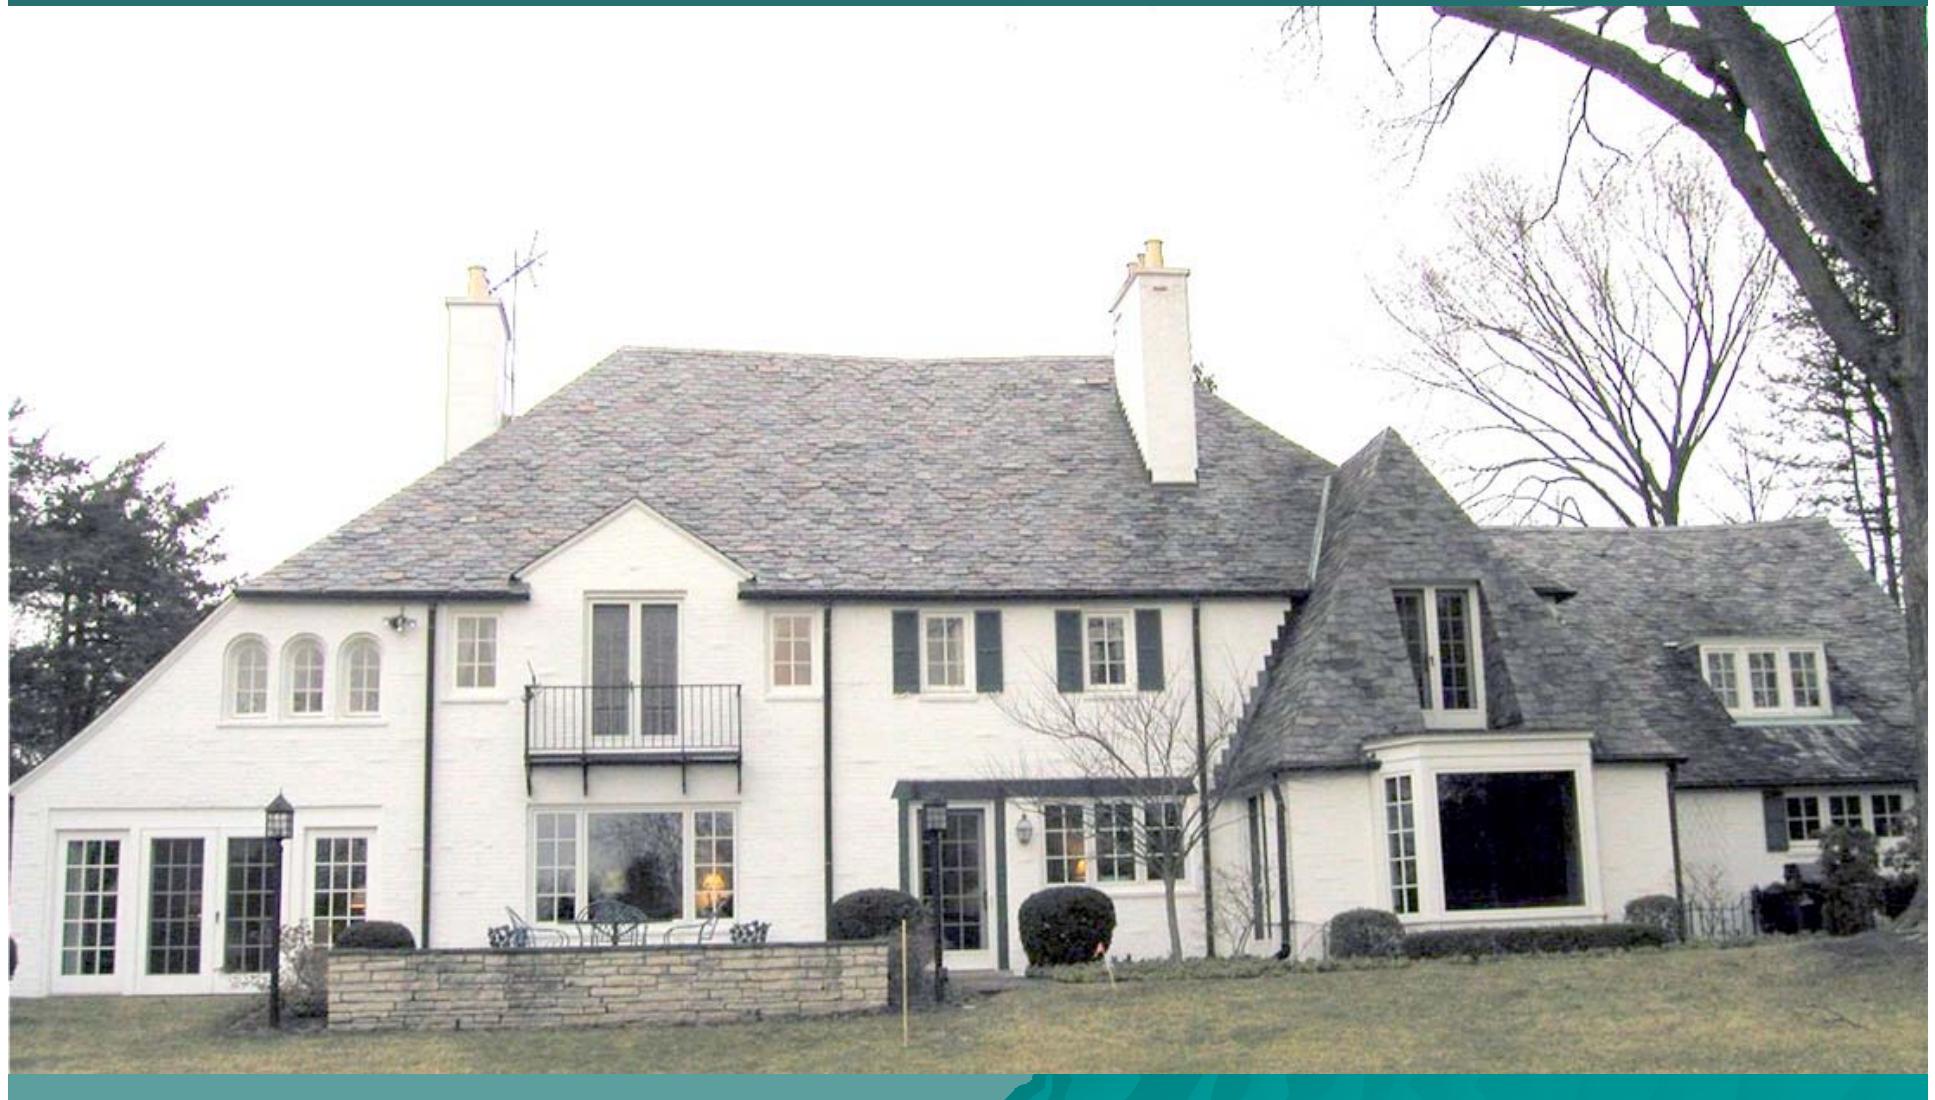
This ragged butt roof was condemned by 3 roofing contractors, although little was wrong with it. It was eventually repaired.

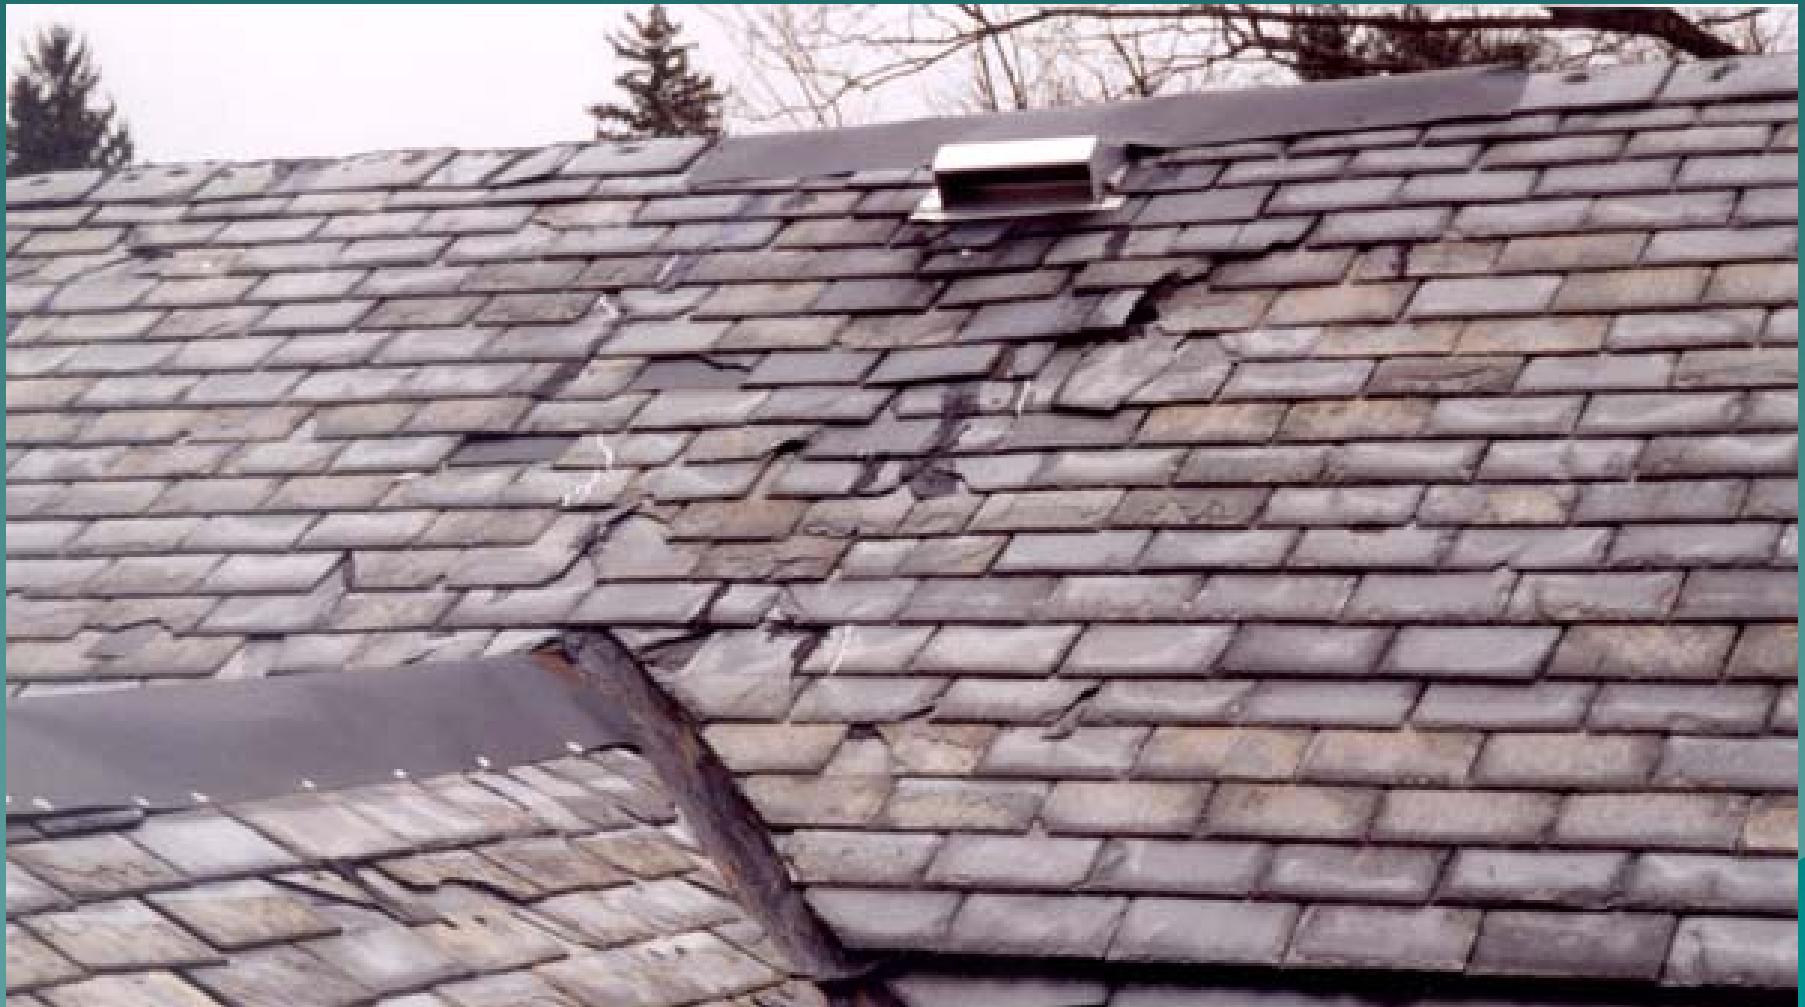
This Pennsylvania black slate roof is near the end of its life at about 90 years of age.

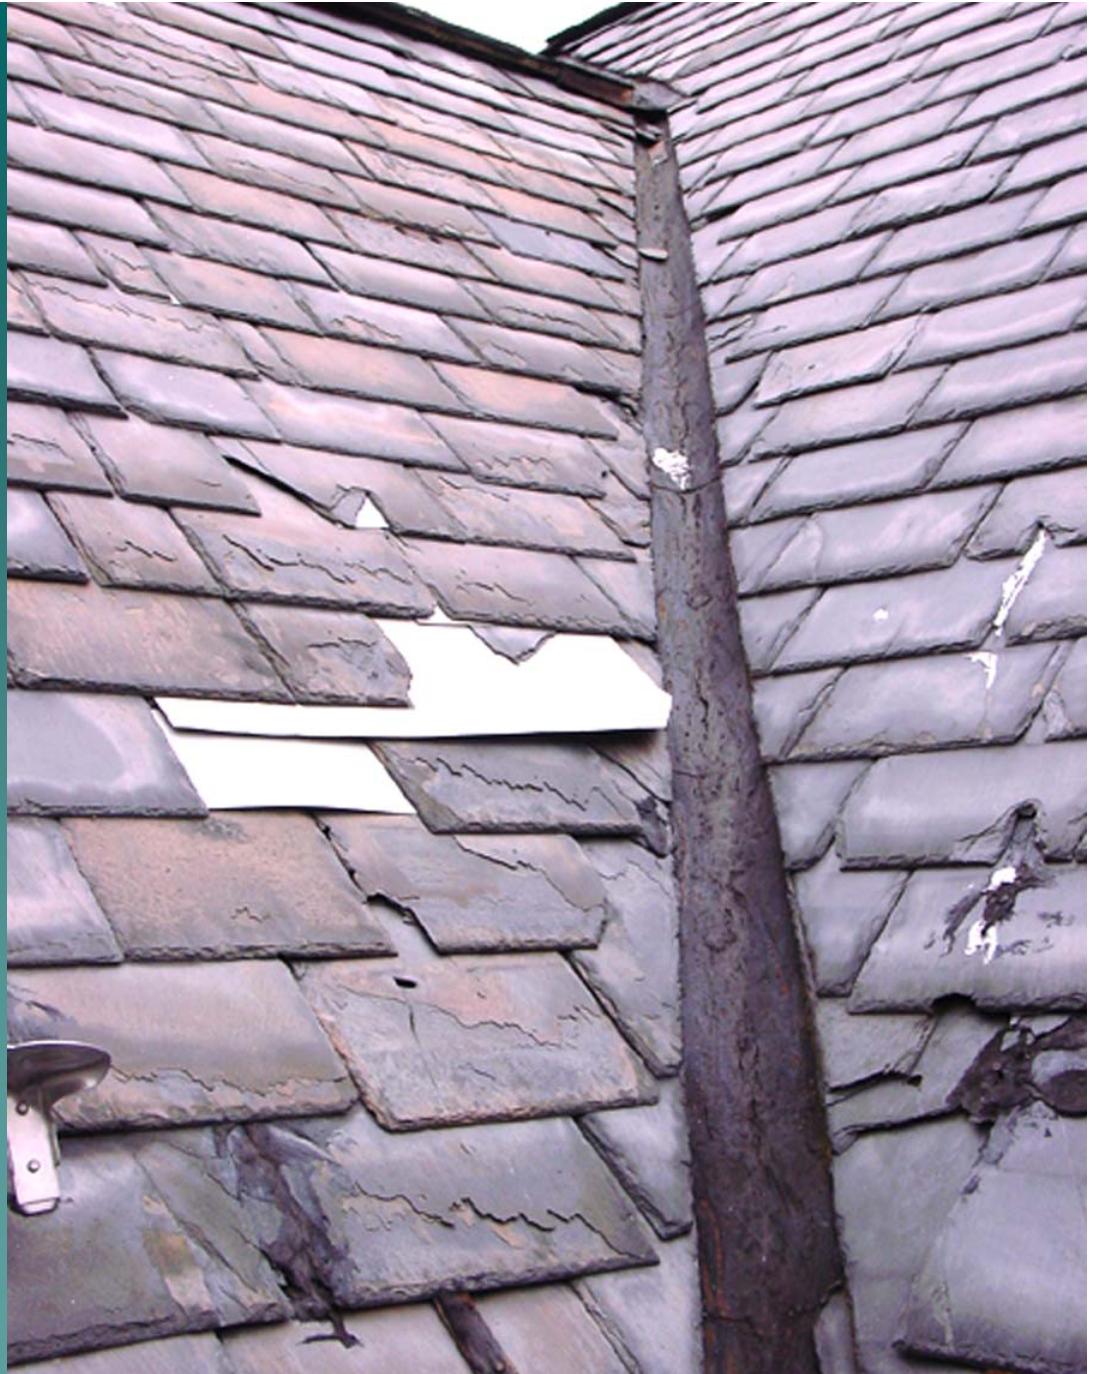
Softer slates will flake, crumble and fall apart, in time. These tend to be mainly PA black slates, but others can deteriorate prematurely as well.
