What Home Inspectors Need to Know About

Slate Roofs

Fabrication and Installation

By Joe Jenkins

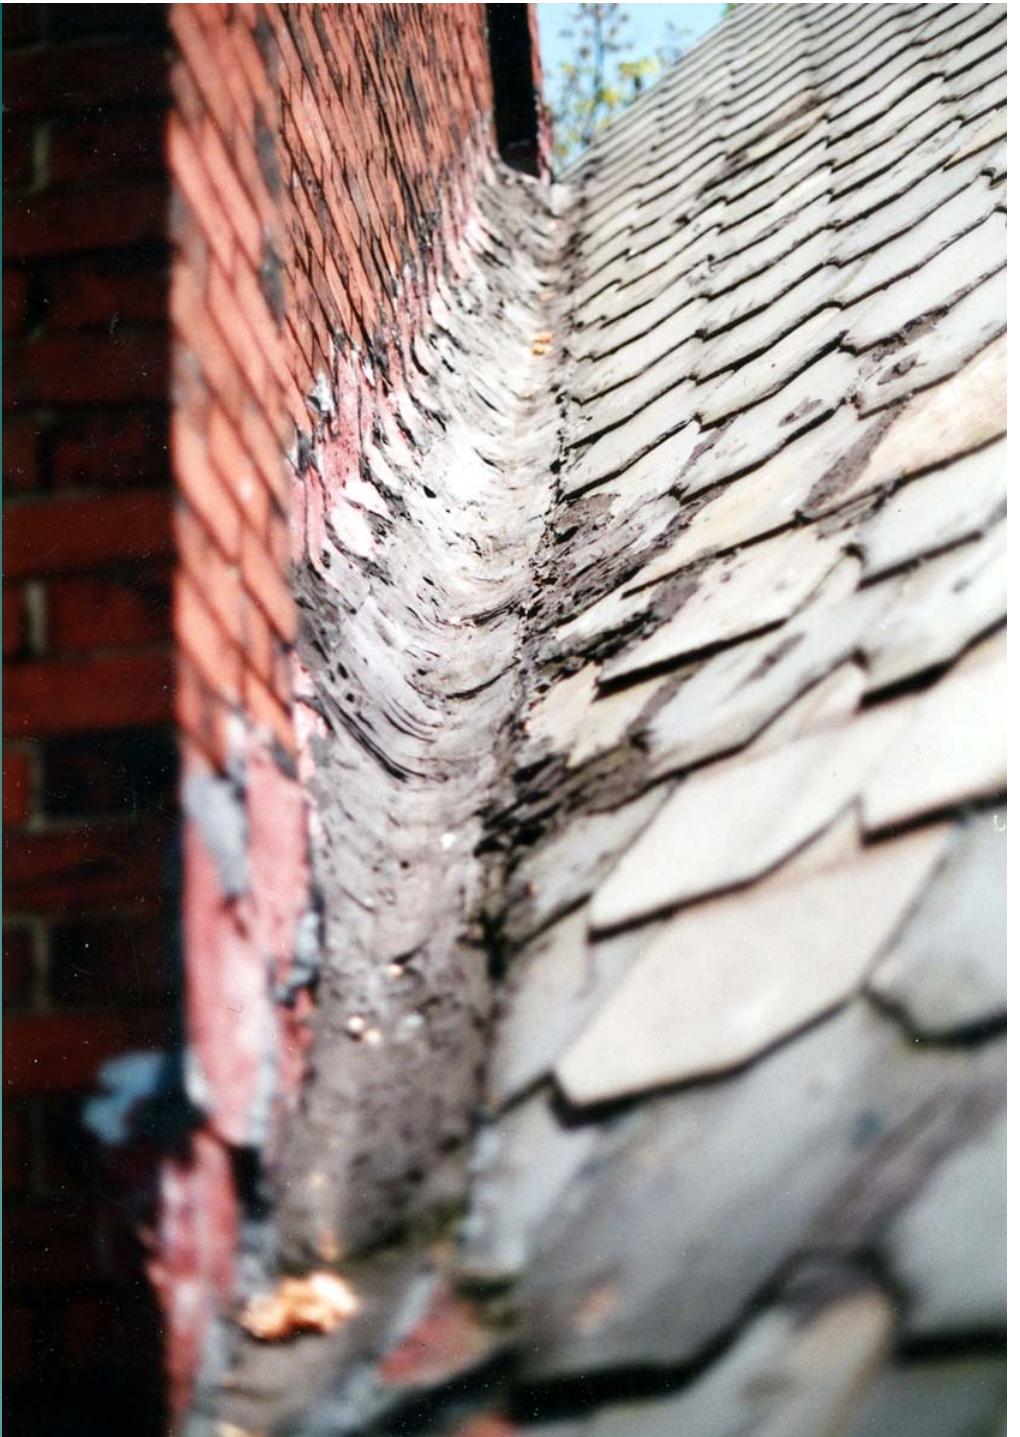
This is a “soft” PA black slate roof on a church at 104 years of age. Looks pretty bad – surely this roof must need to be torn off and replaced.

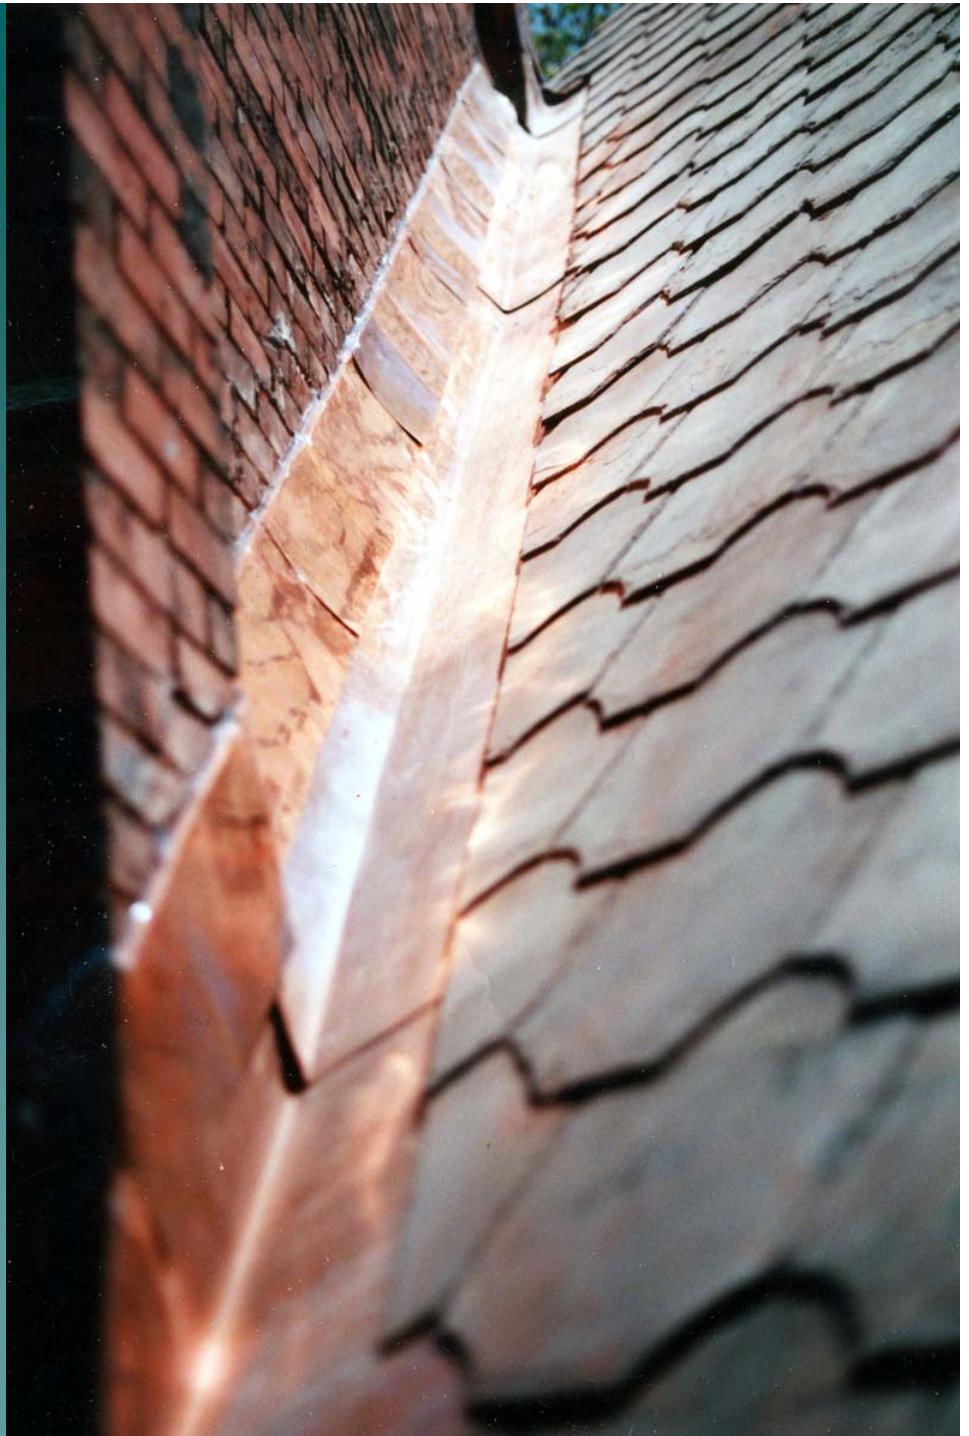
Yet, one day's work for a slate roof restoration professional, with a helper, puts the roof back in shape.

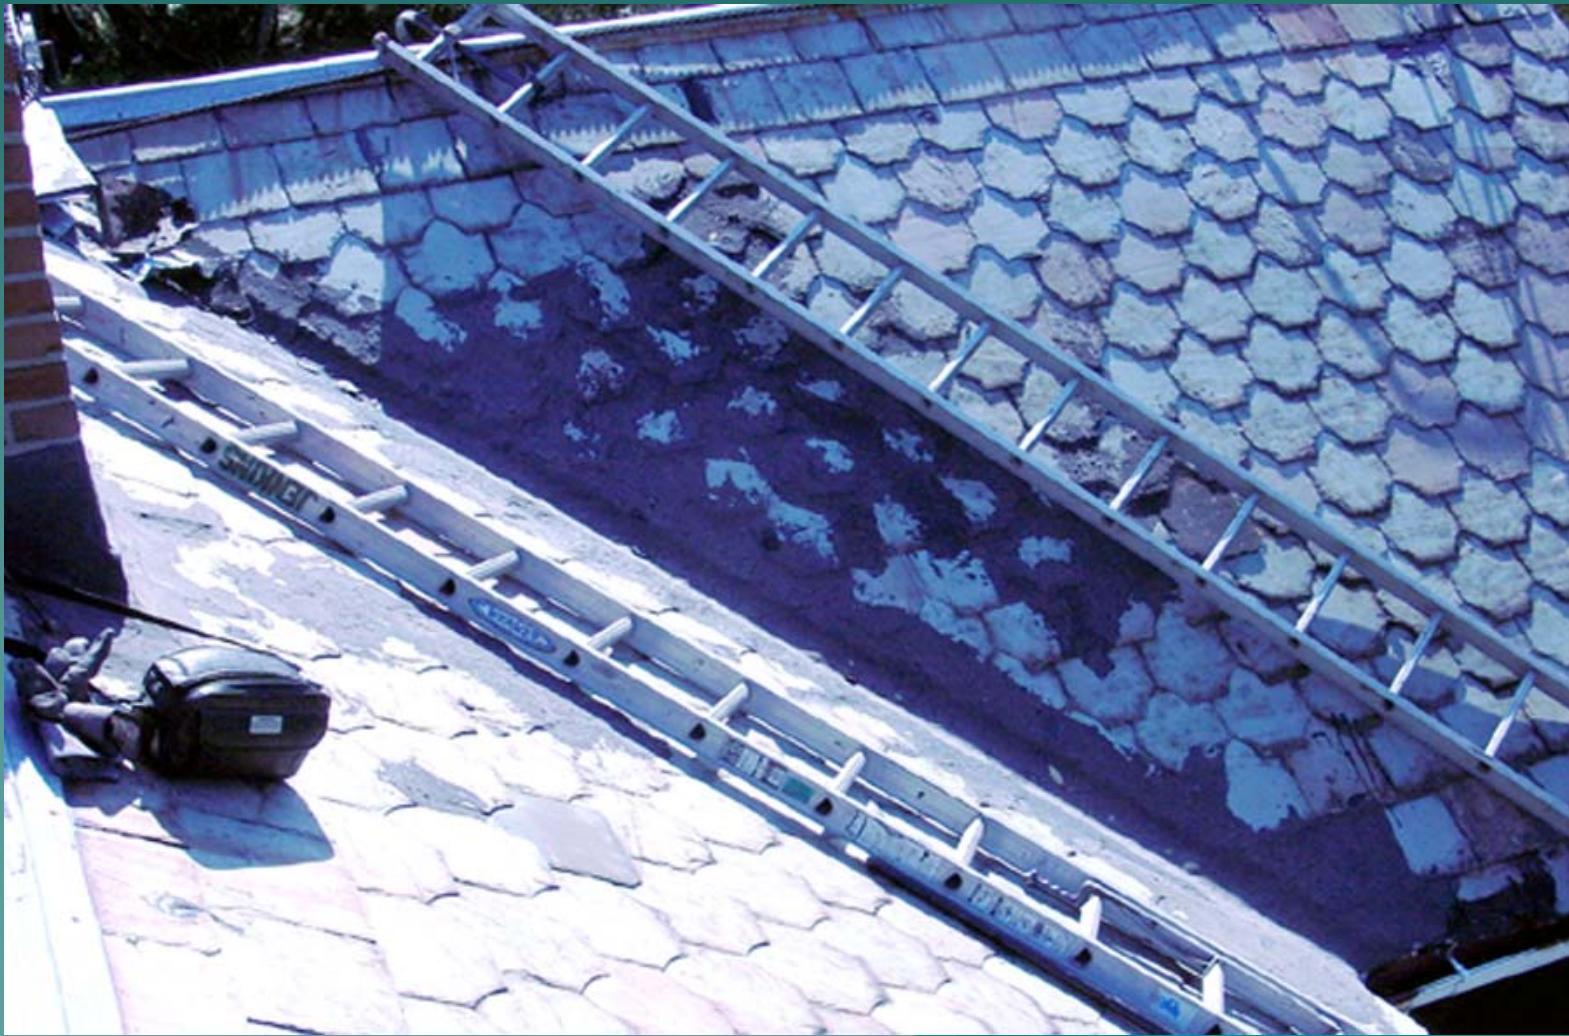
This is a VT “sea green” slate roof that has been heavily damaged by roofing contractors. At first sight, it looks like it needs replaced.

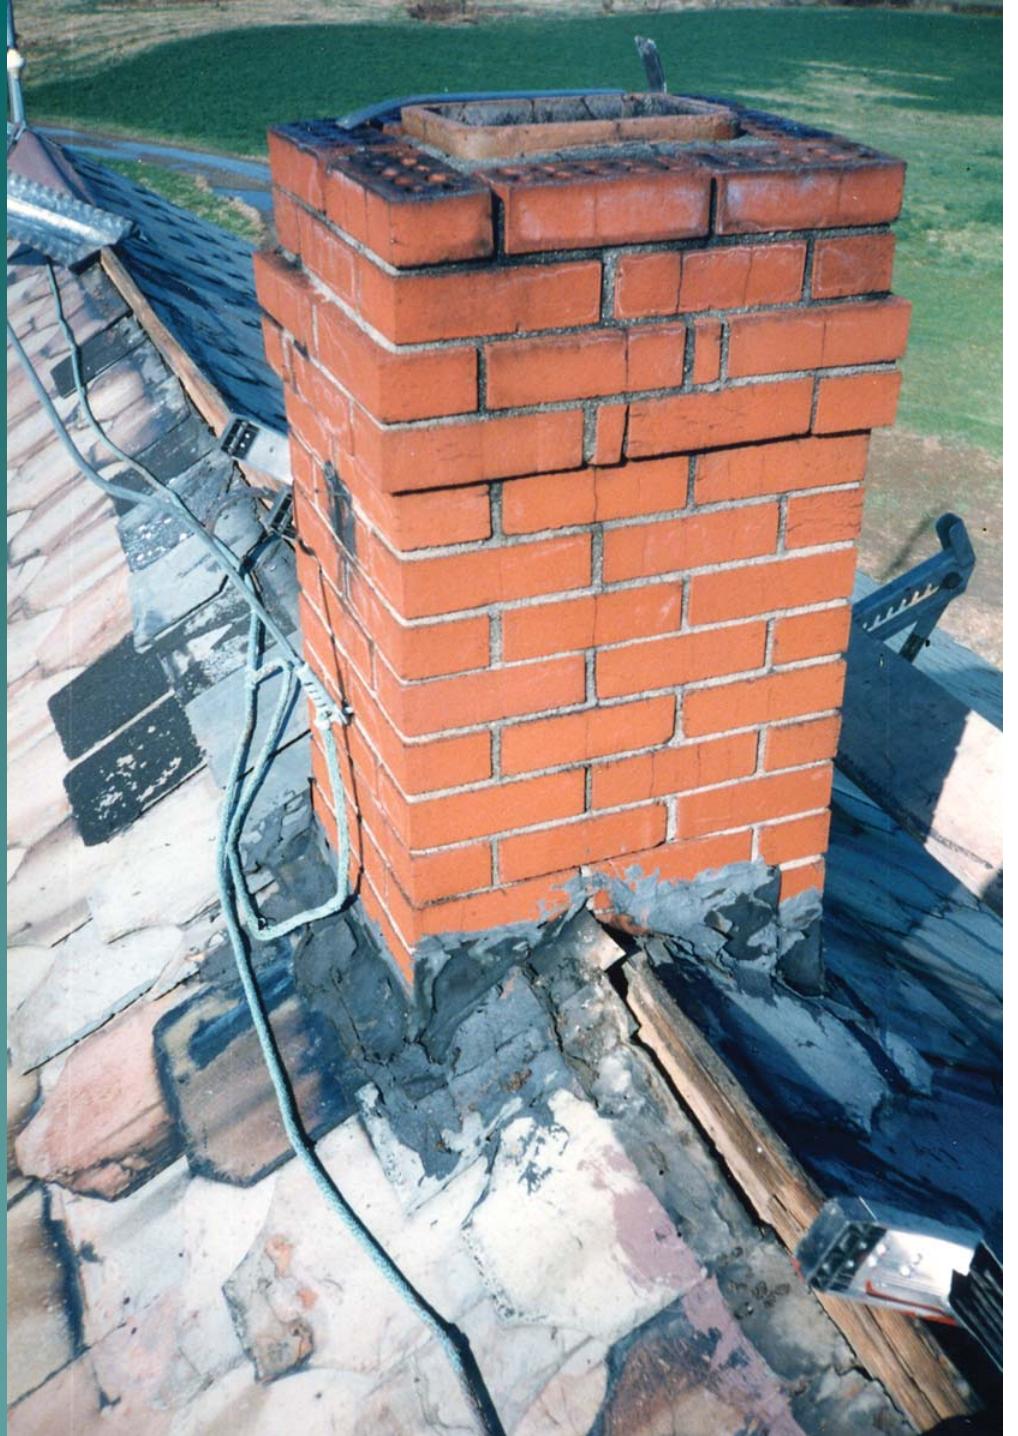
Typical “Neanderthal” roof repair makes a slate roof look terrible. Should this roof be condemned and replaced?

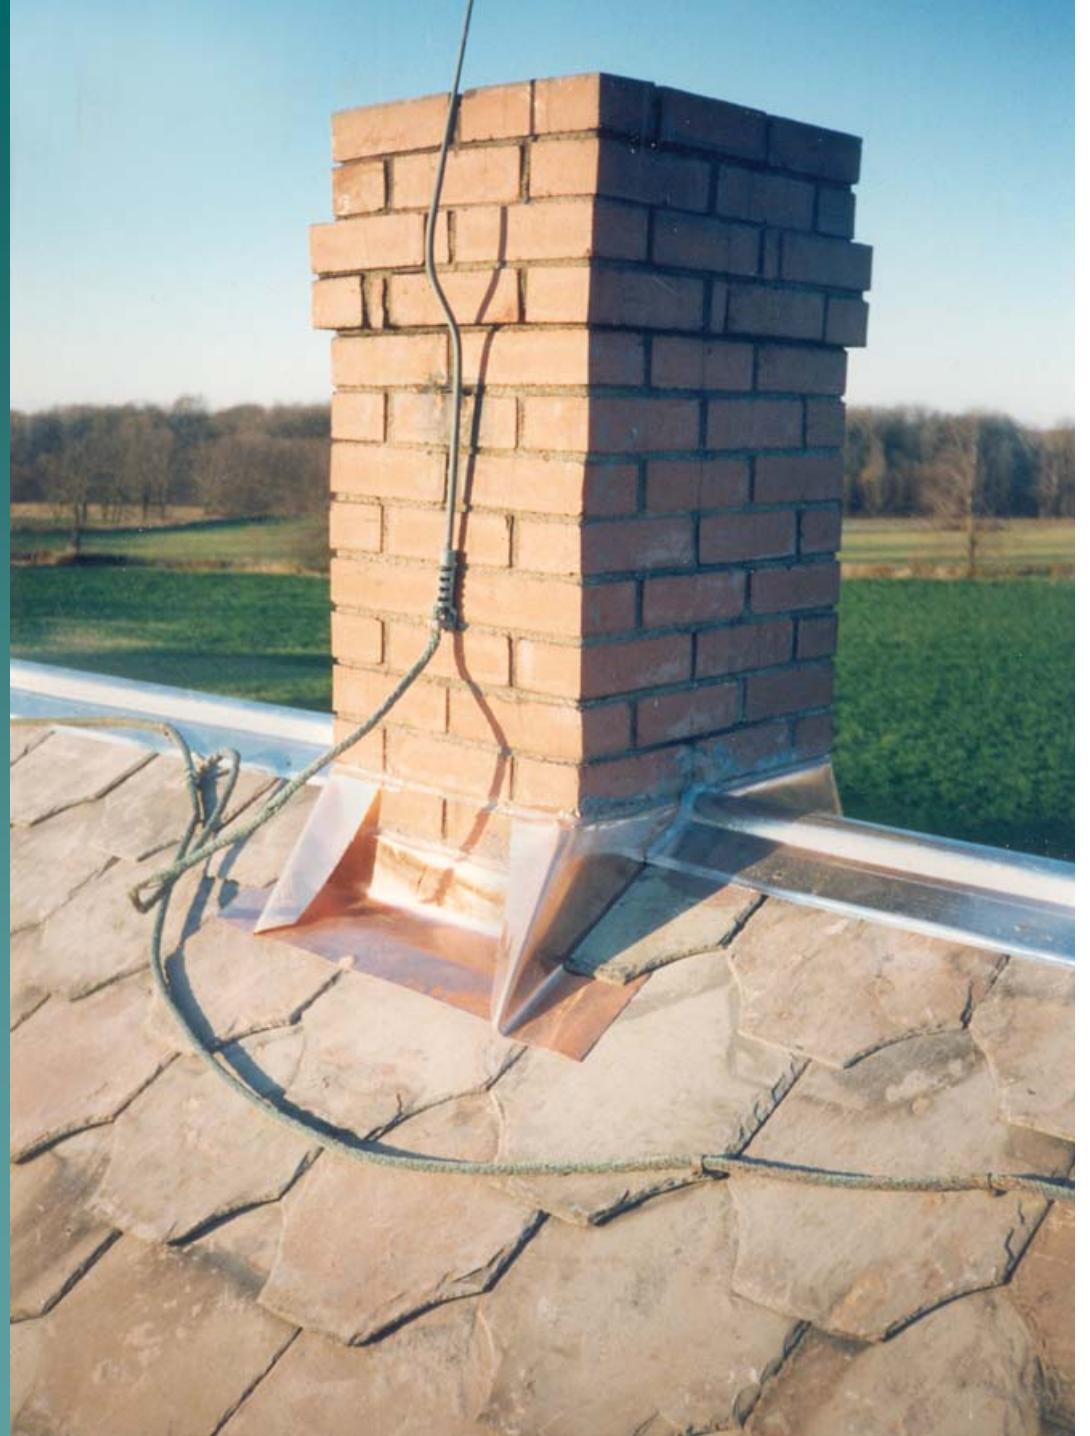
This is the same chimney
after five hours of
professional slate roof
restoration work.

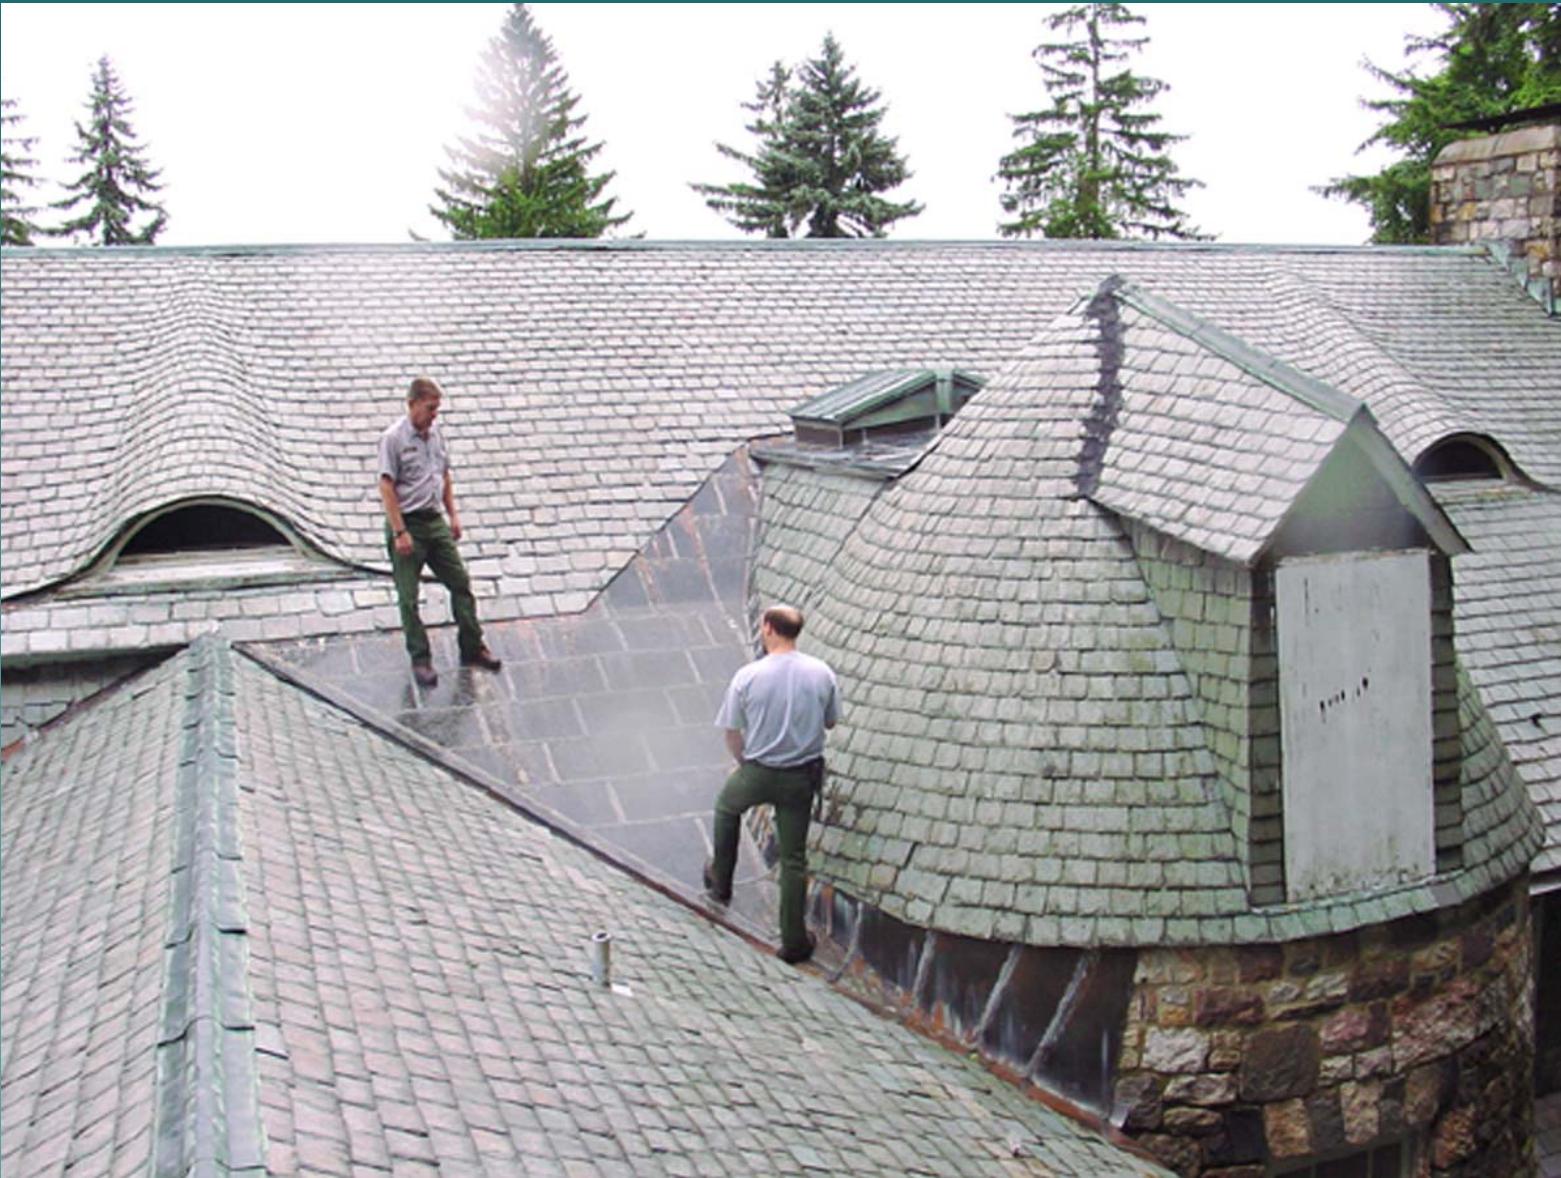
This VT “unfading green” slate roof is in good condition, but with severe leakage.

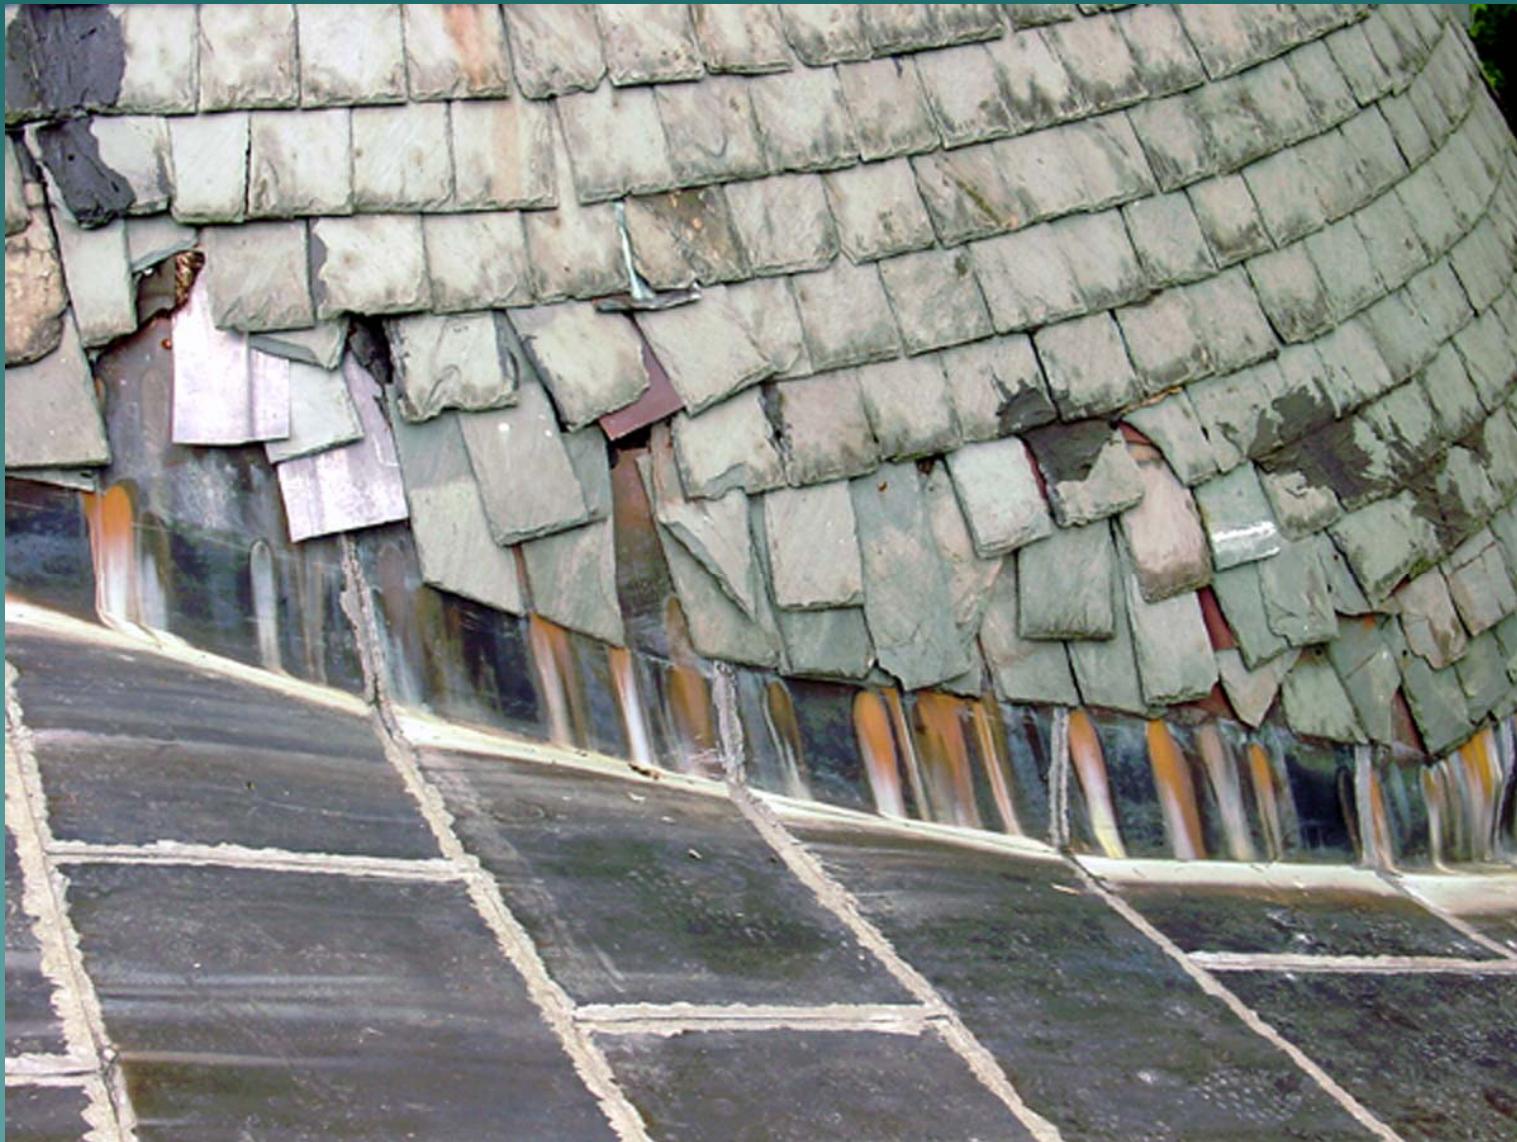
The leakage was caused by poor workmanship by the copper contractor (he screwed up the slate). The slate itself is excellent.

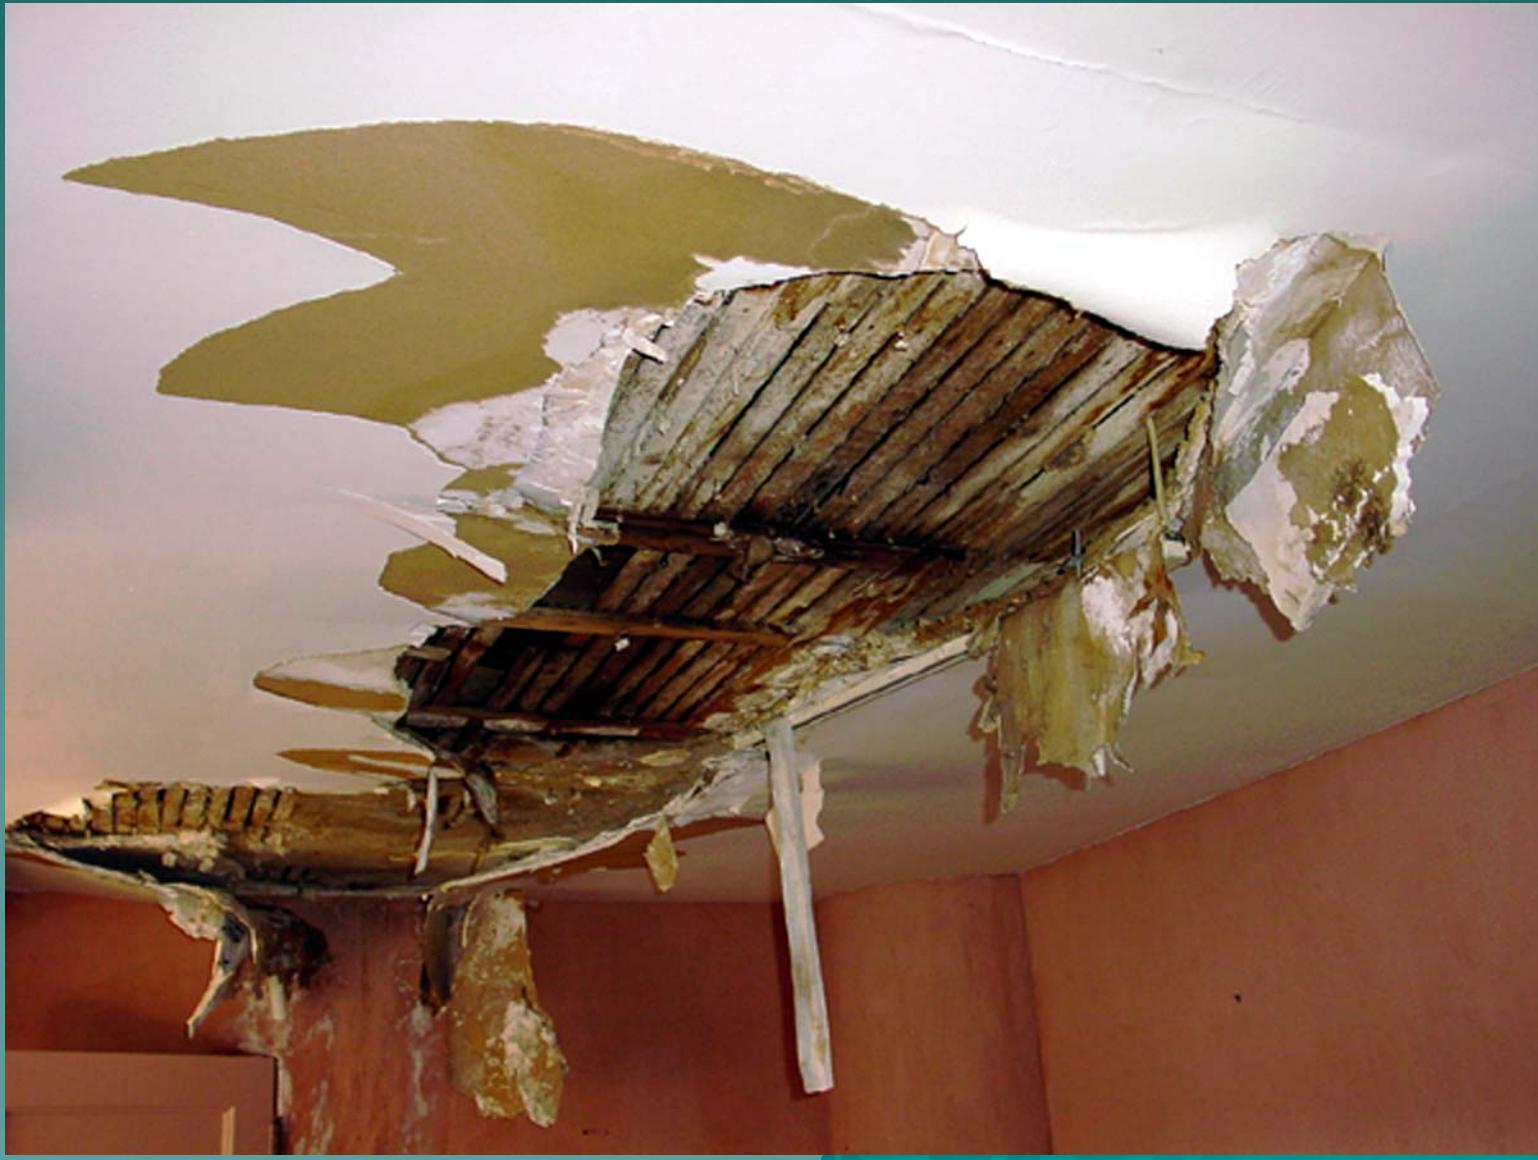
Here is a sign of severe leakage on a church – does the slate roof need replaced? Many would say yes.

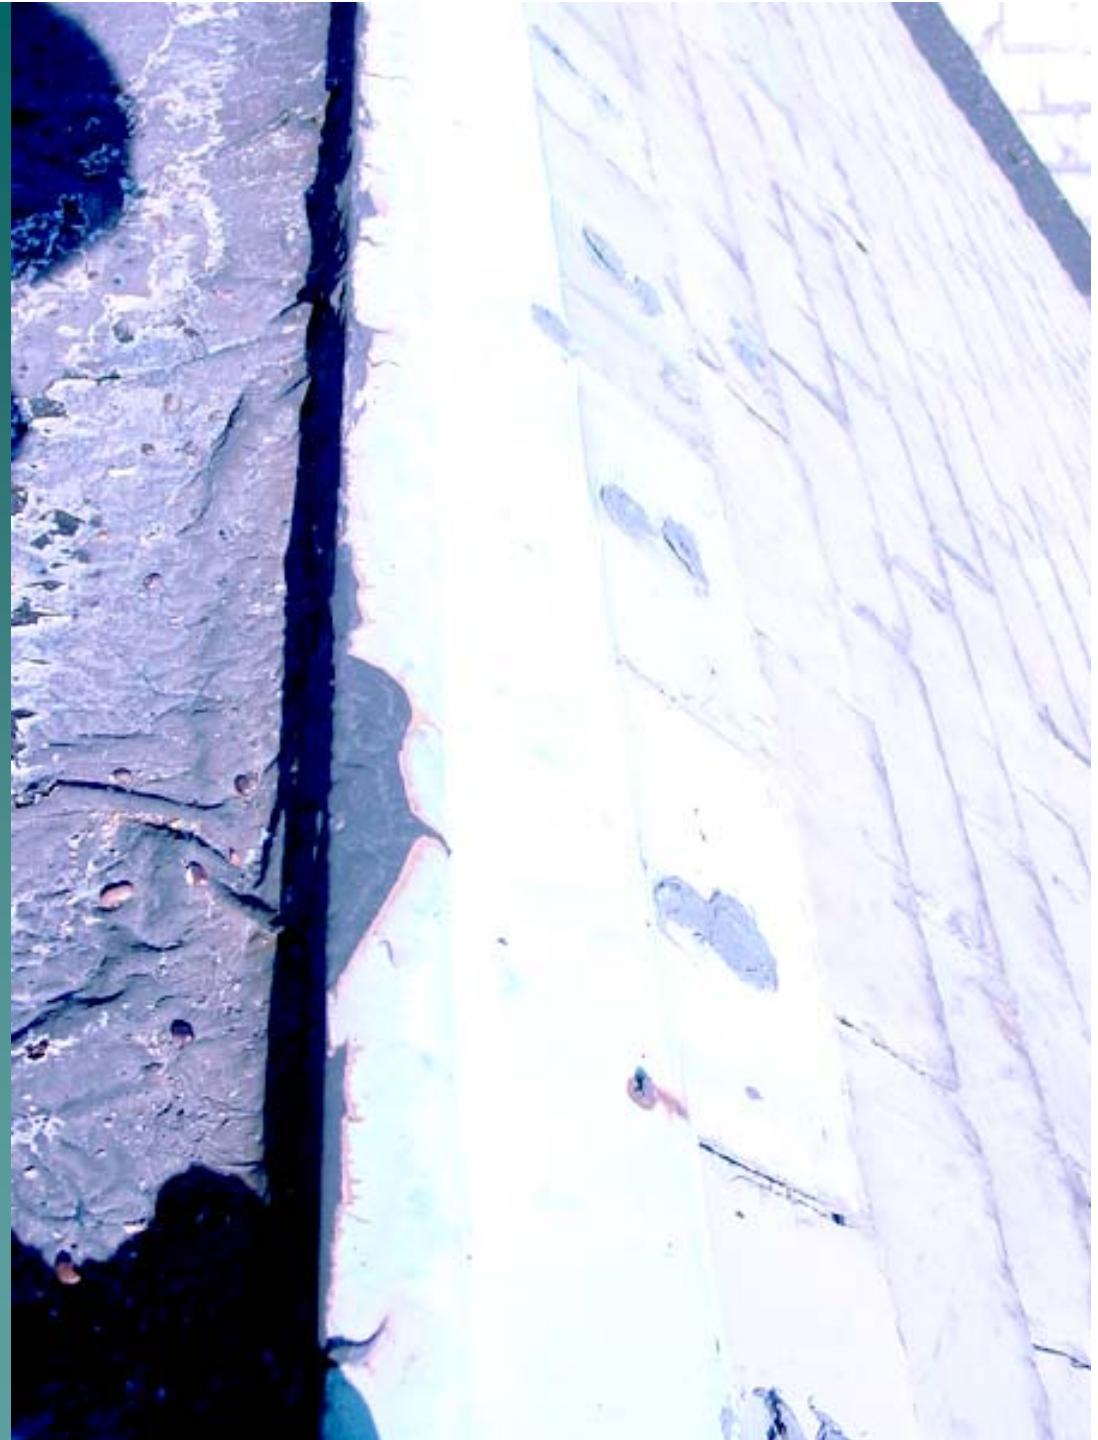
No. The leakage was not in the slate roof, but in an adjoining low-slope built-up roof. The Vermont slate itself was excellent.

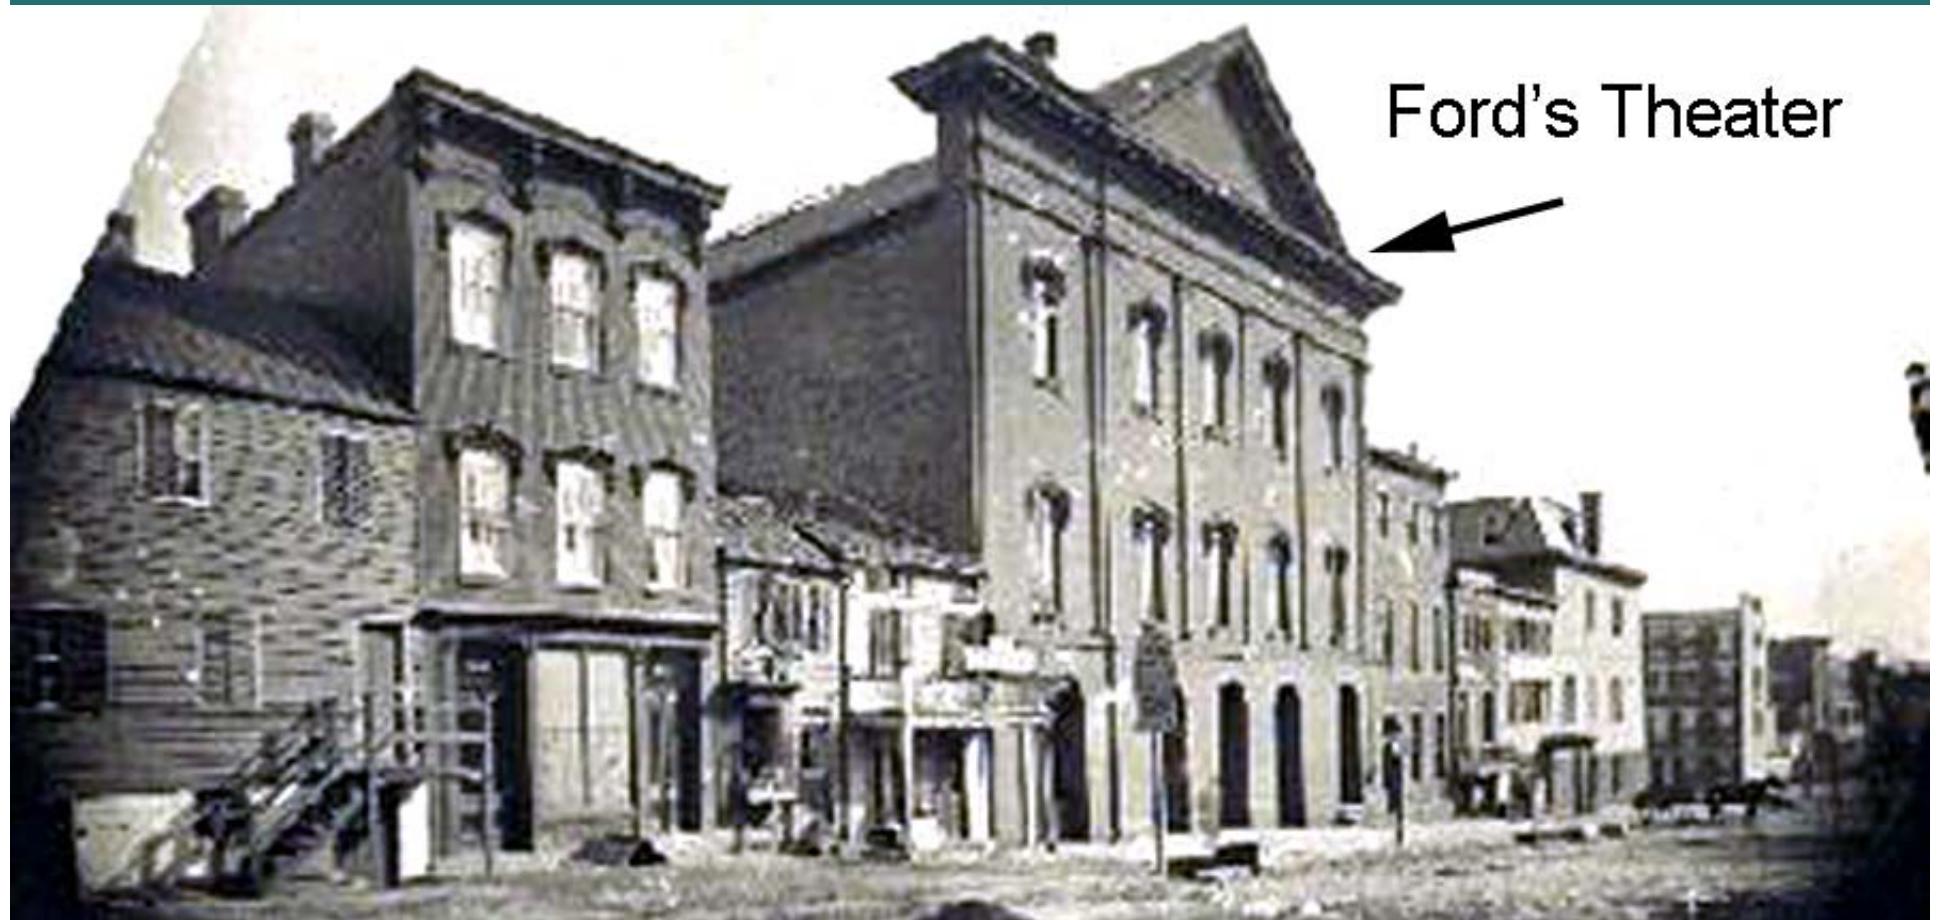
The coping was leaking on a parapet wall at a spot indicated by the arrow. The slate roof had already been completely replaced.

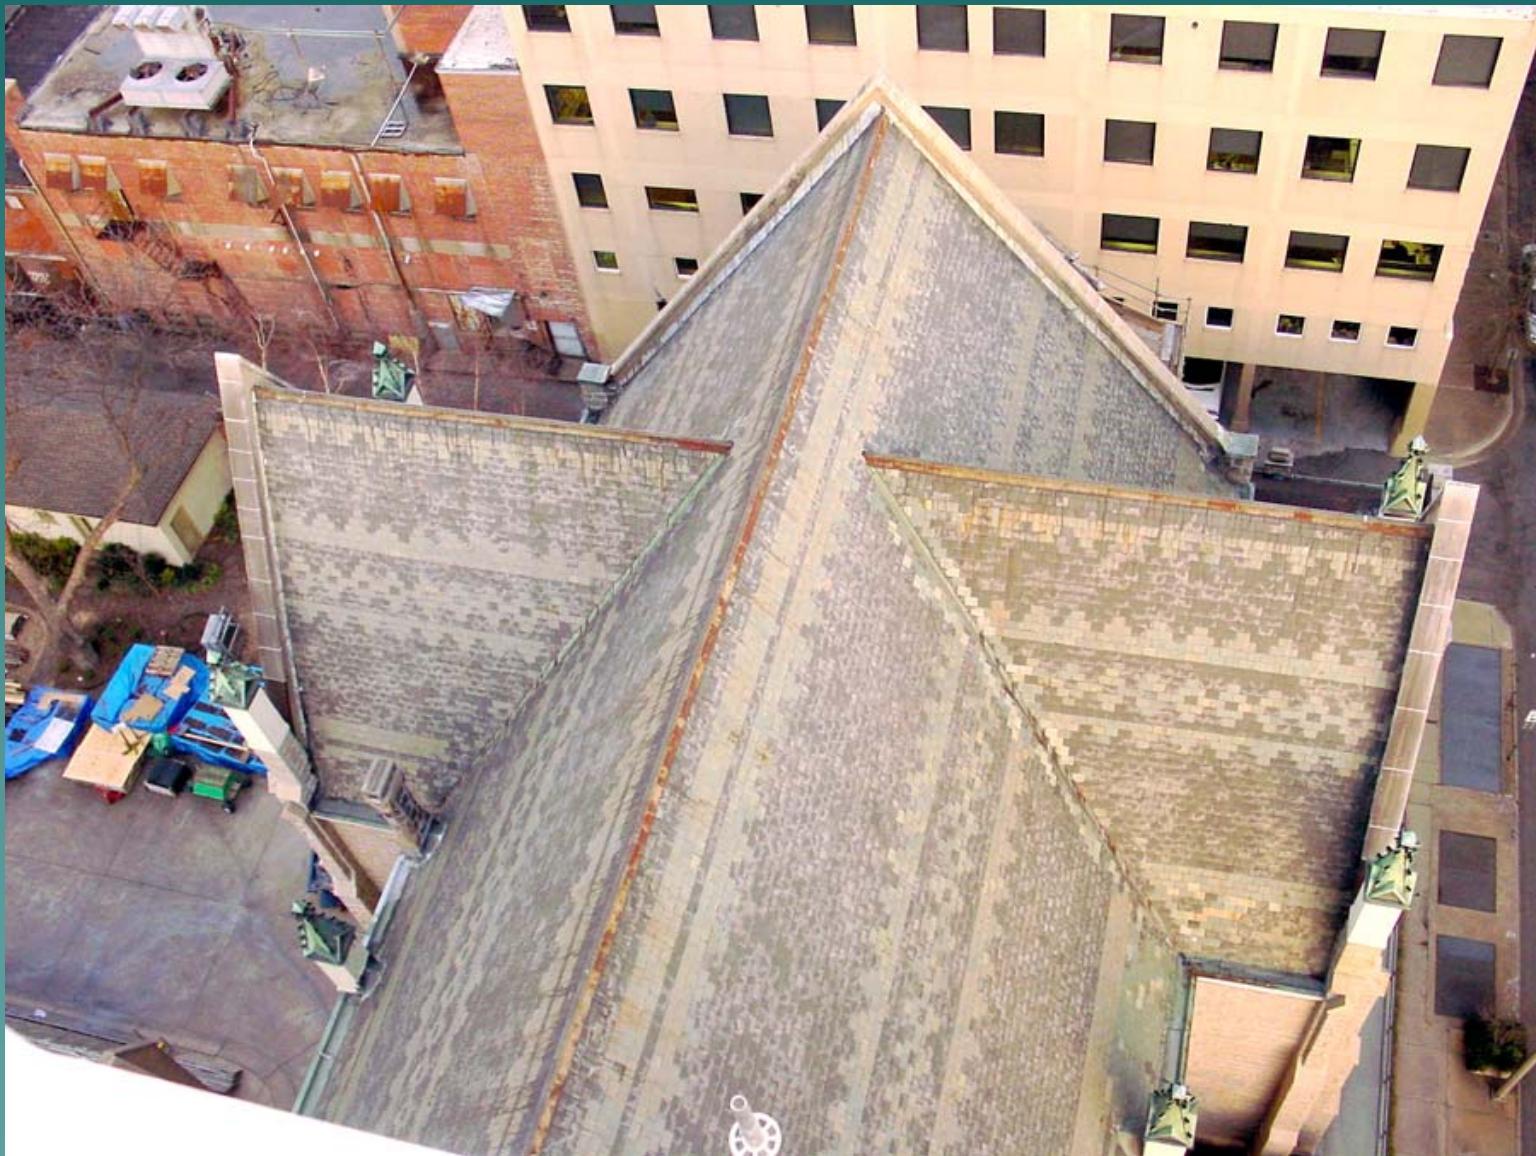
The black PA slates had worn out, although the green VT slates were still good after 120 years.

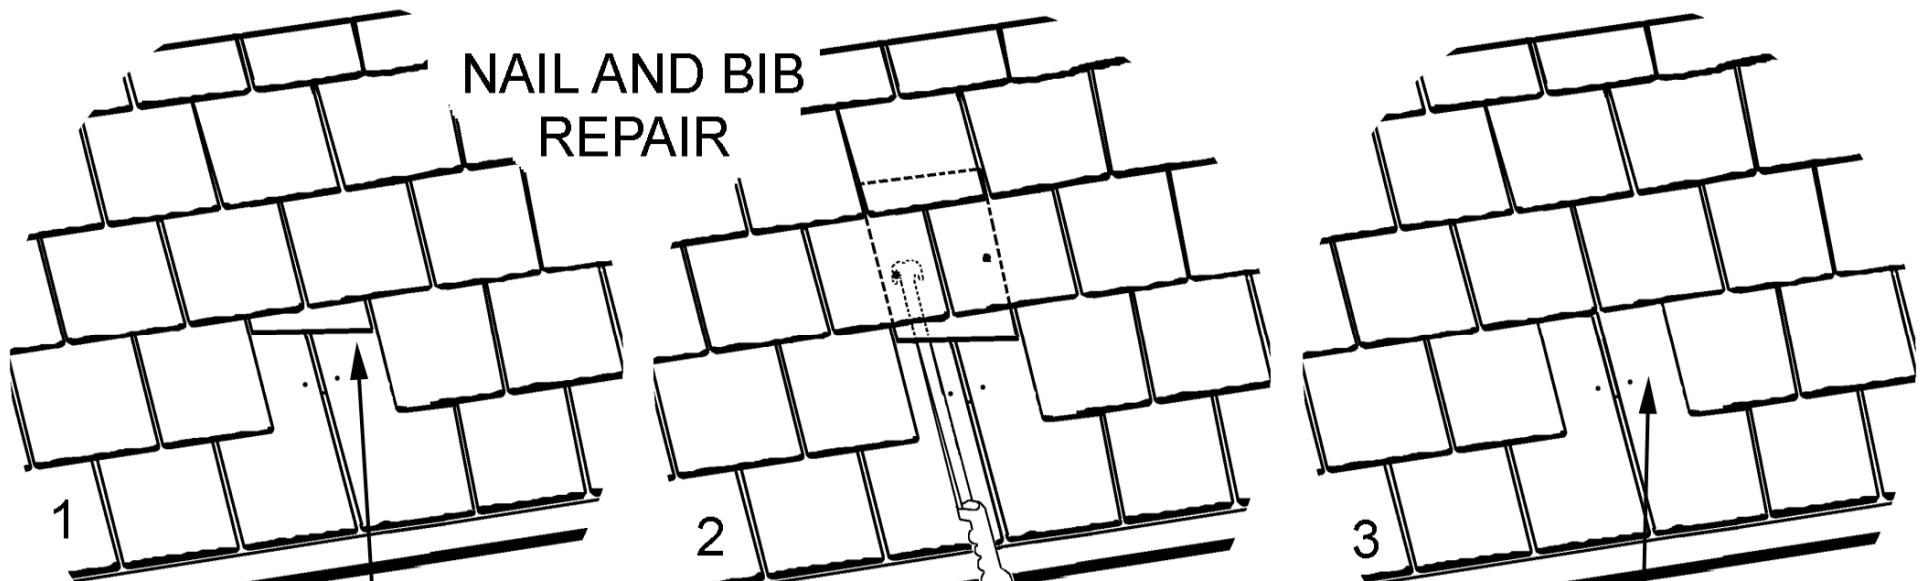
Any part of a slate roof can be removed and replaced. An individual slate can be removed and replaced, as can any flashings. This allows for long-term maintenance and repair.

Broken slate needs replaced

Slate ripper hooks slate nails
and pulls them out, removing slate

The slate has been removed and
the roof is now ready for a replacement

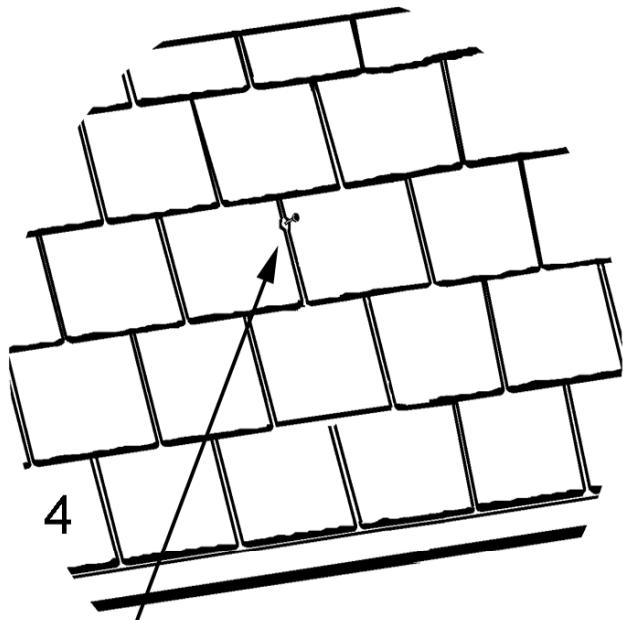
Replacement slate is slid into place
and fastened with a nail in the slot

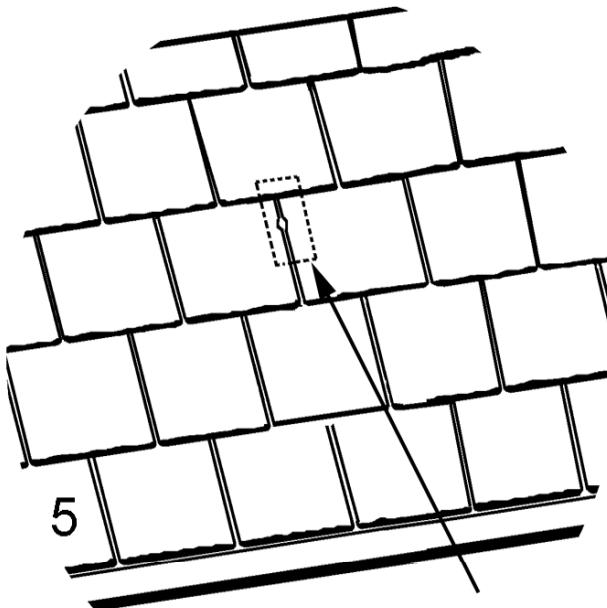
The roofing nail is tapped down and
a bib flashing is slid under the slate
but over the nail head

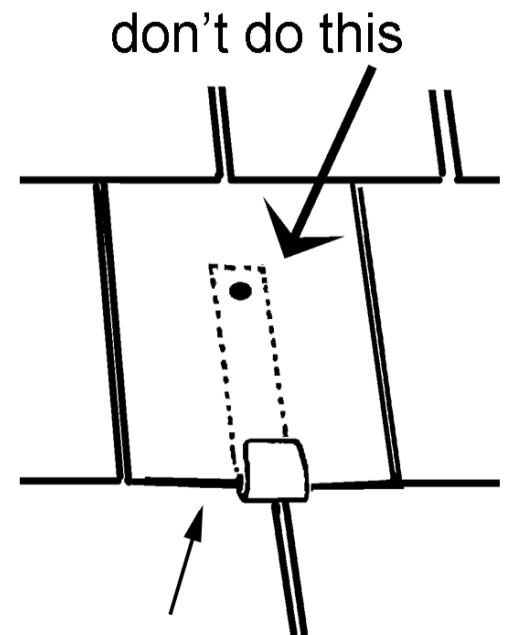
The above strap technique is undesirable
for two basic reasons: it looks bad and the
straps are easily bent open by sliding
ice and snow

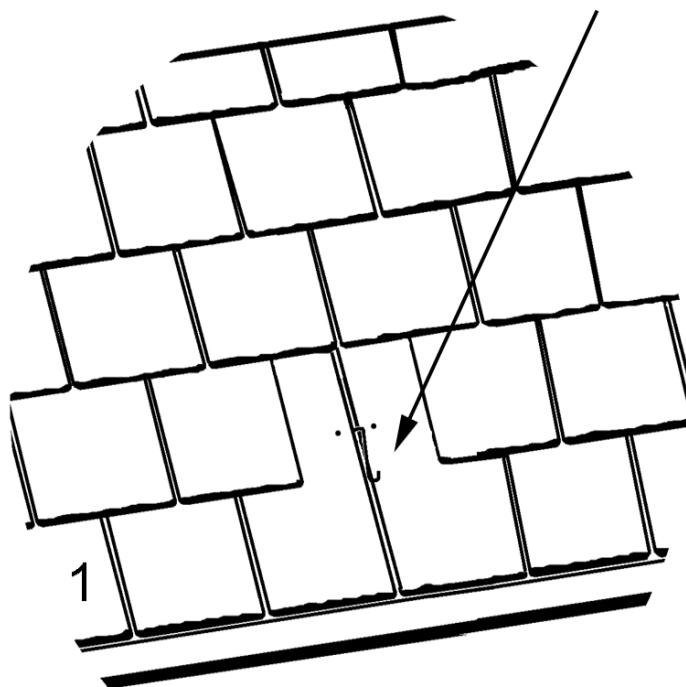
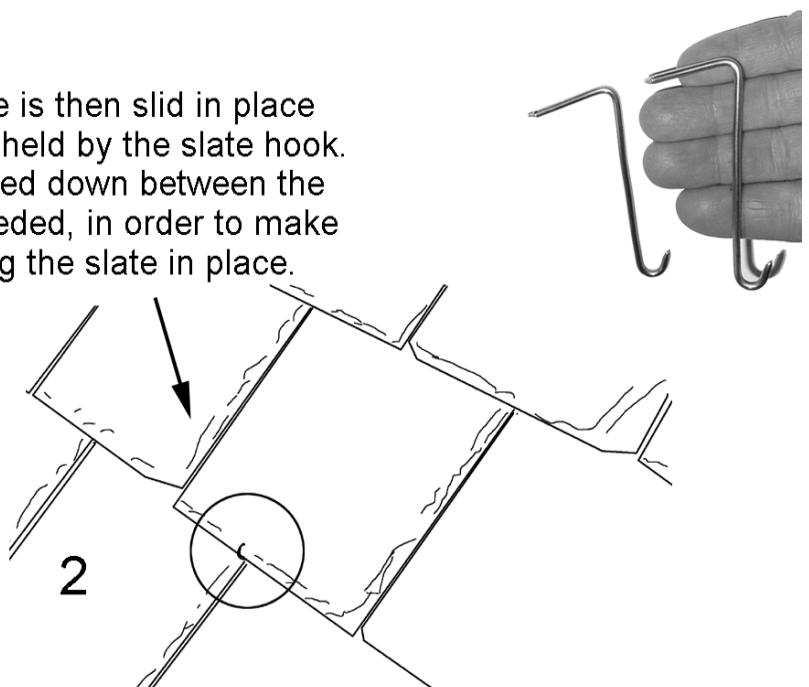
SLATE HOOK REPAIR

Alternatively, a copper or stainless steel slate hook can be nailed into place after the old broken slate has been removed

The replacement slate is then slid in place where it is permanently held by the slate hook.
The hook can be pushed down between the underlying slates, if needed, in order to make more room for sliding the slate in place.

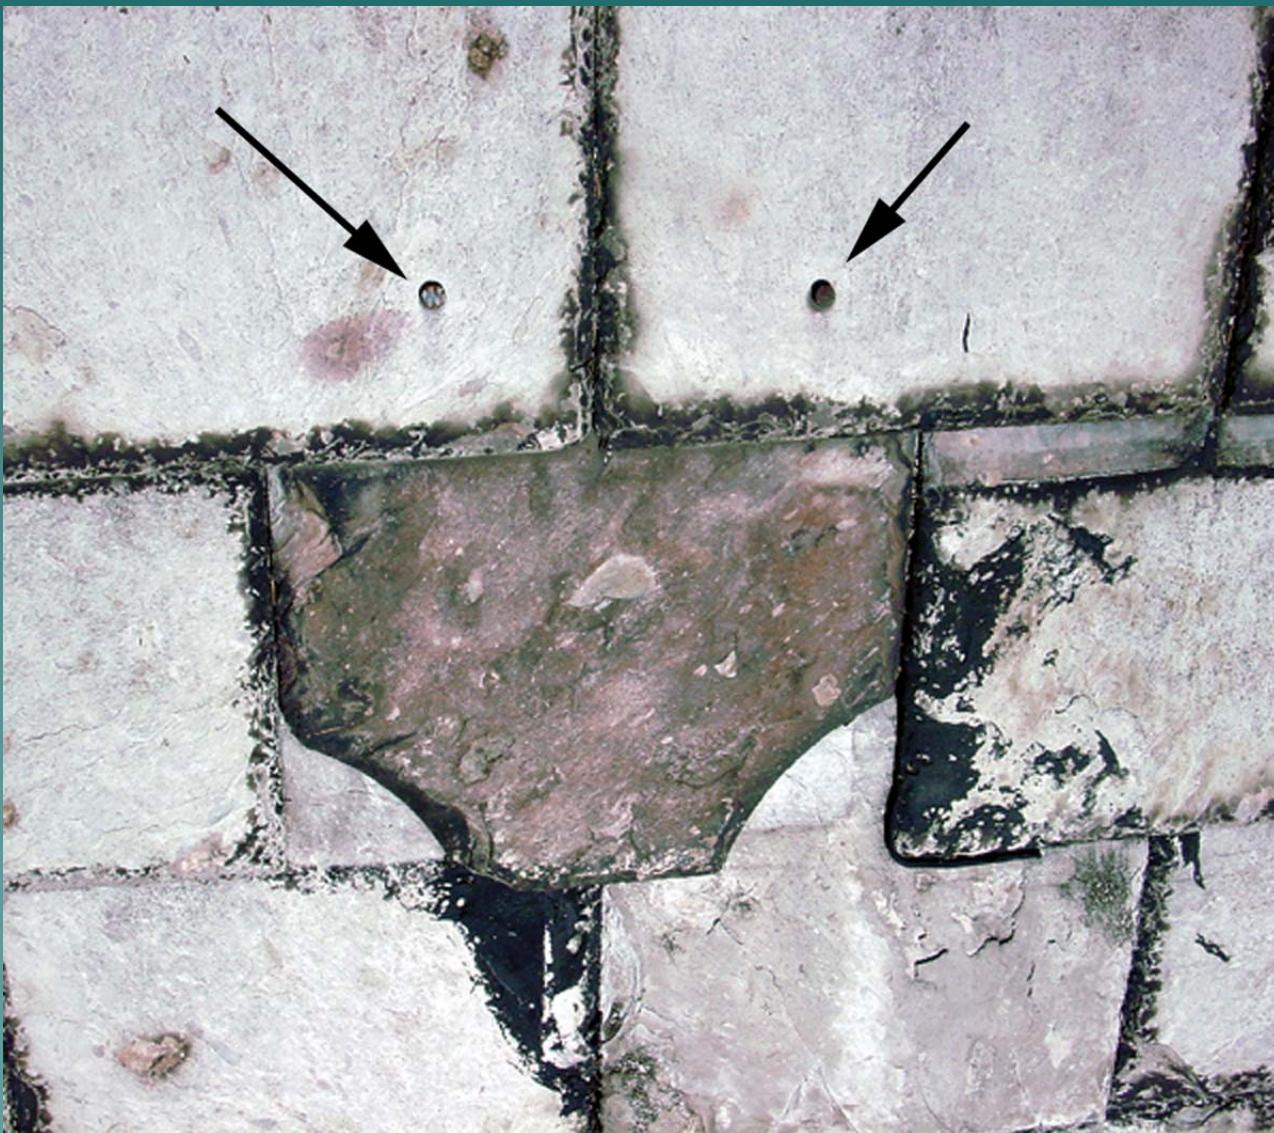
Bad repairs are a plague on many existing slate roofs. This repair slate is the wrong shape, wrong type, probably wrong length, and face-nailed.
