What Home Inspectors Need to Know About

Slate Roofs

Fabrication and Installation

By Joe Jenkins

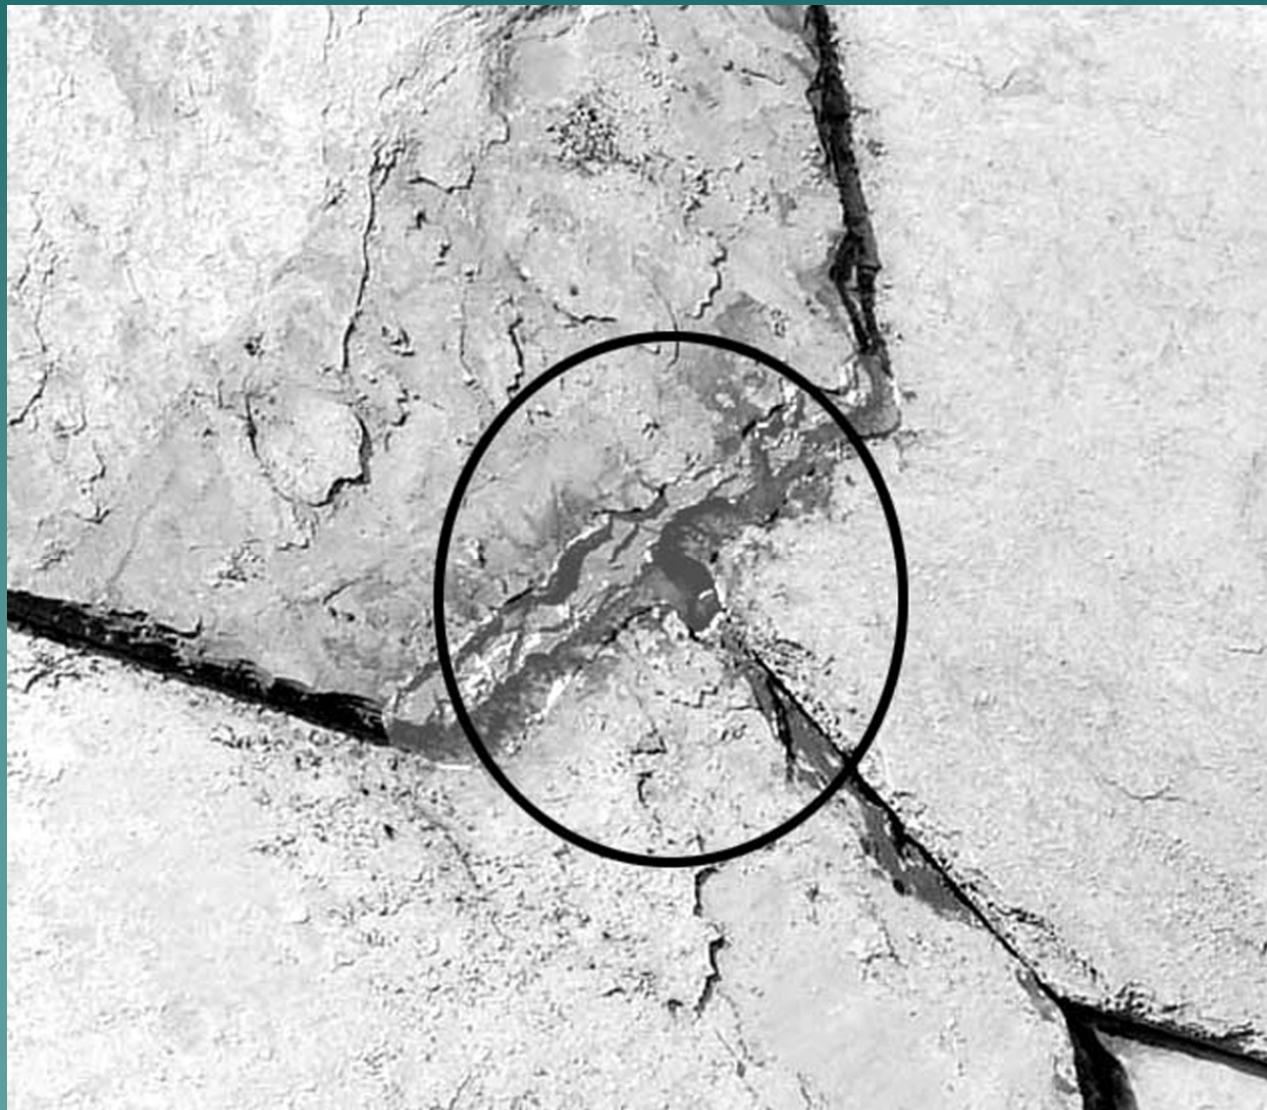
A hidden “repair” nail, without a bib covering it, creates a persistent leak that is difficult to see or find.

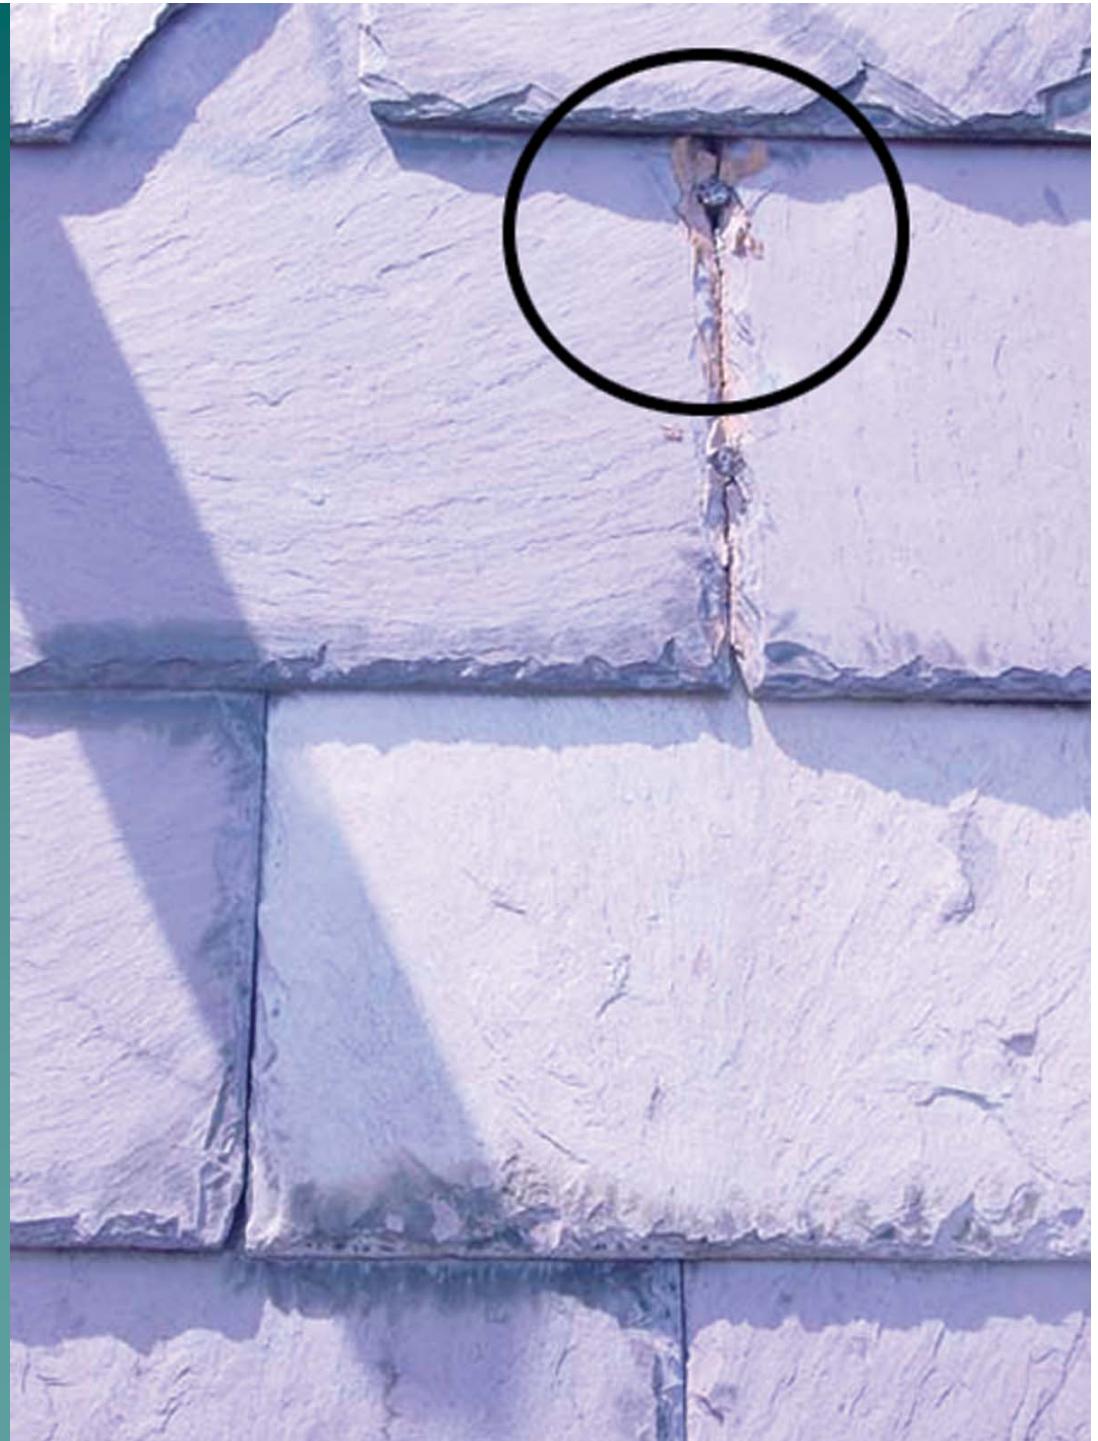
Here's another example of a repair nail without the necessary bib flashing. This is a notorious source of leakage and is difficult to spot from the ground.

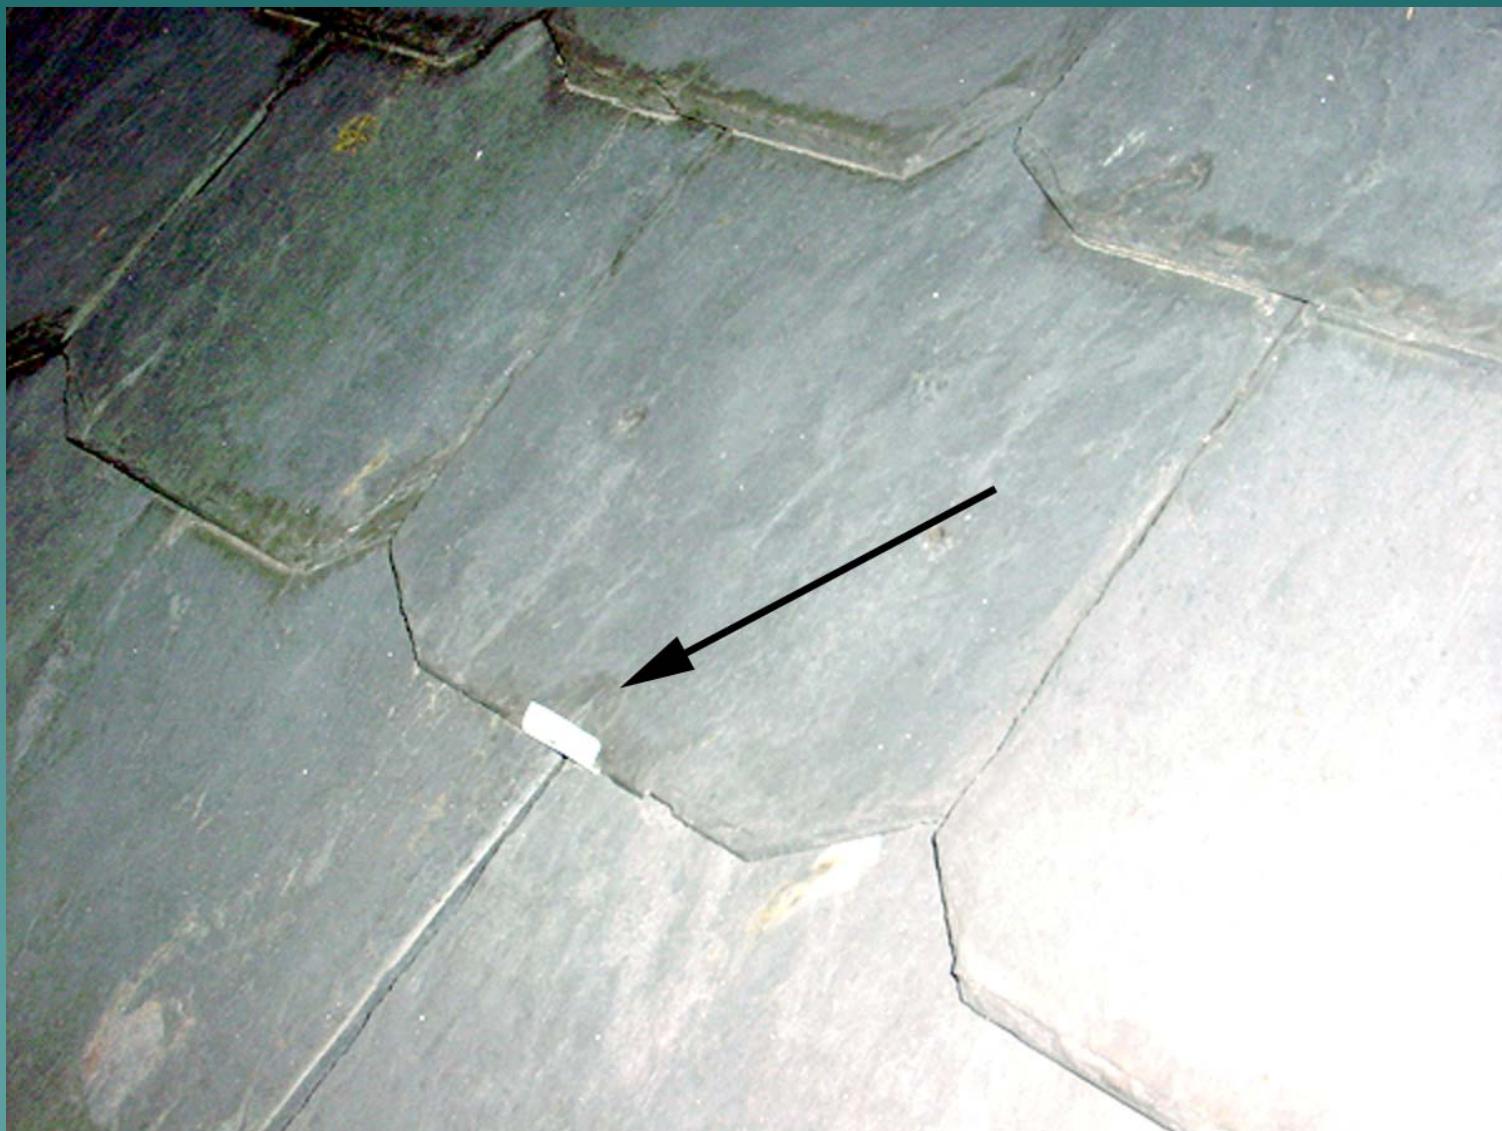
Strap hangers are a mistake. They are unsightly and unnecessary. They will flatten out under the pressure of ice and snow and will allow the slate to slide out.

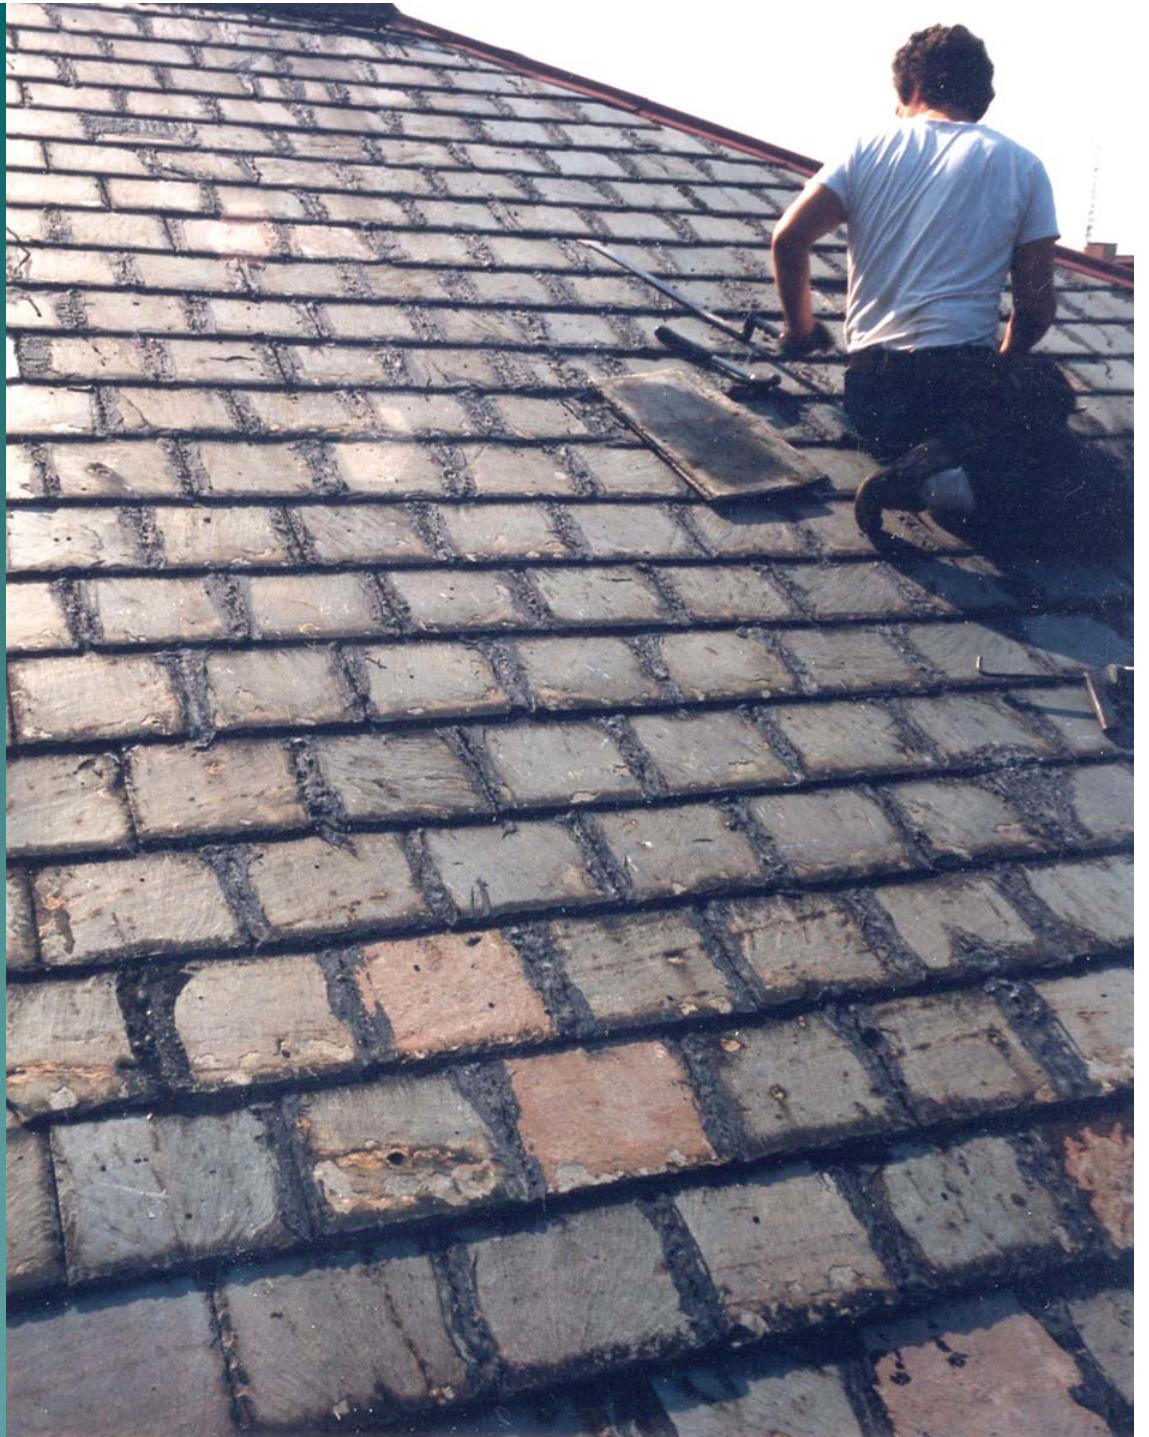
Roof cement (or “mastic”) applied to the surface of a slate roof is a mistake. It is very unsightly and does not permanently stop leaks. It makes the roof much more difficult to repair properly.

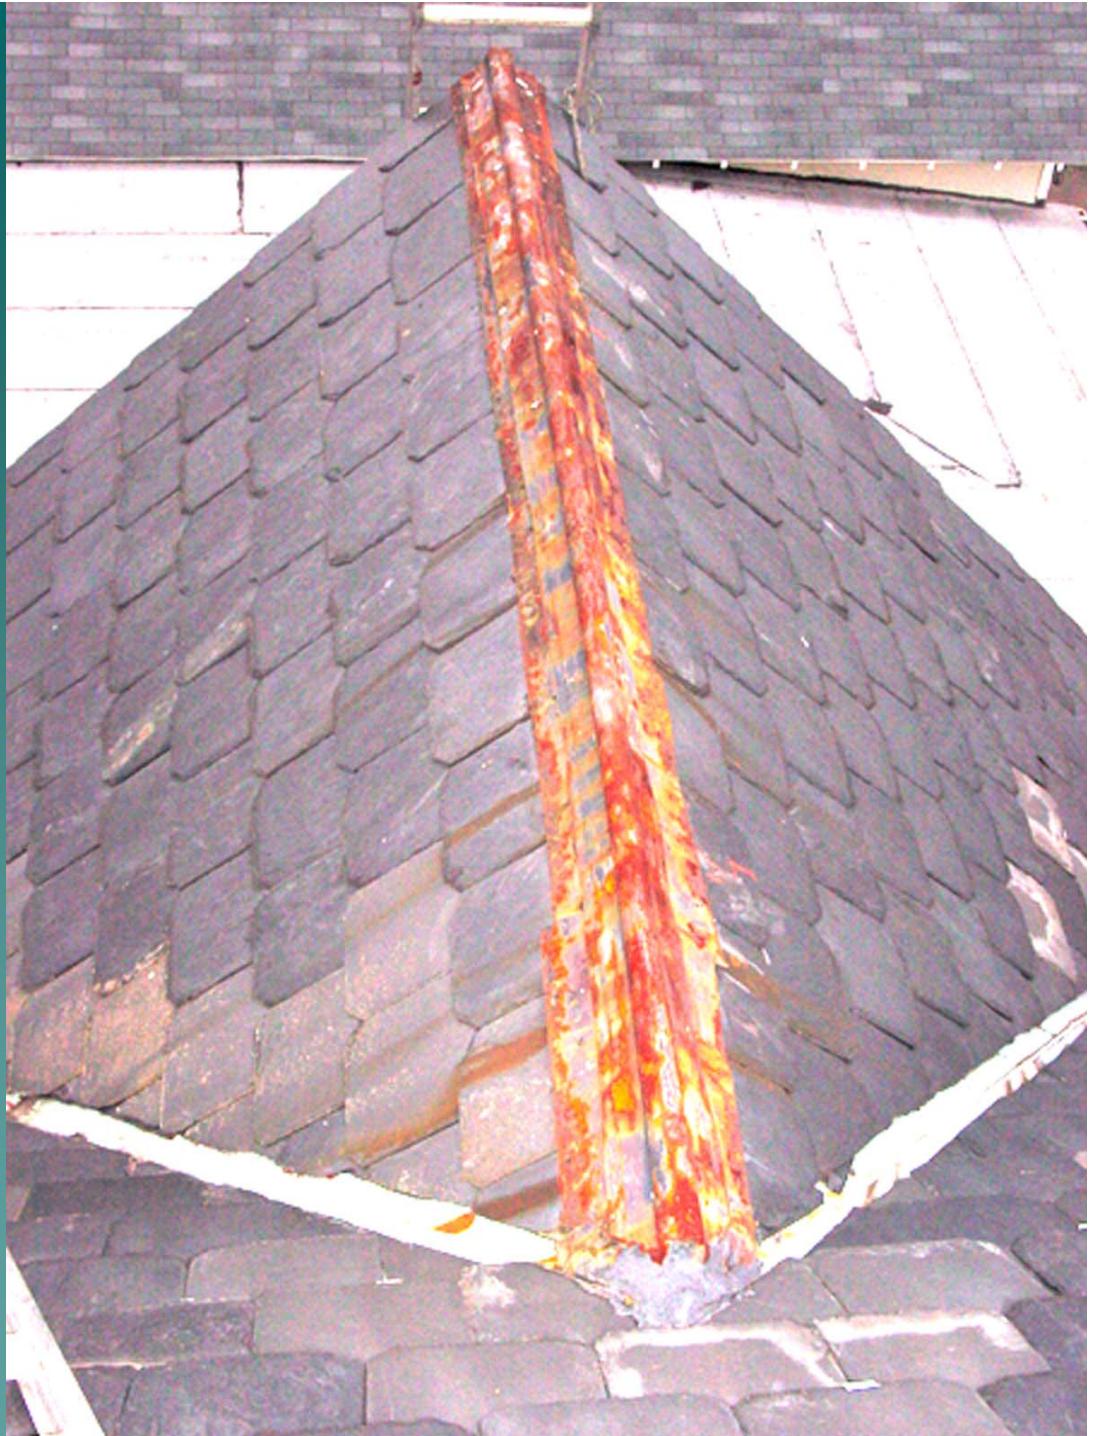
During restoration, old rusty tin flashings, such as the ridge metal on this church, should be replaced. Often, just a coat of paint will be enough if the metal is still sound.

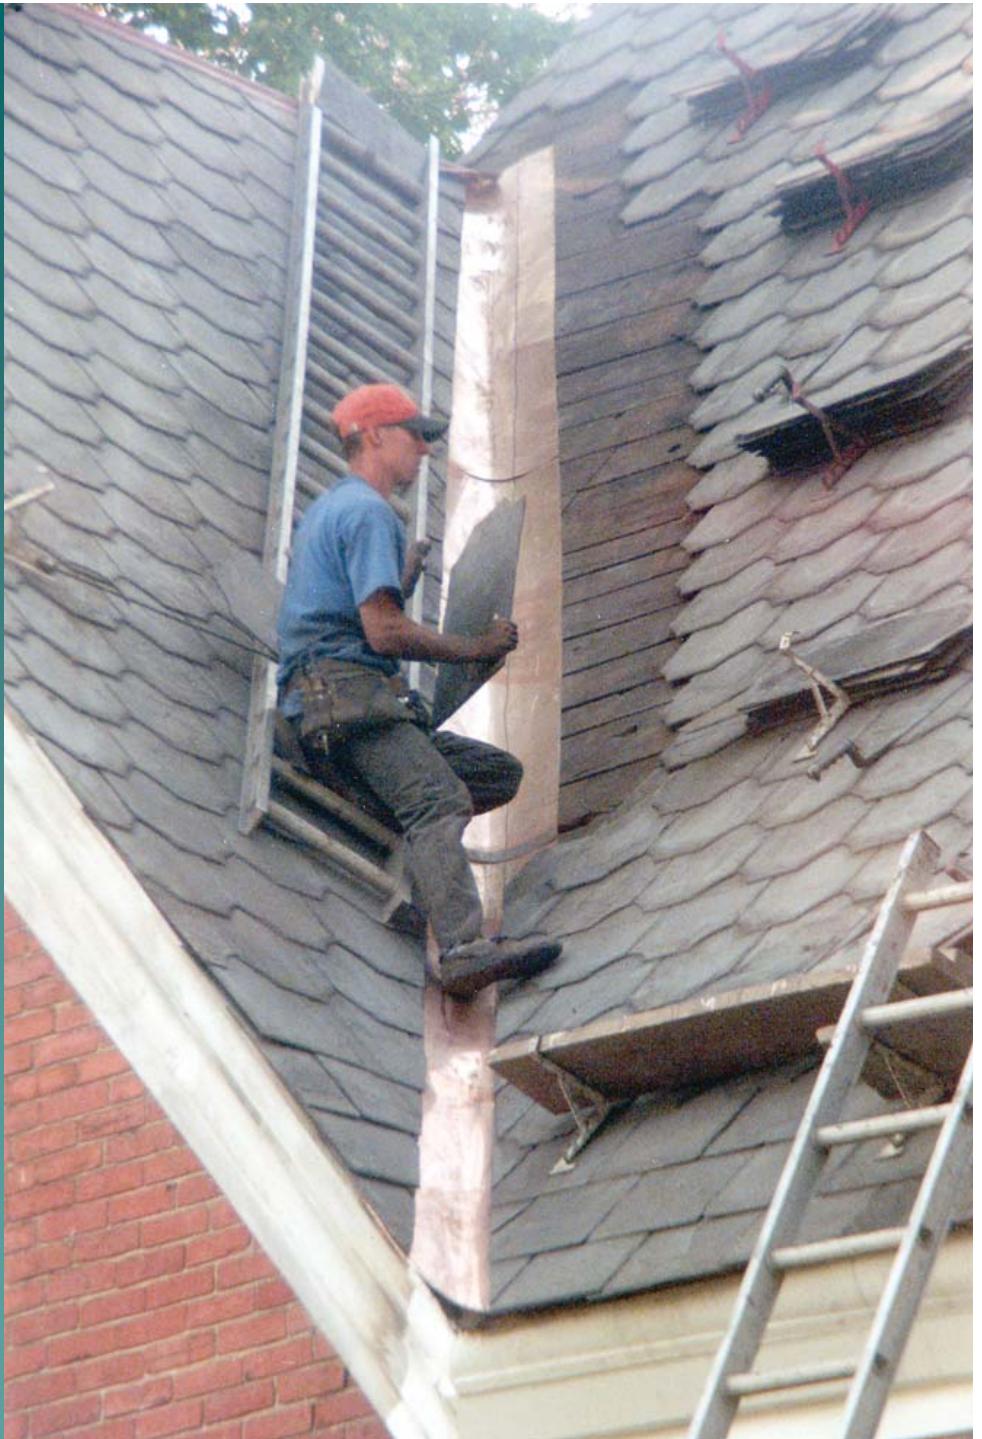
This is a valley replacement on a church with a 104 year-old PA black slate roof. Note that no underlayment (felt paper) whatsoever is being used - it's not necessary. There is no functional underlayment on old slate roofs anyway.

When replacing valleys, the old valley metal must first be completely removed.

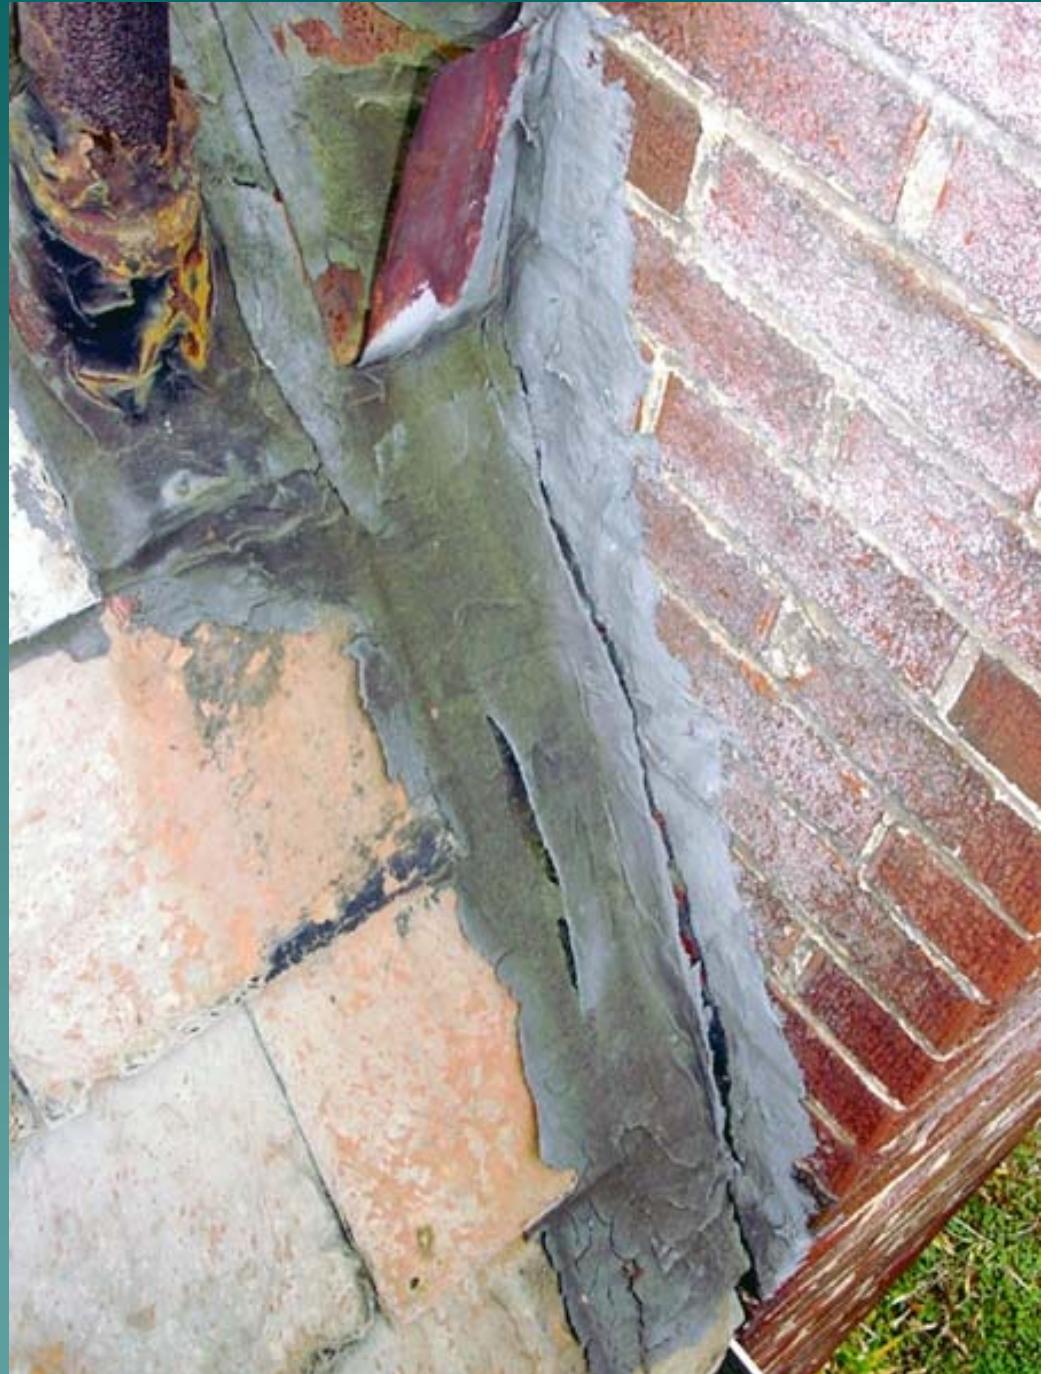
This is the sort of faulty chimney “repair” seen all too often on slate roofs.

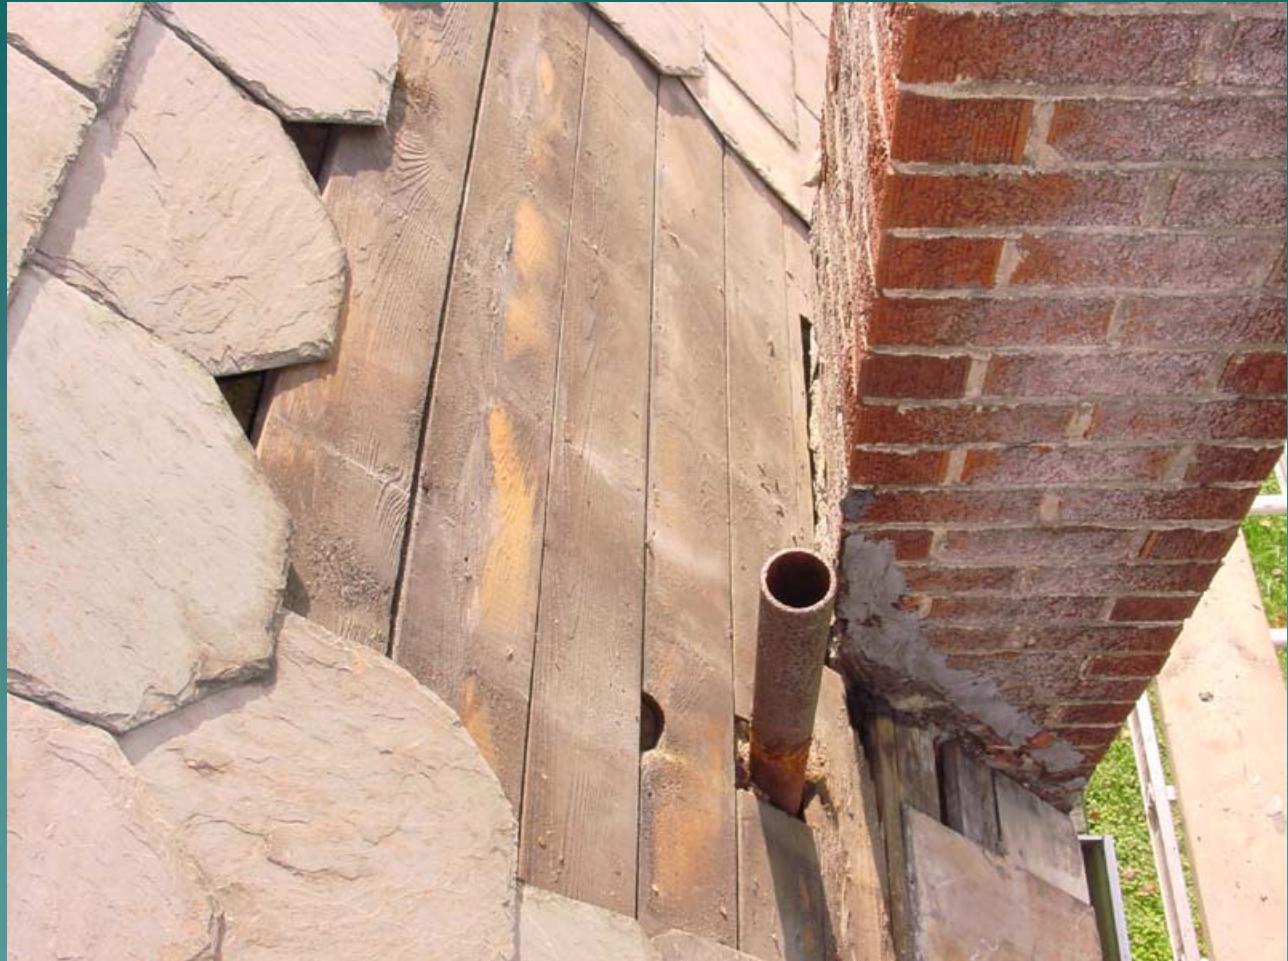
First, all of the offending material is removed down to bare wood.

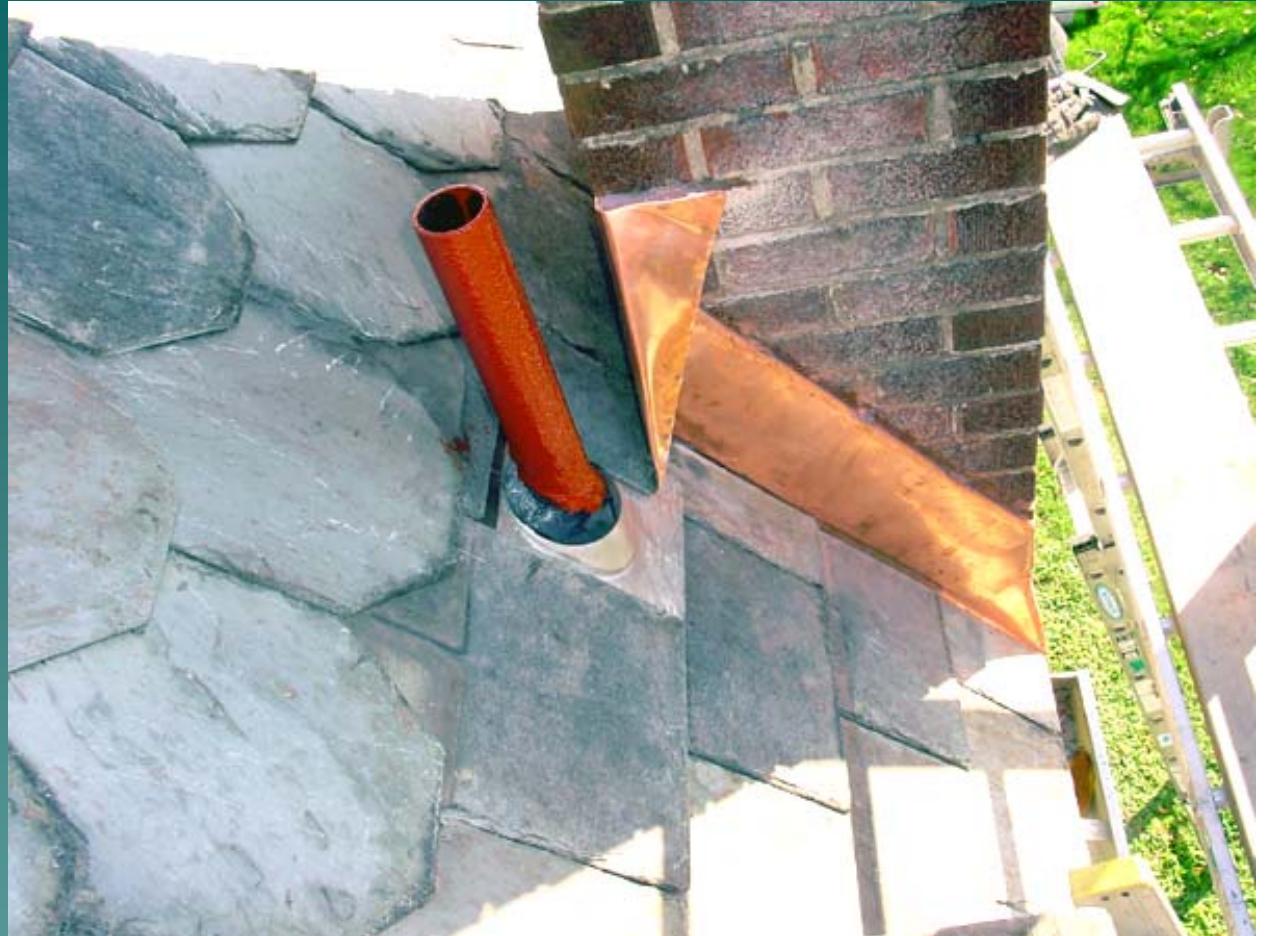
Then it is properly replaced.

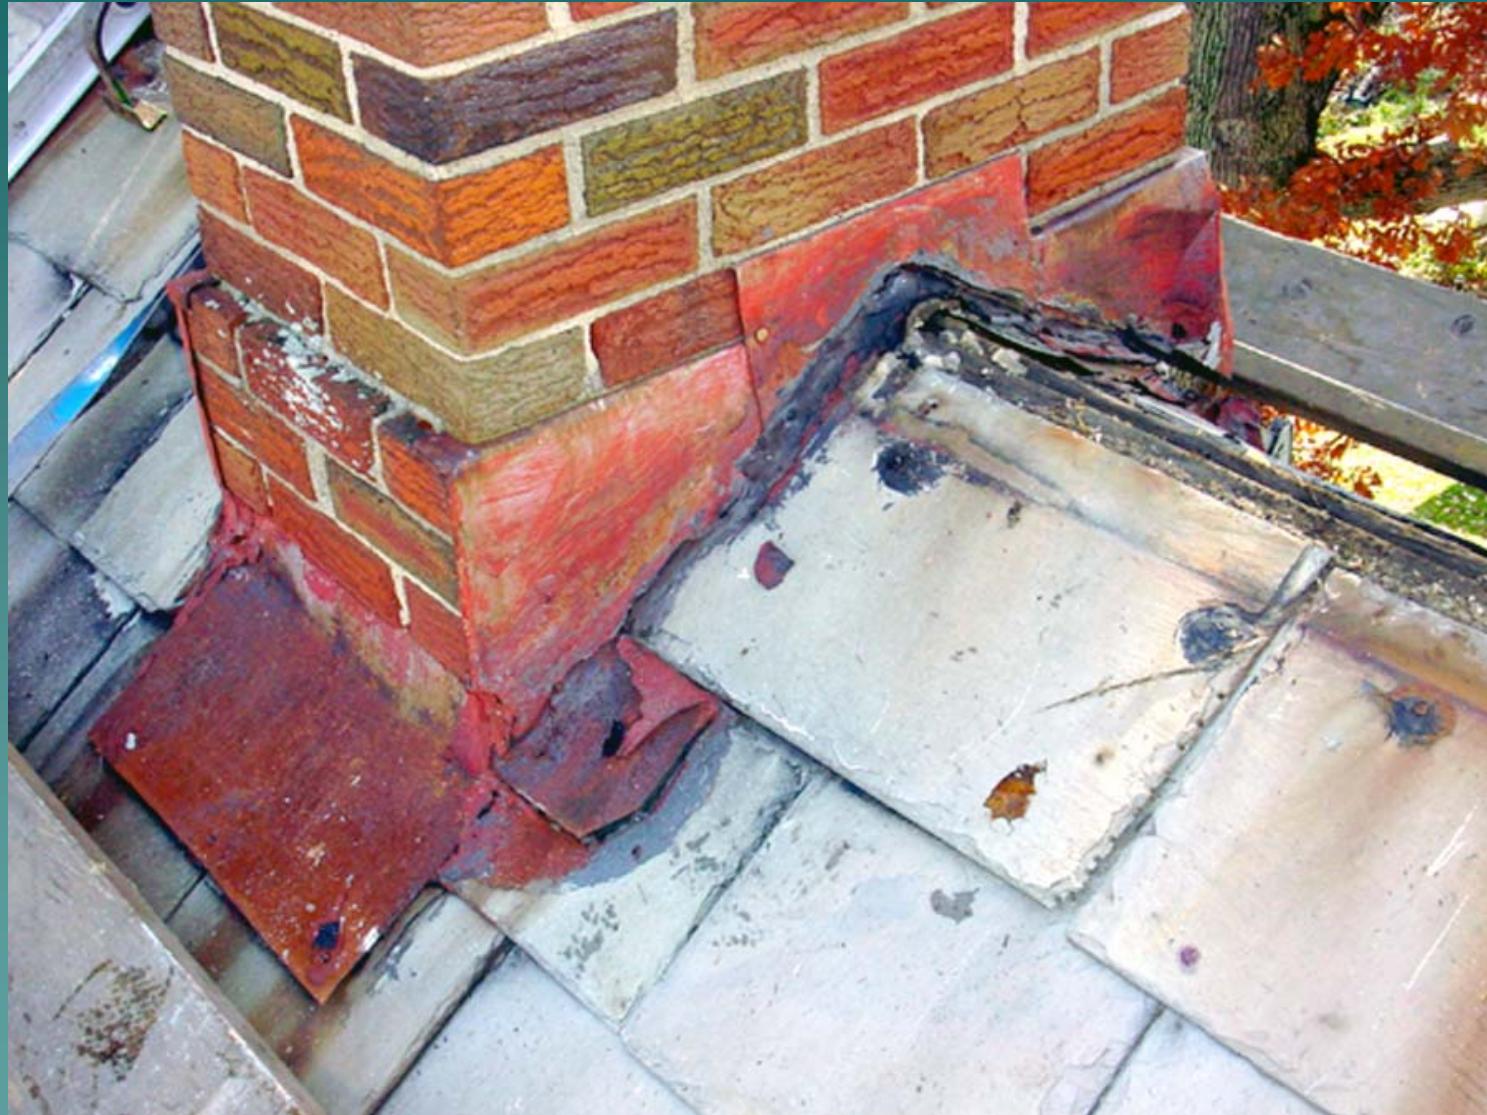
Another example of a chimney in poor condition.

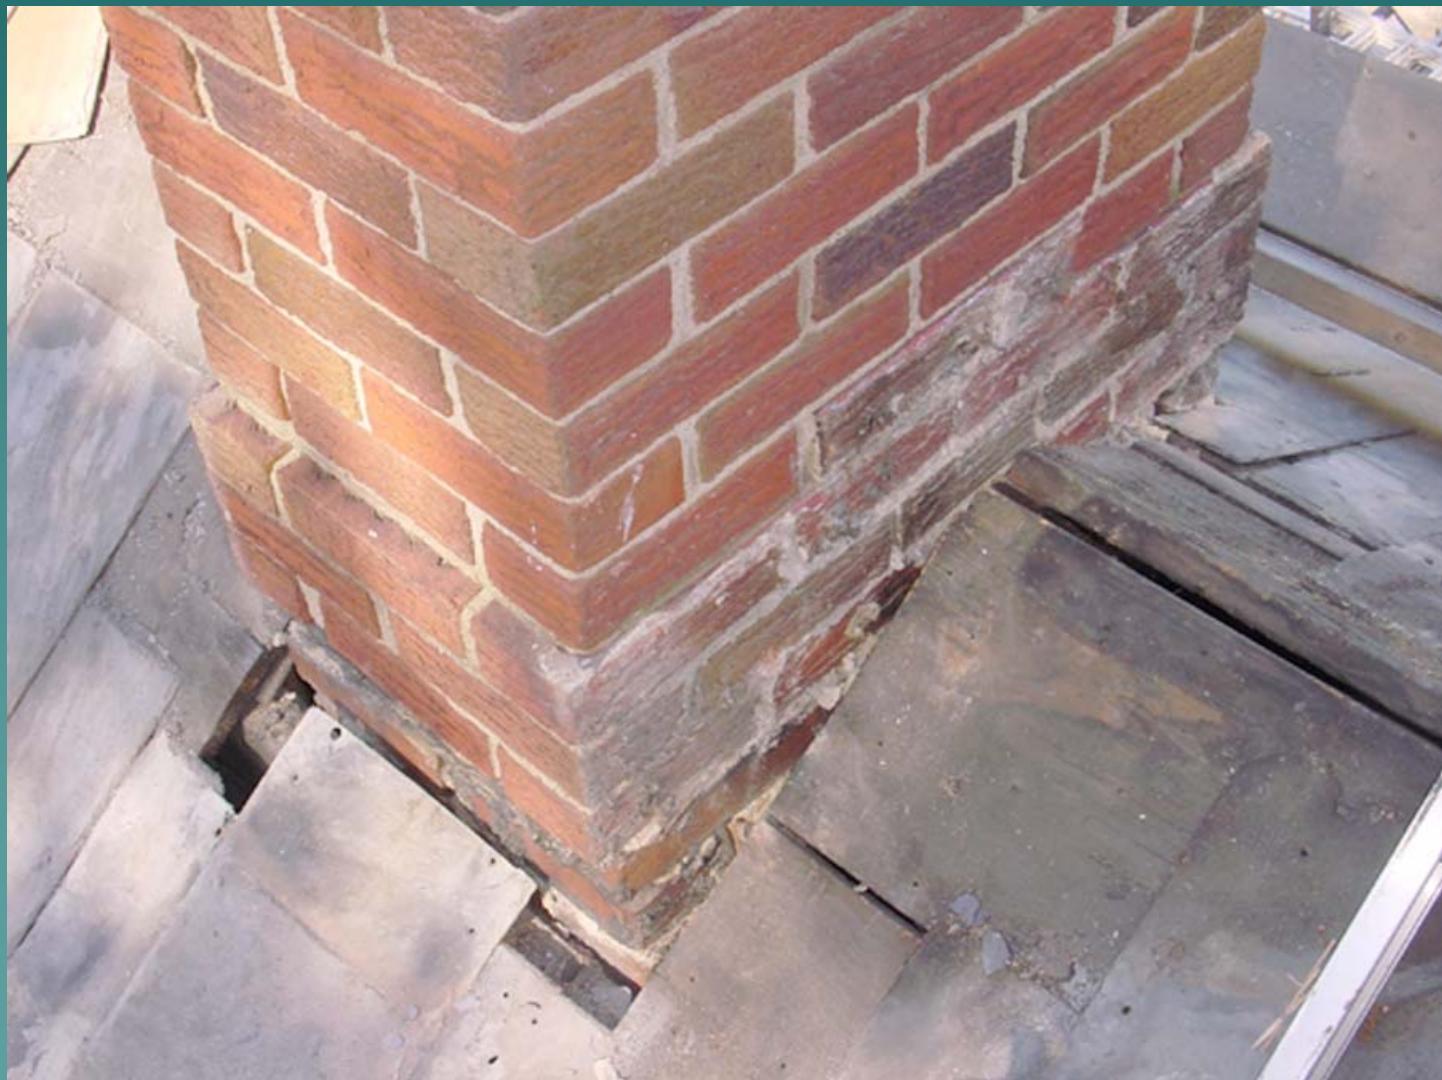
The same procedure is followed – clean it down to the bare wood and get rid of all tar, bad flashings and bad slates.

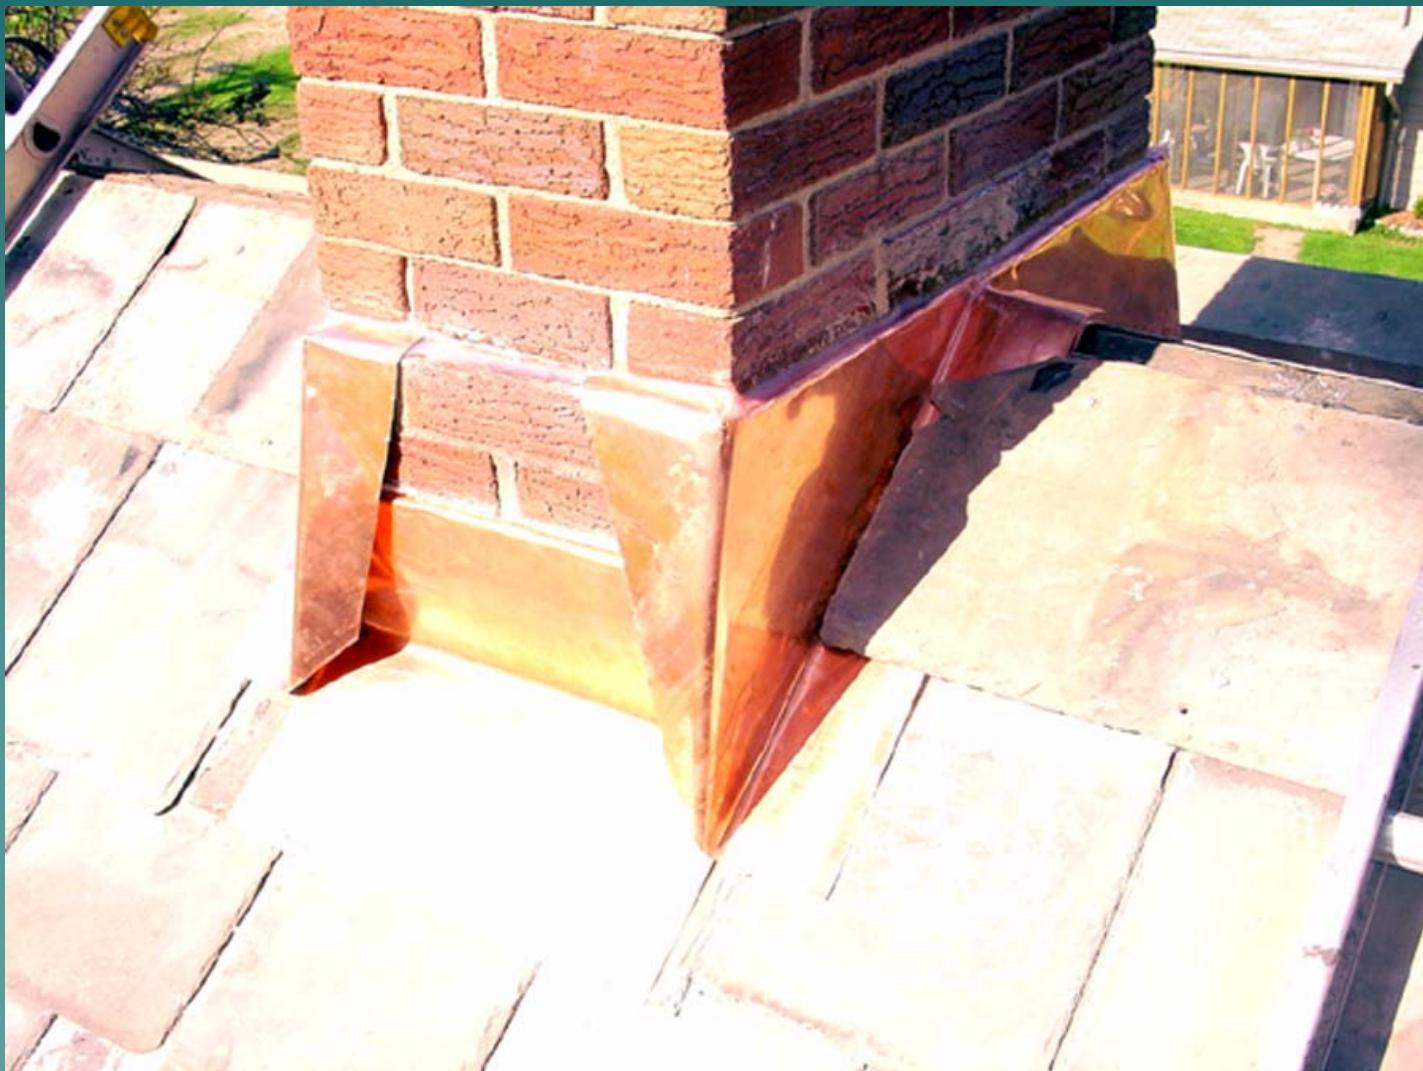
Replace the old metal with new copper and replace all faulty slates with good matching slates. Now the roof is as good as new.

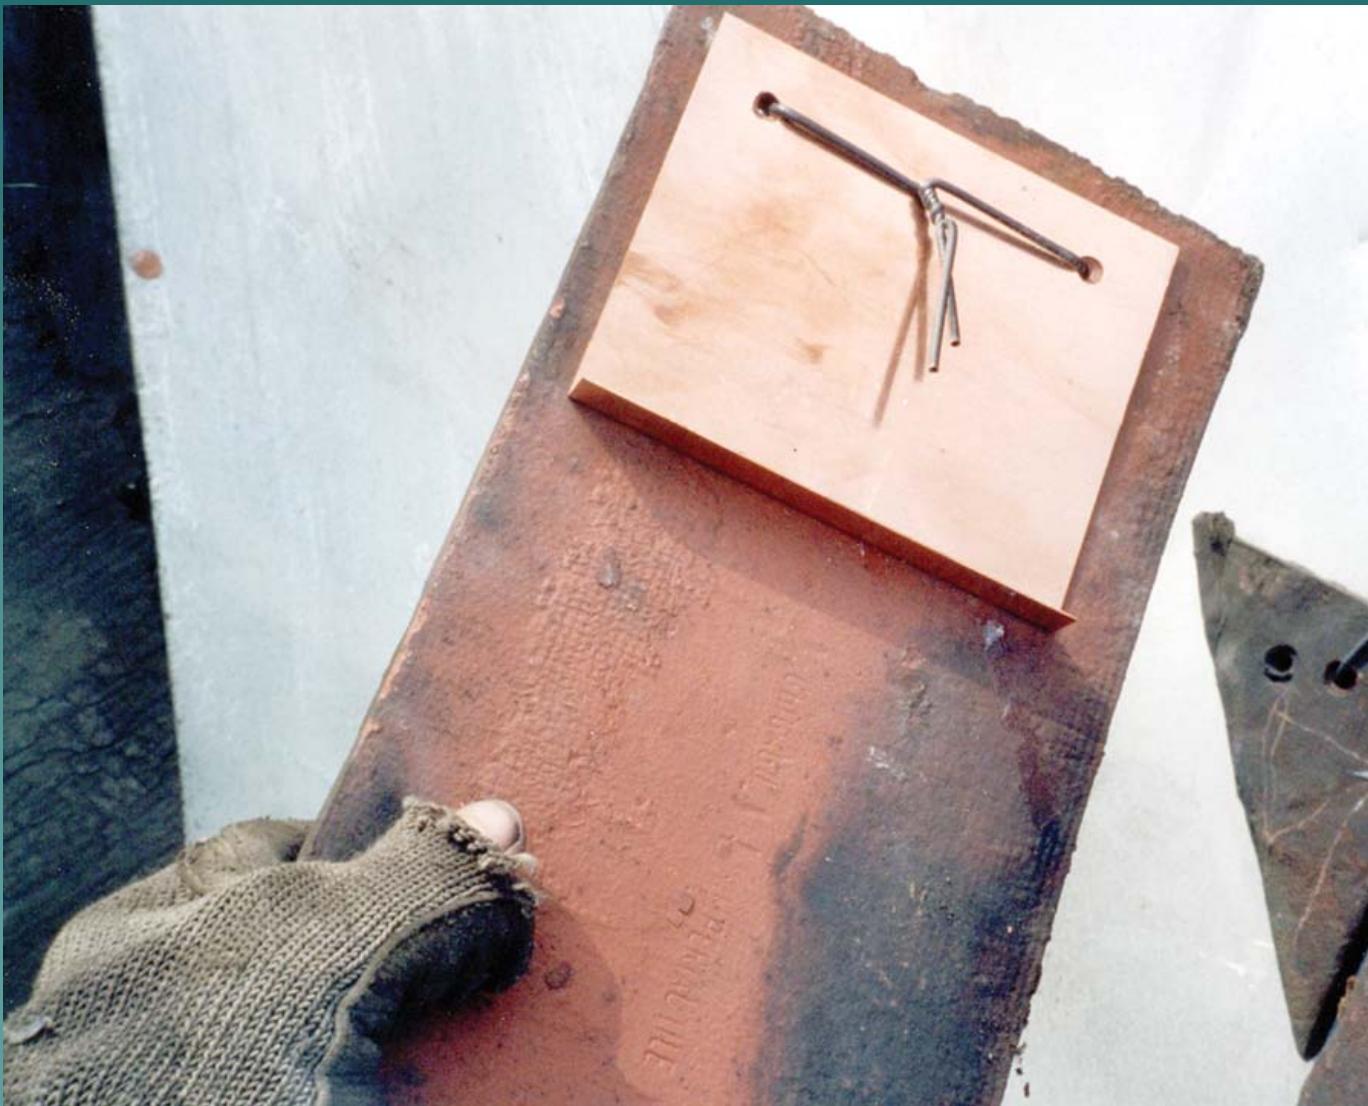
Replacement tiles must be hung on “tile hangers” attached to the back of the tile. This hanger is 20 ounce copper attached with caulk and a copper wire.

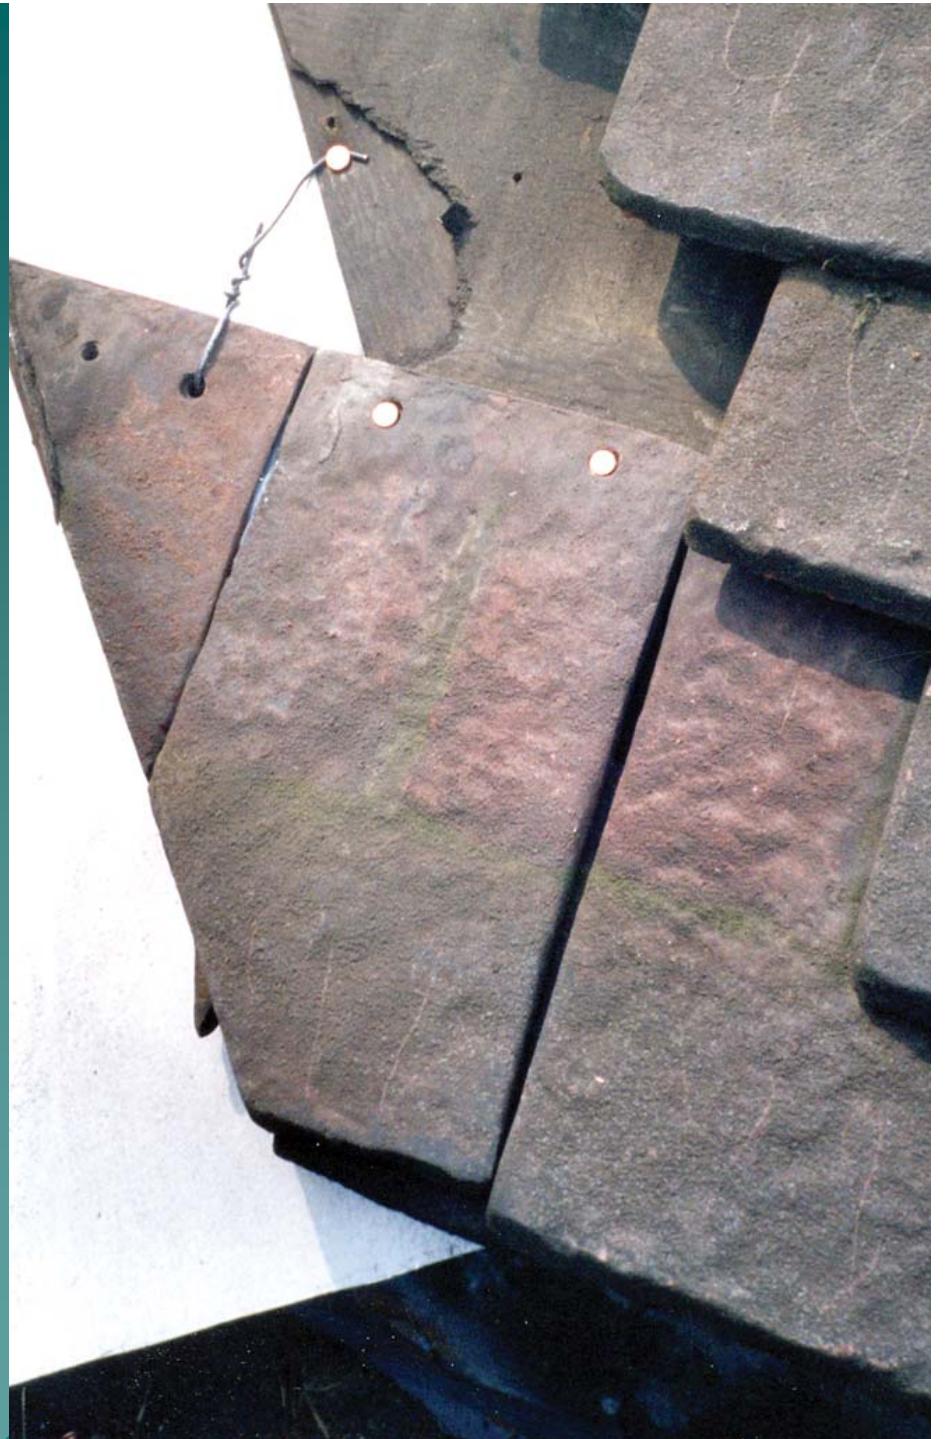
Unlike slates, replacement tiles
are sometimes hung on wires.
