# What Roof Consultants Need To Know About Slate Roofs

By Joseph Jenkins

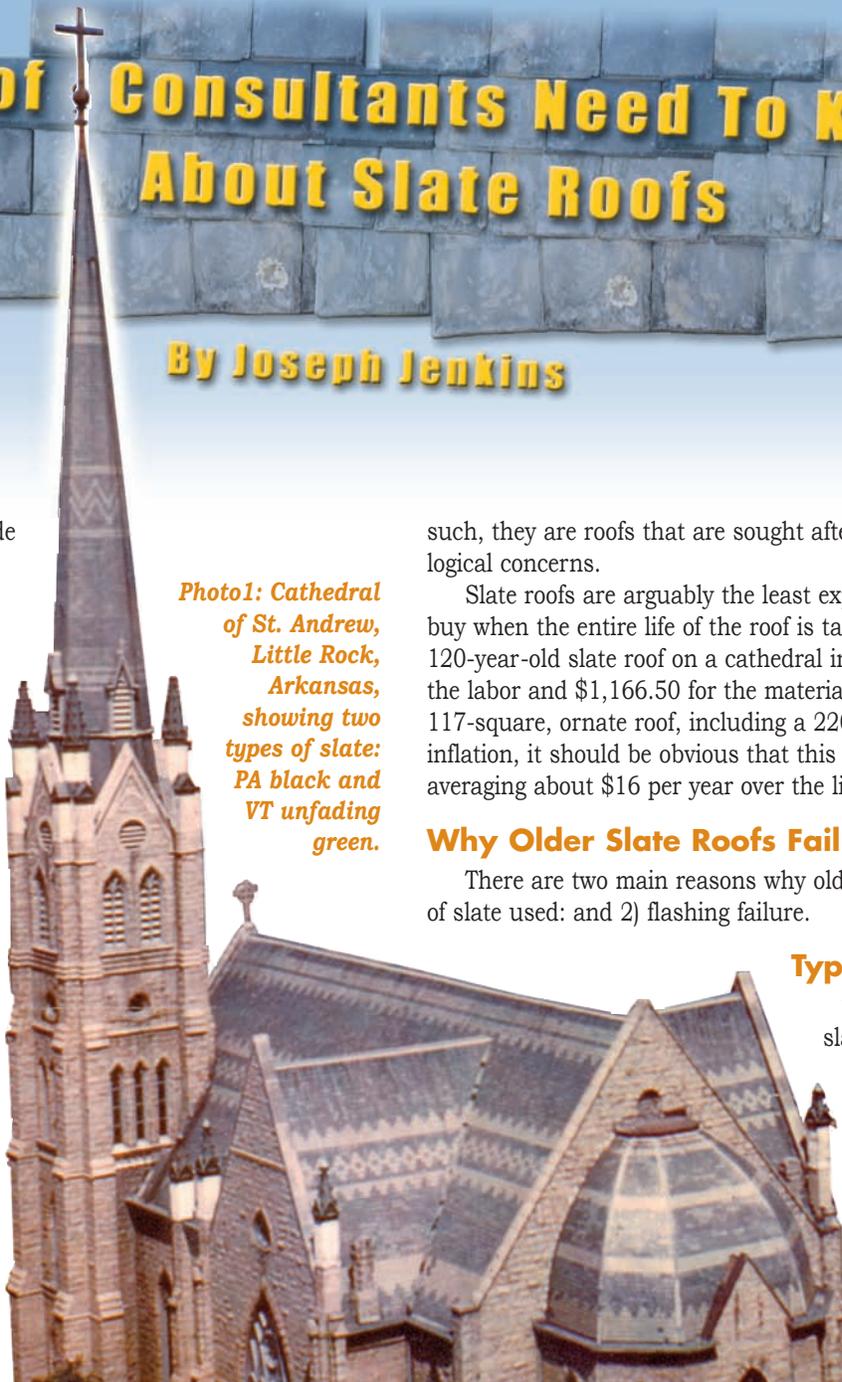
*Photo 1: Cathedral of St. Andrew, Little Rock, Arkansas, showing two types of slate: PA black and VT unfading green.*

Slate roofs are arguably the least expensive roofs money can buy when the entire life of the roof is taken into consideration. A 120-year-old slate roof on a cathedral in Arkansas cost \$765 for the labor and \$1,166.50 for the materials in 1881 to install the 117-square, ornate roof, including a 220-foot spire. Adjusted for inflation, it should be obvious that this was money well spent, averaging about \$16 per year over the life of the roof (See Photo 1).

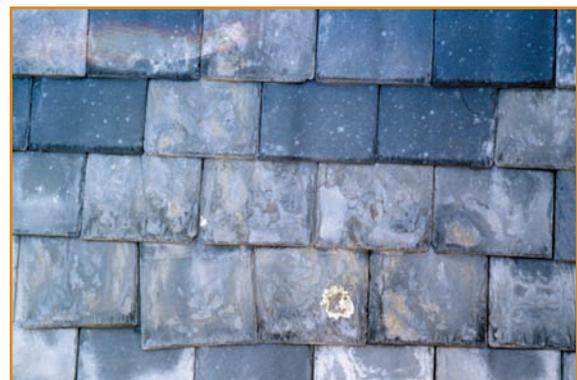
*Photo 2: Softer Pennsylvania black slate, 120 years old, on cathedral in Little Rock.*

black and green slate. The green slate originated in Vermont, while the black slate originated in Pennsylvania (Photo 2). The black slate had a life expectancy of about 120 years and was showing a lot of delamination and crumbling. The slates had served their useful life and were now failing. The green slates, on the other hand, showed no deterioration after 120 years (Photo 3). It's anyone's guess how much

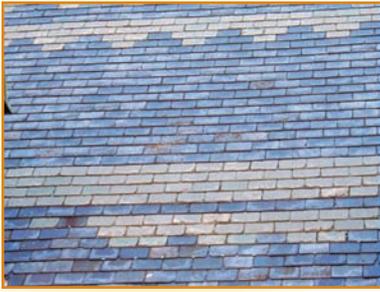
**Photo 3: Pennsylvania black and Vermont unfading green slate, 120 years old, on St. Andrews Cathedral. Black is worn out; green is still good.**

longer they would last. If the entire roof had been installed with the green slate, it would not have needed to be replaced at this time.

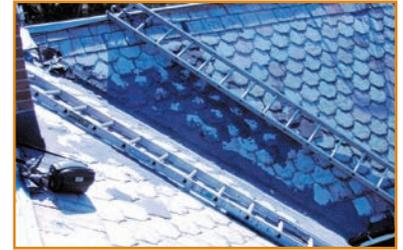
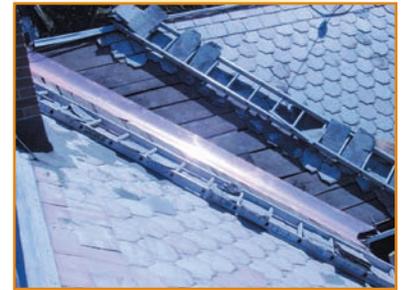
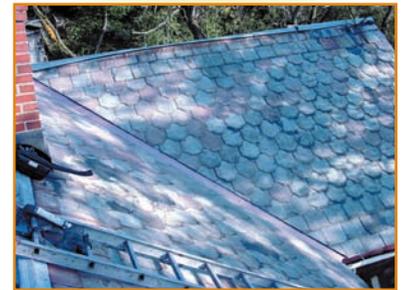
**Photos 4, 5, and 6: Typical flashing repair – before, during, and after: valley replacement on badly abused residential slate roof.**

When flashings begin to fail on a roof that is made of sound slates, only the flashings should be replaced, not the entire roof. This is routine work for slate roof restoration professionals (Photos 4, 5, and 6). One of the extraordinary characteristics of slate roofs is that they can be taken apart and put back together. Broken slates, worn flashings, rotted sheathing boards, or any element can be removed and replaced without the need to replace the entire roof. Because of this unusual maintenance characteristic, slate roofs can be made to last as long as the slate itself will last, which could be hundreds of years.

When repairing or restoring a slate roof, individual slates are removed to expose the existing flashings, which can then be removed and replaced. The removed slates can then be put back into their original positions, and the repaired roof will look much the same as it did before the repair. Faulty slates are also removed in order to be replaced, and matching slates must be used whenever possible. The tool required for removing slates from a roof is the slate ripper (Figure 7), a sword-like object that slides under the slate to be removed and pulls out the two nails that hold it in place. Rippers do not cut the nails as many

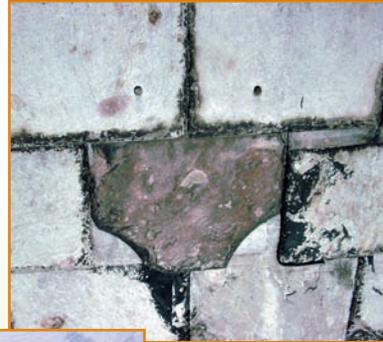
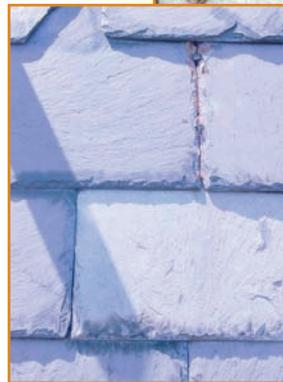
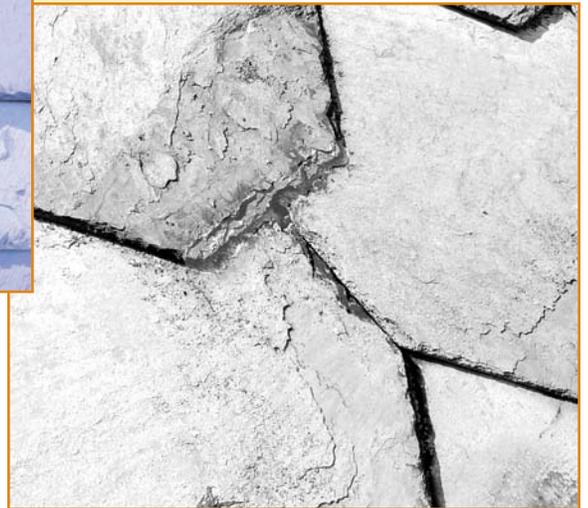
**Photos 10, 11, and 12: Typical bad repairs. 10: wrong type and shape of replacement slate, face-nailed through overlying slates; ugly and a sure leak. 11: Nail in slot to fasten replacement slate, then caulked – another sure leak (should have used a bib flashing). 12: Nail in slot without caulk or bib flashing becomes a “hidden leak” because the hole is almost invisible.**

Finally, one of the most common causes of leaks in older slate roofs is, unfortunately, improper repairs (Photos 10, 11, and 12). Bad repairs will still leak, they look ugly, and they can be very costly because the owner usually has to pay to correct them.

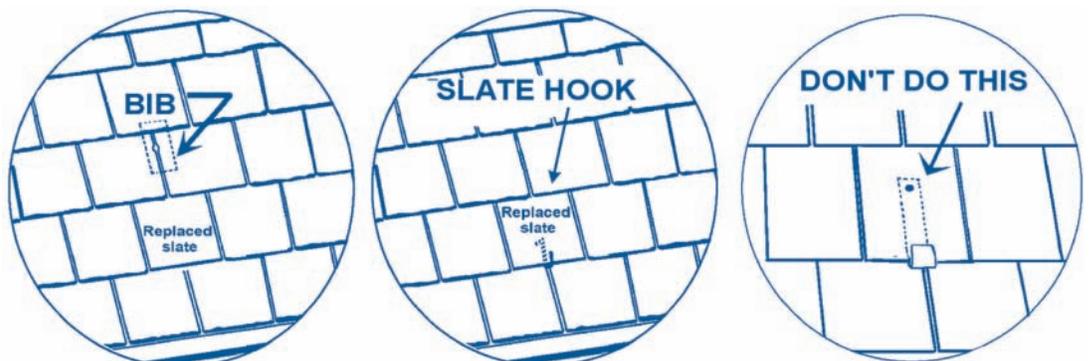
**Figure 13: Standard methods for replacing slates in the field of the roof include the nail-in-slot and bib method (left) and the slate hood method (center). The exposed strap method (right) is to be avoided).**

These combined factors can make a roof owner, in frustration, want to forever remove her slate roof no matter how much longer it will last if properly repaired. In addition, roofing contractors, as well as consultants, who have little or no expertise in slate roofs, will advise an owner to replace a slate roof that may have many decades of life remaining. A client will listen to bad advice when it is the only advice that can be found. (See Figure 13.)

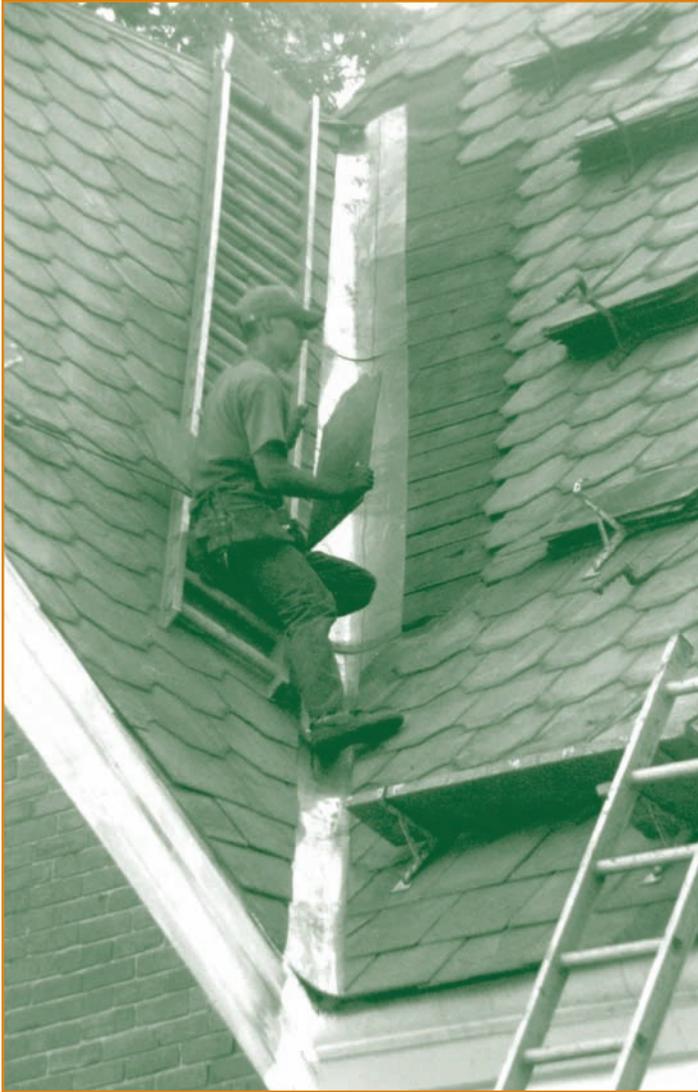
*Photo 14: A fully sheathed board roof deck with a temporary 30-lb. felt underlayment is a very successful tried and proven roofing system used with slate roofs and should be used with all new slate roofs for best results. The felt is optional. No underlayment is needed for the proper functioning of the roof. The valley replacement on a 104-year-old church shown above reveals the 1" hemlock board decking and the complete absence of underlayment. The slate is PA black, still in good condition. No water can penetrate the slate/copper roof system, which is why the underlayment is optional.*

The common steep-slope asphalt roof system of today employs a plywood or other laminated or glued wood product deck, often covered with a self-adhesive underlayment. A properly installed slate roof, however, will avoid any laminated or glued wood product for decking, as these materials have no record of the longevity required for a slate roofing system. Self-adhesive underlayment is a product designed to prolong the life of laminated wood decking, and therefore has no real purpose on a properly constructed slate roof (*Photo 14*).

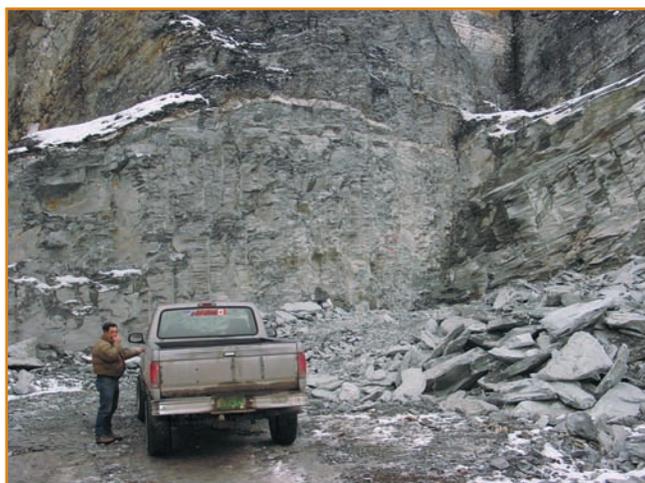
**Photo 15: Camara Slate Quarry, Vermont.**

Purple Vermont slates, for example, have been historically proven to last 150 years (*Photo 15*). PA black slates often last 100 or more years. Chinese or Spanish slates of an unknown origin are a gamble, some failing in as little as one year. Any roof consultant who specifies or encourages the use of a slate material of unknown origin is asking for a nightmare.
