THE PECULIARITIES OF HISTORIC SLATE ROOFS WITH EXAMPLES OF WRONGFUL CONDEMNATIONS

BY JOSEPH JENKINS

The following are some examples of slate roofs that illustrate these, and other peculiarities.

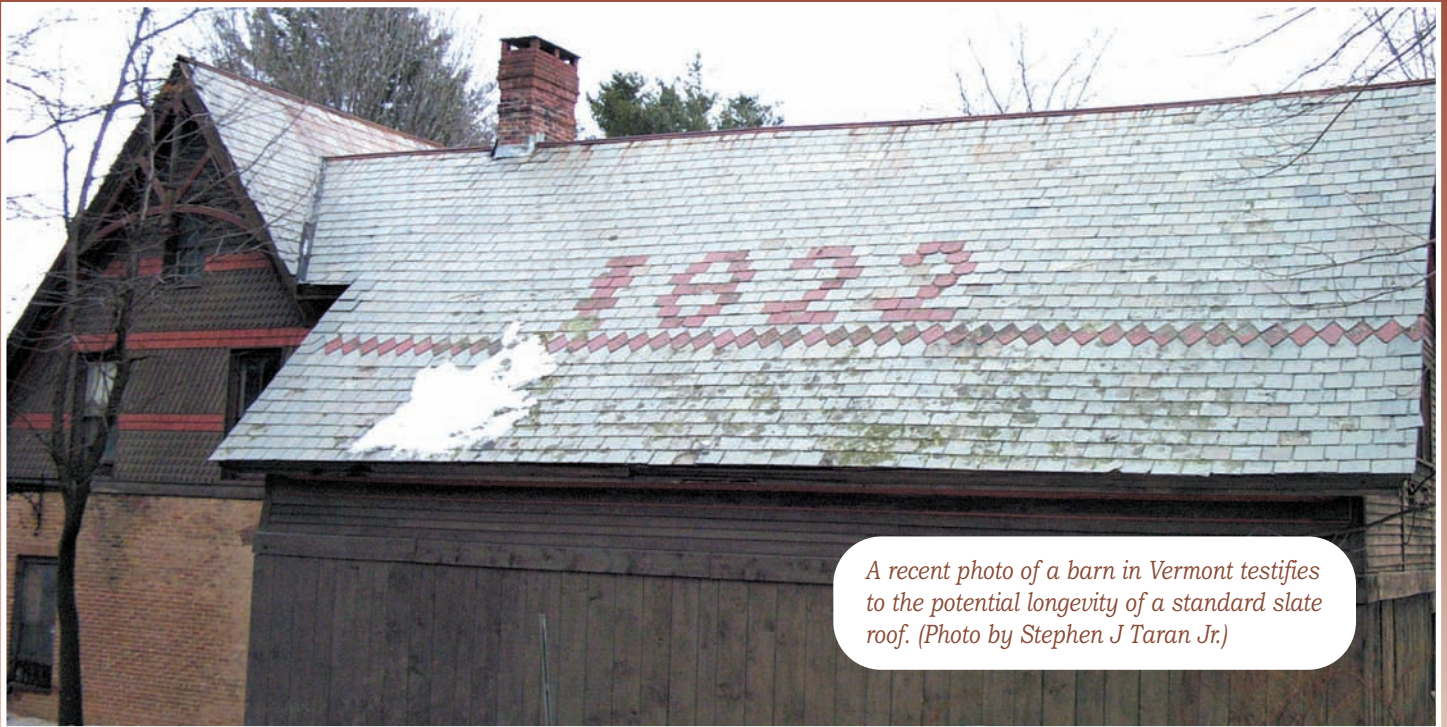
A recent photo of a barn in Vermont testifies to the potential longevity of a standard slate roof. (Photo by Stephen J Taran Jr.)

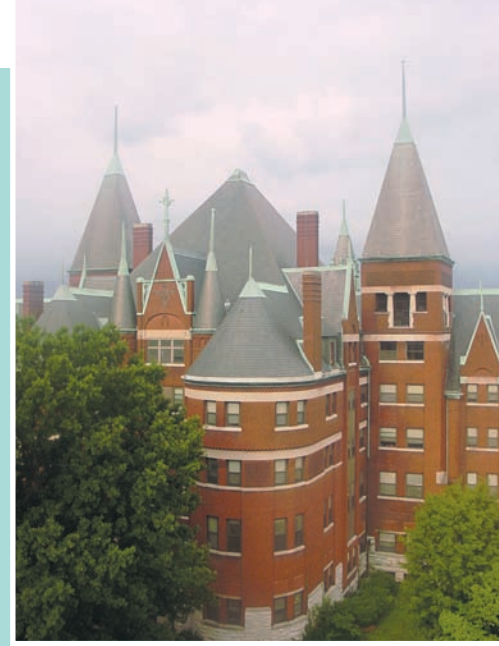
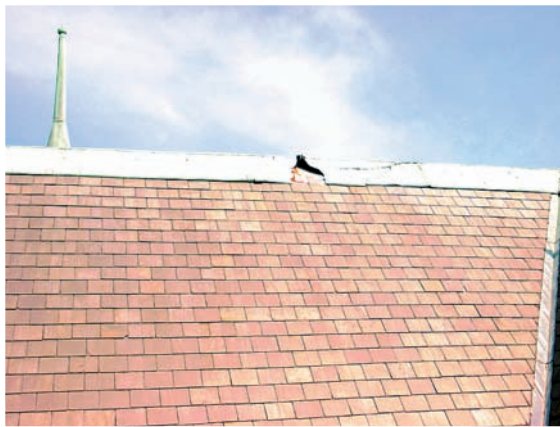
An inspection by the author revealed that the slates were a Buckingham or Peach

Bottom variety of exceptional quality. There was essentially no wear visible on the slates after 120 years. The very steep slopes and the semi-dry conditions of the area had helped preserve the copper, most of which was original. The wind and hail damage on the roof was quite limited and all of it was repairable for less than 3% of the replacement cost. The slates themselves could be expected to last another century, although the copper flashings would have to be replaced eventually. The main leak was in a copper valley and was unrelated to the storm damage. Although this beautiful slate could last at least another century, contractors were earnestly attempting to permanently destroy it.

The photo at right is only the entranceway to Castle Park, which has large wings emanating in three directions. The slate, at 120 years of age, is in excellent condition. Roofing contractors, however, would love to tear it off. Left: Minimal wind damage does not justify replacing the entire roof when the slate is still in good shape. (Photos by Joseph Jenkins.)

The Castle Park building, near St. Louis, is a huge, sprawling, five-story building with an 850 square slate roof built in 1882. The roof suffered hail and wind damage in the early 2000s and was subsequently condemned by contractors who offered to replace the roof with asphalt shingles for \$10 million. The entire roof was original – flashings and all – and some leaking was occurring.

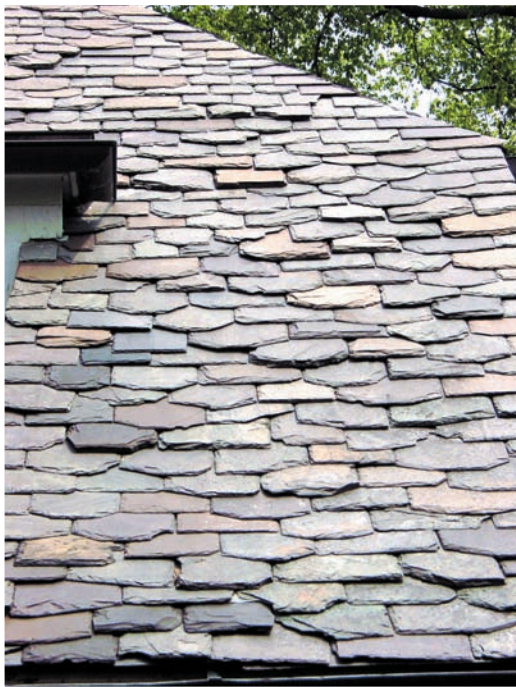
Chicago area home with beautiful 75-year-old "ragged butt" slate roof condemned by three roofing contractors. (Photo by Joseph Jenkins.)

A residence in an upscale Chicago neighborhood suffered hail damage to its unique "ragged butt" style 75-year-old slate roof. Three firms looked at the roof and all three condemned it before the owner contacted the author for an impartial inspection. Hail damage to the mixed Vermont and Buckingham slate was certainly evident, but it was limited and all readily repairable by any contractor with a minimum of slate roof restoration experience. The inspection revealed about 150 slates needing to be replaced – a couple days' work for experienced professionals.

The condemning roofing contractors were evidently influenced by the idea that insurance money would pay for an entire new roof. That may have been a much easier approach for them than trying to duplicate a slate roof that is a work of art. But the owner didn't want a new roof – he liked the one he had. Yet, if he hadn't put his foot down and hired the services of a knowledgeable roof consultant, he would have lost both his roof and the character of his home.

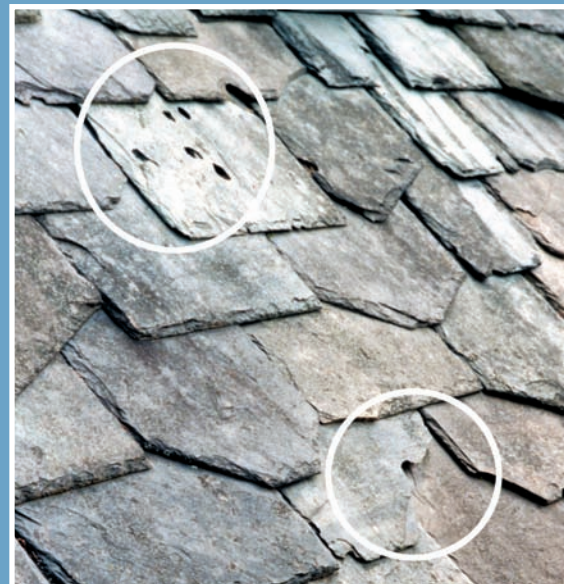
Hail damage of this nature, as seen on Chicago area "ragged butt" slate roof, is repairable by simply removing the damaged slates and replacing them. Most of the slates are undamaged. (Photo by Joseph Jenkins.)

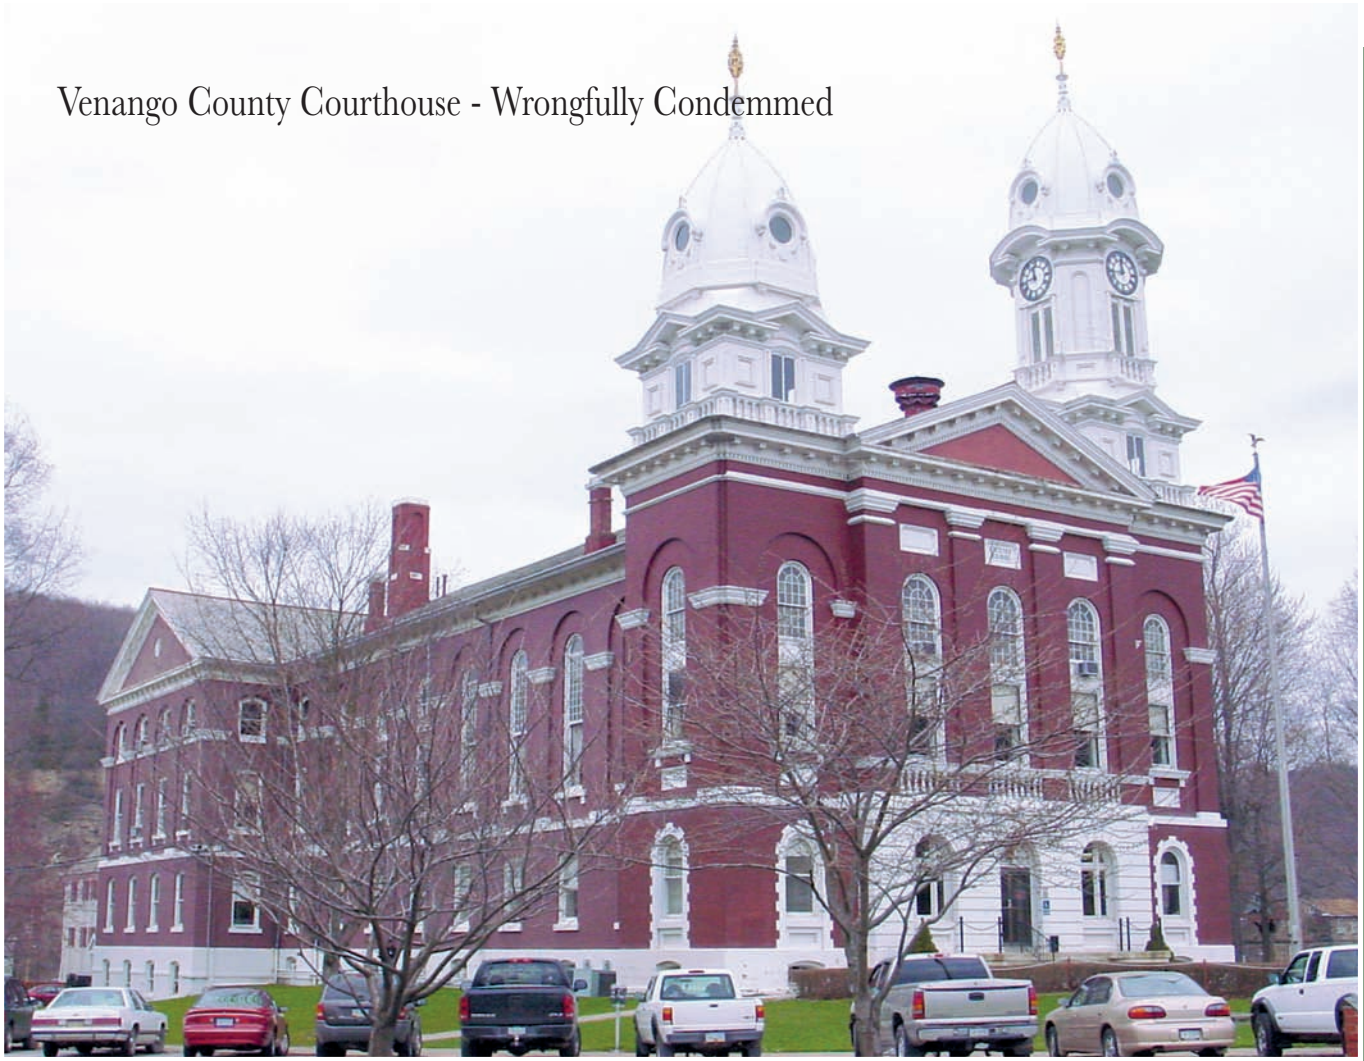
This courthouse roof was unnecessarily condemned and scheduled for replacement. The Vermont “sea green” slate roof is only 72 years old – about halfway through its life. Comprehensive restoration work on this roof will only cost 10% of the cost for total replacement because the slates and fasteners are still in good condition. Most of the flashings, however, need to be replaced. (Photo by Joseph Jenkins.)

In 2004, the author was called to consult on the replacement of a Pennsylvania courthouse roof. The 130-square Vermont “sea green” slate roof was approximately 72 years old. A county engineer insisted that the roof was beyond repair and was “absolutely certain” it had to be completely replaced. The author’s inspection revealed that most of the problems with the roof were related to bad repairs in the past, all reversible. The slate itself was still good and could be expected to last at least another 50 years if not 75 or more. Replacement costs of \$358,451 were reduced to restoration costs of \$35,000, which included replacement of virtually all flashings with stainless steel – a savings to the cash-strapped county of over \$300,000.

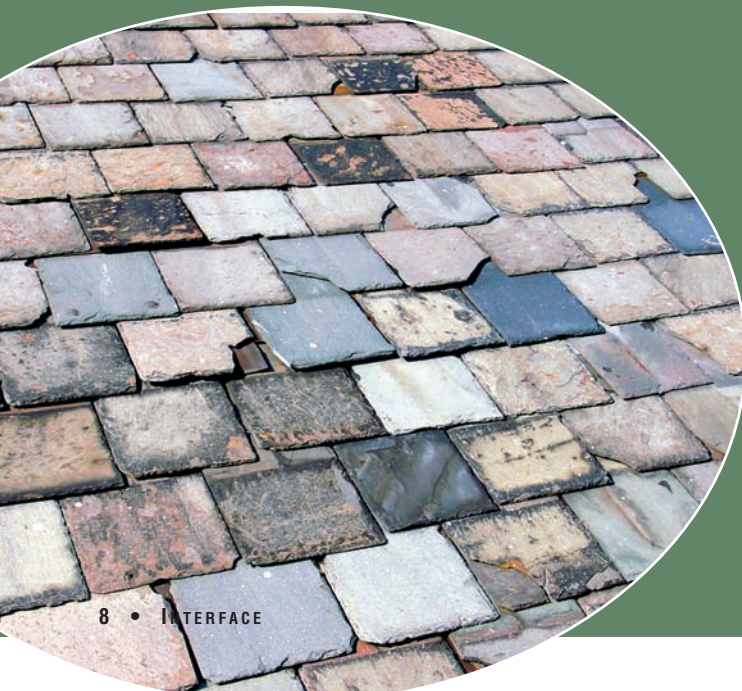
Most of the problems associated with the Venango County Courthouse roof were caused by bad repair work over the years, an example of which is shown at left. The wrong type and color of slates were used to repair this roof, indicating the repair contractor didn’t understand proper restoration techniques. These will all need to be removed and replaced with slates that match the original roof. The author counted approximately 700 slates like this on the courthouse roof. (Photo by Joseph Jenkins.)

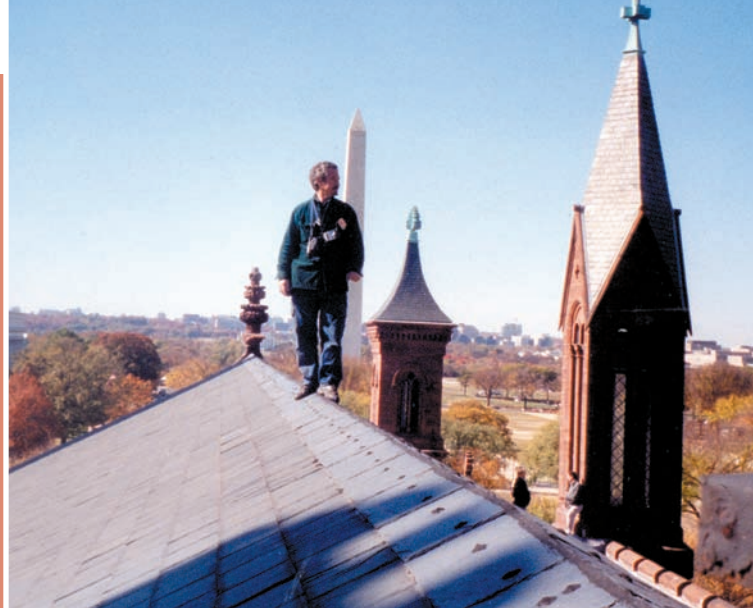
refurbished around the time of the bicentennial in 1976. At about that time, the Castle got a new roof. For some unknown reason, however, not all of the Castle's flashings had been replaced. Four main central valleys and the flashings along two parapet walls had been left as original, and they now leaked. Furthermore, the maintenance crew had the habit of tromping on the slate roof in what appeared to be combat boots, crunching the slates underfoot, breaking them, and adding to the roof problems. The solutions were simple and relatively inexpensive: replace the old flashings with new copper and keep people off the roof who don't belong there.

The Smithsonian Institute Building known as "The Castle" had already been replaced with new slate, but some of the original flashings had been left in place, and they leaked. The author is inspecting the roof in the photo above. (Photographer unknown.)

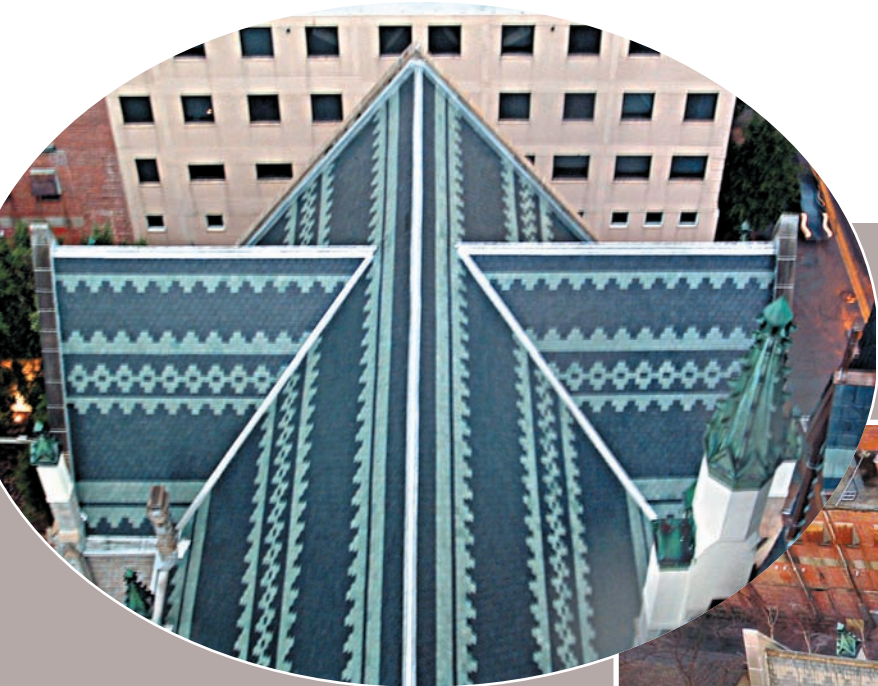
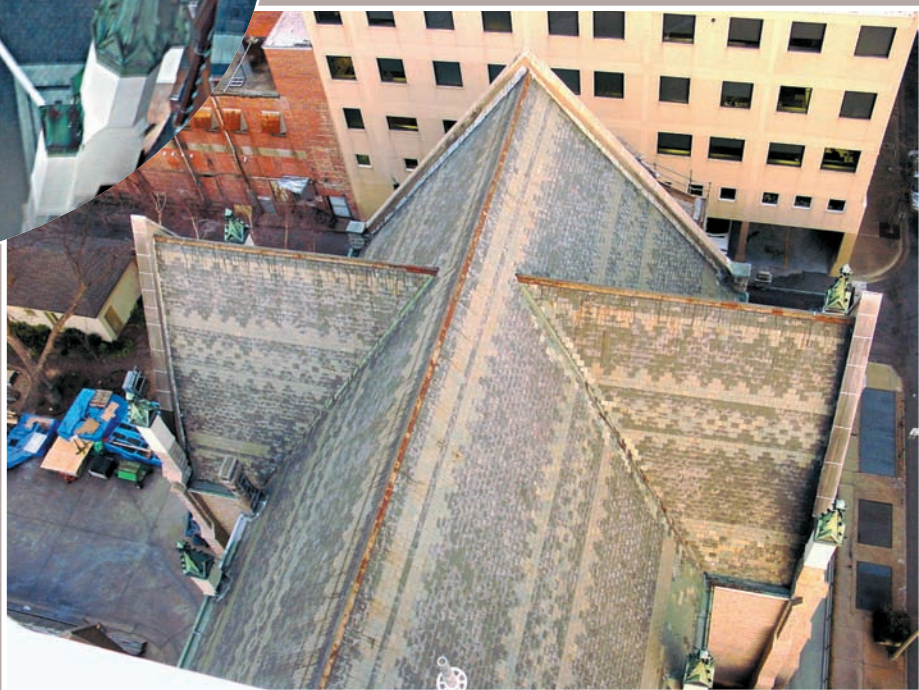
The Cathedral of St. Andrew in Little Rock, Arkansas, had worn out its black Pennsylvania slate after 120 years (below). The cathedral's new roof, left, installed by Midland Engineering in 2003, is likely to last 150 years. Vermont unfading green slate mixed with Welsh black slate and terne-coated stainless steel flashings should outperform the original roof. (Photo below by Joseph Jenkins; left photo by Lyle Bandurski.)

A slate roof will wear out, of course, and at the end of its life, nothing can save it. This was the case with the Cathedral of St. Andrew in Arkansas. The cathedral roof was made up of Pennsylvania black slates and Vermont unfading green slates mixed in an ornate pattern. At 120 years of age, the PA black slate had simply worn out – become soft, flaky, and falling apart – especially on the southern exposure and on the main body of the church. The Vermont unfading green slates showed almost no wear at all, despite their age of 120 years.

The original roof was inspected by the author to determine its condition and to draw up specifications for replacement. The new slate roof was subsequently installed by Midland Engineering of South Bend, Indiana, to match the original roof. This time, however, Vermont unfading green slates were mixed with Welsh black slates from Cwt-y-Bugail. All of the copper flashings were replaced with terne-coated stainless steel (some 4-lb. sheet lead was also used). The new slate roof is expected to last at least 150 years.
