SLATE ROOFS

WHY LEARN THE HARD WAY?

By Joseph C. Jenkins

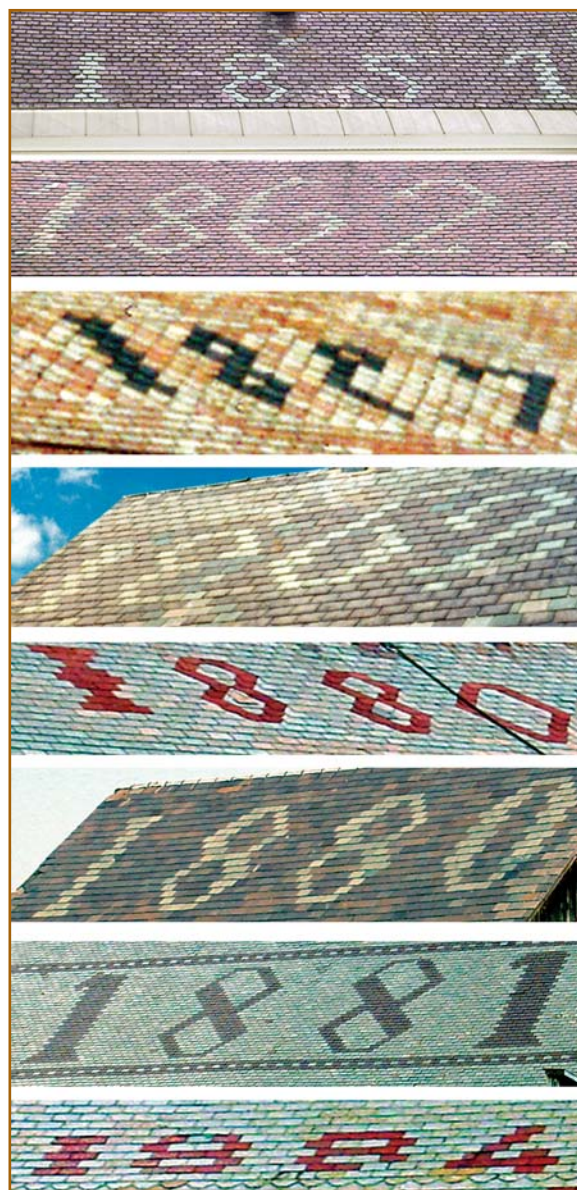
Figure 1 – These photos of existing slate roofs attest to the durability, beauty, and longevity of this natural roofing system.

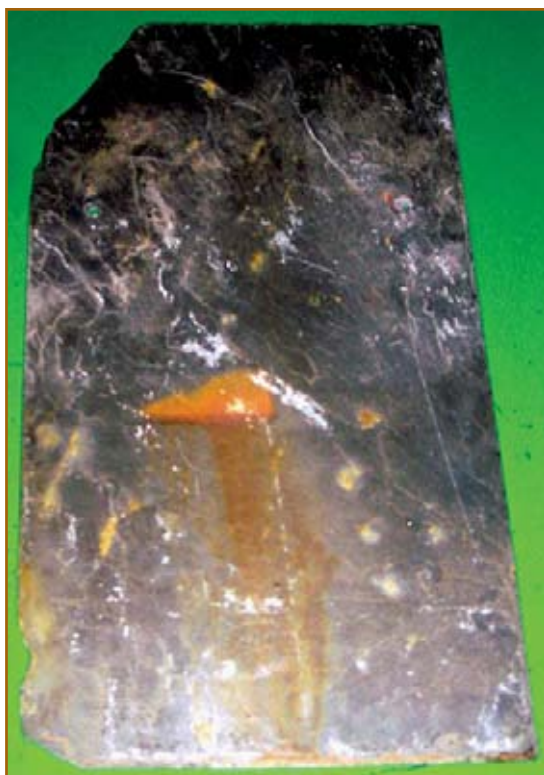
Figure 2 – This Spanish black slate leached rust stains down the new slate roof. This photo shows the slate after only one year on the roof.

Some Spanish black slates are known for their pyrite content, which will bleed red rust stains down the roof. *Figure 2* shows such a slate, taken from a residence in

Florida after only one year on the roof. This large residential roof had to be completely reslated at great expense. The owner of the residence selected this slate because he liked the shade of black on a new sample piece and did not understand that some slates will change in appearance with exposure to weather. When selecting Spanish slates, it is important to know whether those being considered are pyrite-bearing, a condition that may or may not be obvious by visual inspection. In a recent case on the east coast, an entire church roof had to be reslated because the new, Spanish black slates were bleeding rust down the roof, and the church people did not like the way it looked. Again, this is not to be construed as a condemnation of all Spanish black slates, as some are quite good.

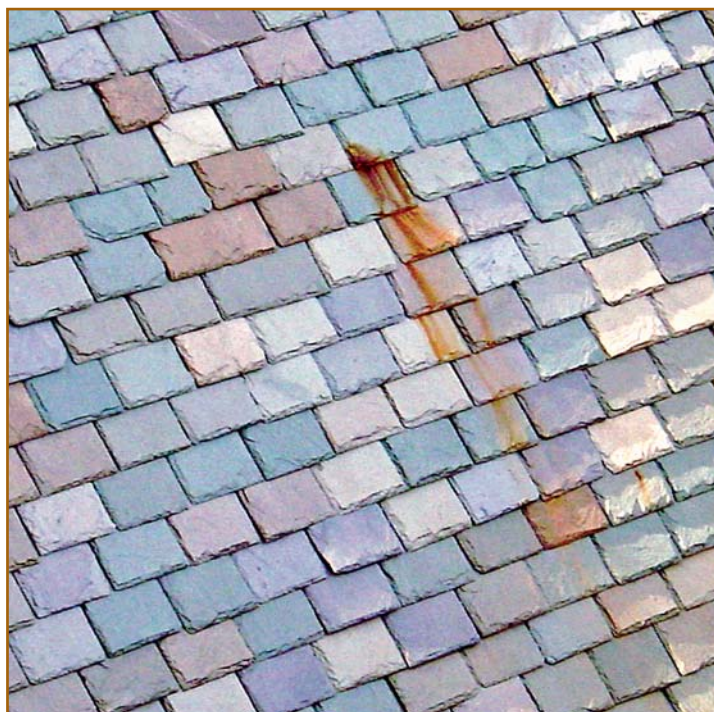
Figure 3 – Even domestic slates can rust. These Vermont slates on a high-rise apartment were poor in quality and should have been screened for pyrite inclusions.

Poor-quality slates occasionally originate from the United States. This may be due to the manufacturer's not culling out rejects, for example. Shoddy quality control can lead to rusting pyrites on even the best American slates. *Figure 3* shows Vermont slates badly rusting down an apartment building roof. This is very unusual and indicates a commercial source of roofing slate that should have been avoided or a bargain slate that wasn't worth the money combined with a contractor who should have culled the defective slates out but didn't know what a bad slate looked like.

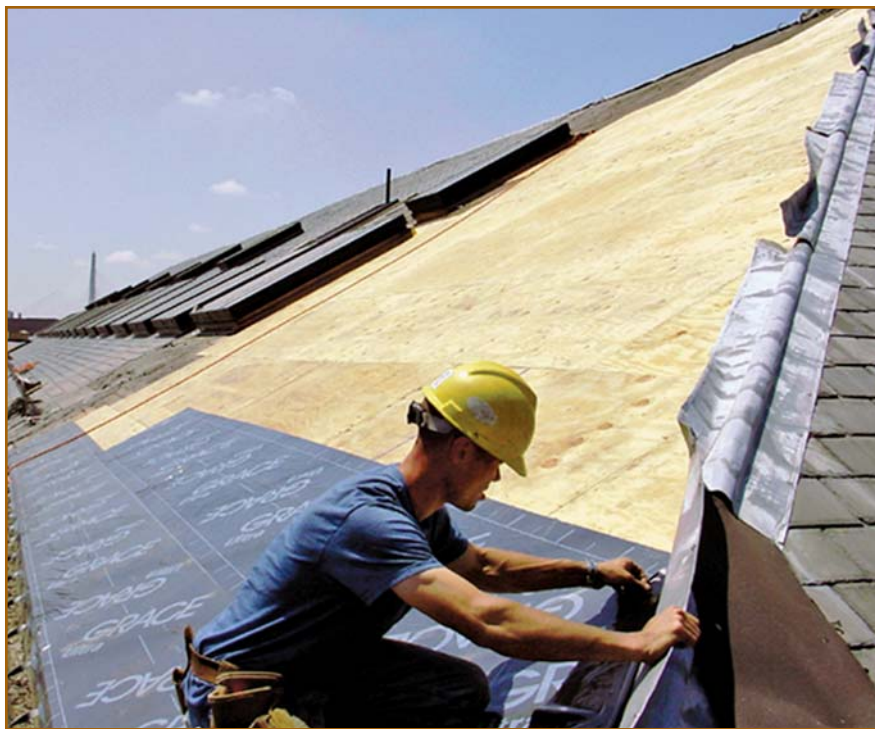
Figure 4 – Traditional slate roofing systems, despite their incredibly successful performance, are being largely abandoned in favor of plywood roofs with peel-and-stick underlayments.

Figure 4 shows a 150-year-old slate roof being replaced in Boston. Although the roof was still functioning at the time of replacement and the existing roof system – made of slate, 1-in boards, 30-lb felt, and nails – had demonstrated a 150-year performance, the contractors who replaced the roof completely abandoned the existing system and replaced it with one that had no proven longevity, emphasizing underlayment and completely eliminating any chance of air transpiration. The original 1-in roof board deck, still sound, was covered with ½-in plywood, then self-adhered modified bitumen, then 30-lb felt, and then slate. Will this new roof system last 150 years? Time will tell, but why reinvent the wheel? A chain is only as strong as its weakest link. Traditional, 3-link slate roofing systems have already proven themselves, are less expensive, are more environmentally friendly, and take less time to install. If one wants to guarantee that a slate roof will last a century or two, traditional methodologies should be followed.

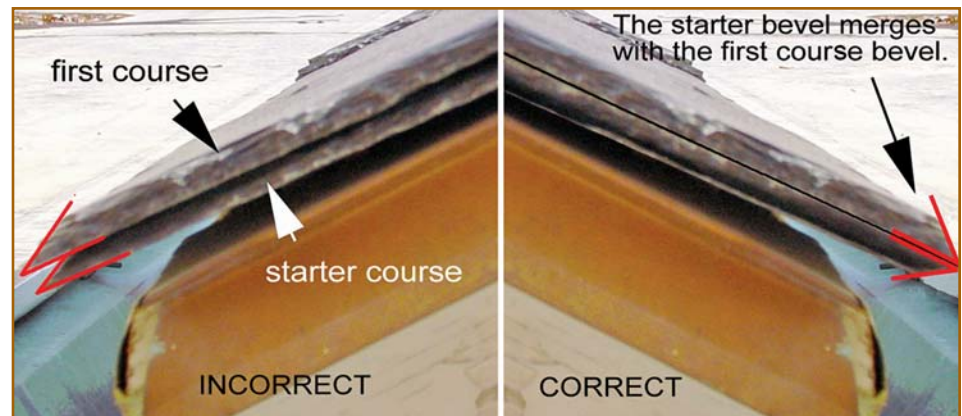
Figure 5 – The starter course should be flipped over and laid upside down as shown on the right in this illustration. This creates a clean drip edge and allows for correct nail countersinking.

quarry with the intention that the slates are to be installed face down. This allows for a clean edge where the starter slate meets the first course (Figure 5). The reason it's important to know this information is because the orientation of the starter course is an indi-

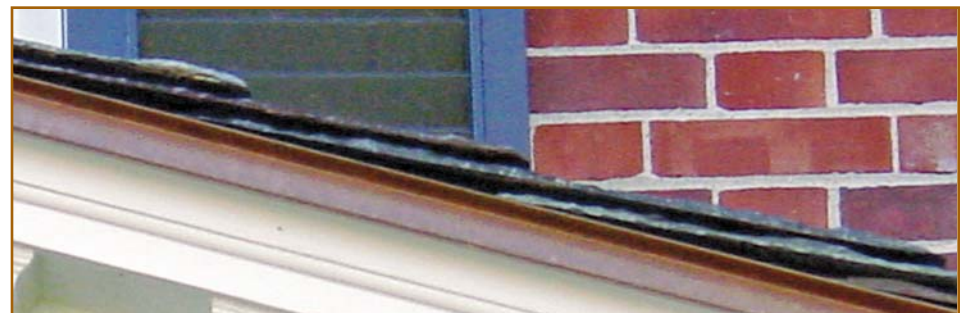
Figure 6 – No slate lies flat on a slate roof. Every slate is angled, which is why it should not be walked upon and why the starter course requires a cant.

match the angle of all the other slates in the field of the roof. No slate lies flat on the roof because every slate is overlapping other slates, as shown in Figure 6. Since the starter course does not have a course of slate underneath it, something else must be

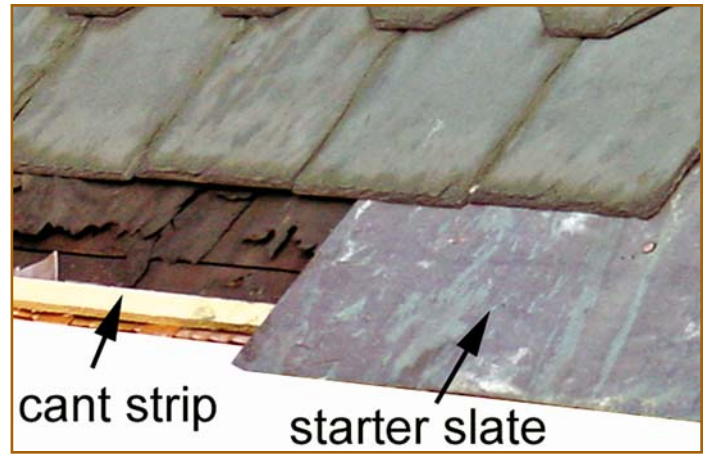
Figure 7 – Note that the starter slate is laid backside up and is propped up by a cant strip.

installed under it to create the proper angle. Typically, this is done by installing a wood strip (*Figure 7*), but it can also be achieved by using a metal drip edge with a cant formed into the metal, or even by raising the fascia.

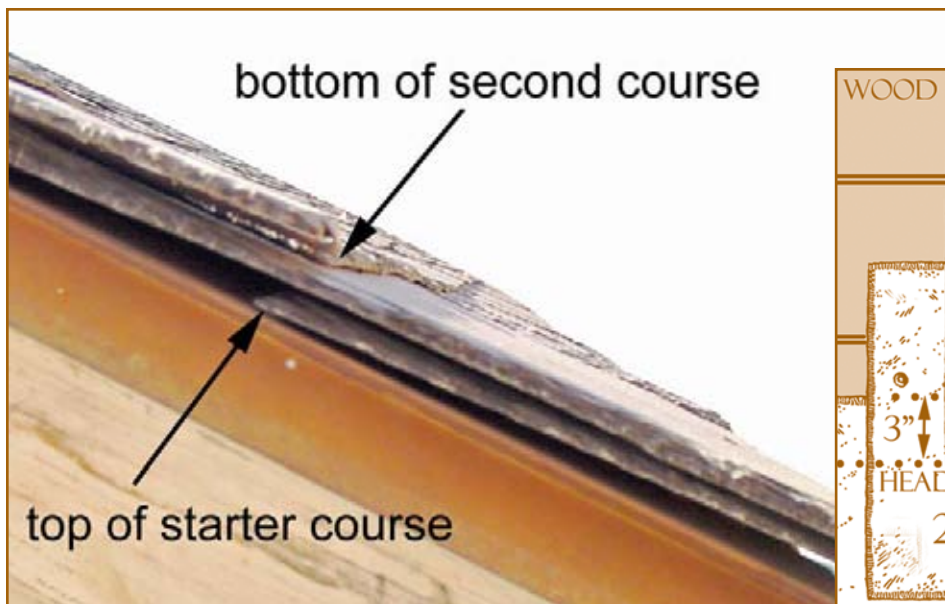
Figure 8 – The starter course should be overlapped by the second course by at least three inches. In this case, it is not overlapped at all. This is a serious but common mistake. Note also that the starter slate is incorrectly laid backside down. This is an indication that the installer was inexperienced in laying slate.

Another very common mistake on starter courses is a lack of headlap, especially when the field slates are turned sideways and used for starter slates. The second slate course must overlap the starter course by a minimum of 3 in. Inexperienced slaters often overlook this important detail. Since the bottom of the roof has more water running over it than virtually any other part of the roof, it is imperative that the headlap on the bottom courses of slate be correct. An example of a starter course lacking headlap is shown in *Figure 8*.

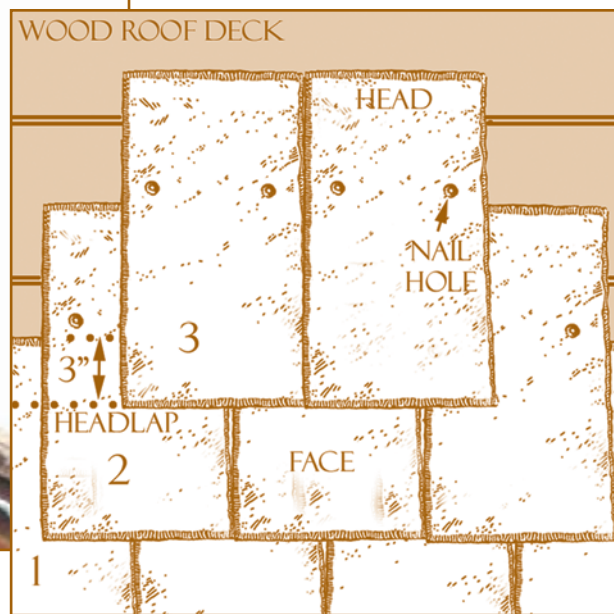
Figure 9 – Headlap is a critical detail on a slate roof. Lack of headlap will cause an entire roof to be condemned.

Speaking of headlap, this is one of the first details that a roof consultant should look for on a new slate roof installation. If the headlap is missing or inadequate, the roof is probably going to be condemned. Headlap is the overlap on each course of slate by the second course above it (*Figure 9*). This overlap is what prevents the roof from leaking. Three inches is standard, but headlap can vary according to the slope of the roof. *Figure 10* shows a newly installed shopping center roof in Louisiana with about an inch of headlap on the field slates. The overlap should be 3 in. There is no fix for this inadequacy other than to rip off the entire roof and start over. *Figure 11* shows a university building roof in Pennsylvania with a new slate roof – and, incredibly, negative headlap. This is the same as having holes all through the roof. It's hard to believe that roofing contractors can make

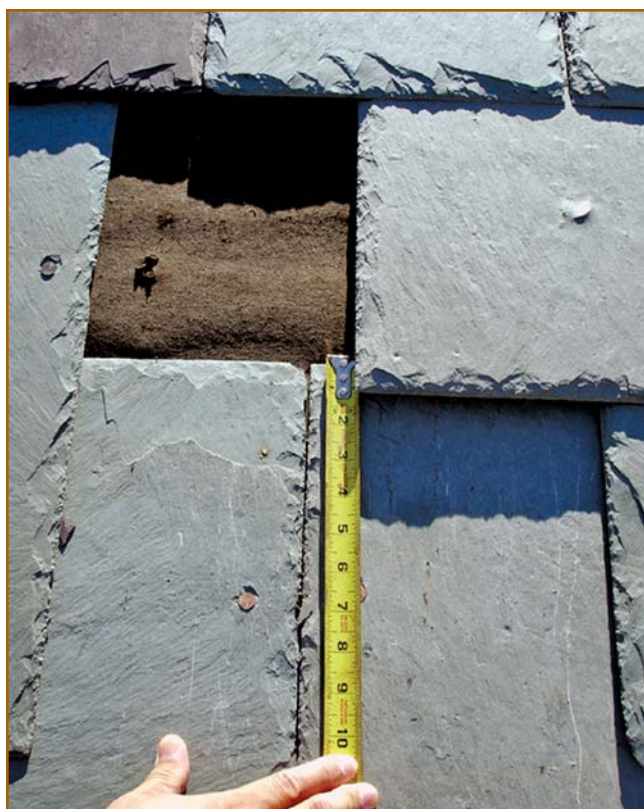
Figure 10 – This is an example of inadequate headlap on a shopping center roof in Louisiana.

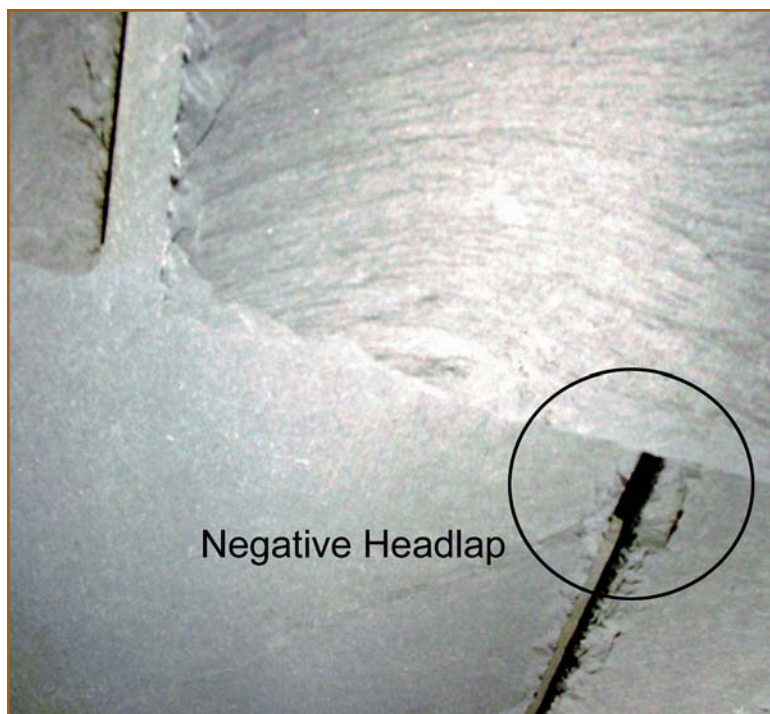
Figure 11 – When the slate courses are spread too far apart vertically, negative headlap can result. Although this requires fewer slates to cover the roof, it also creates holes all through the roof. There is no remedy for an egregious error such as this other than to remove the entire roof and start over.

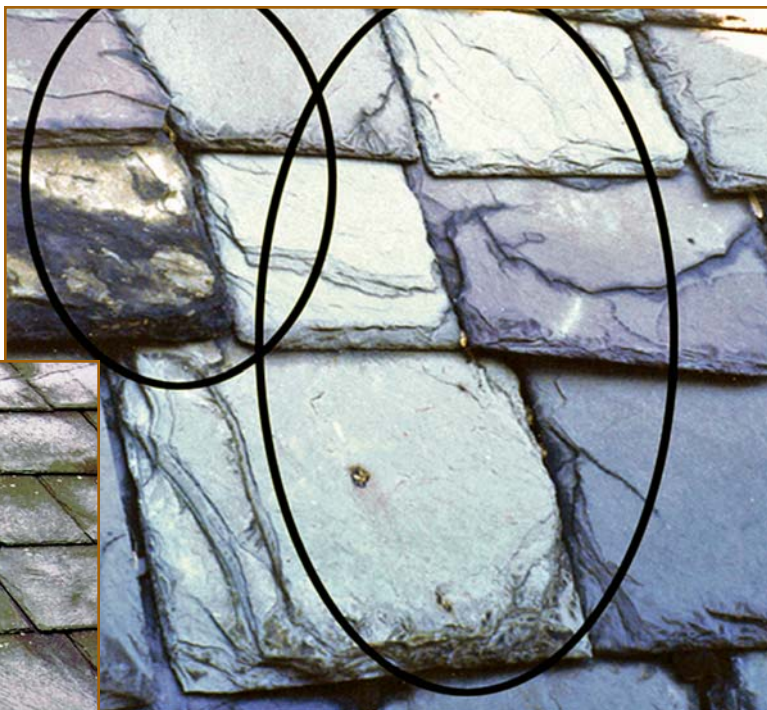
Figure 12 – “Sidelap,” or lateral overlap, should be a minimum of 3 in. Here we see no lateral overlap at all. This entire roof had to be removed and reslated, as it also had no headlap.

Lateral overlaps or sidelaps should also be 3 inches minimum. However, don't be surprised to see slates with no lateral overlap at all, as shown on an historic building in Georgia (*Figure 12*). Incorrectly placed sidelaps can leave the butt joint directly over the slating nails, as shown on an historic Pennsylvania State Park building in *Figure 13*. This will allow direct water entry through the nail holes.

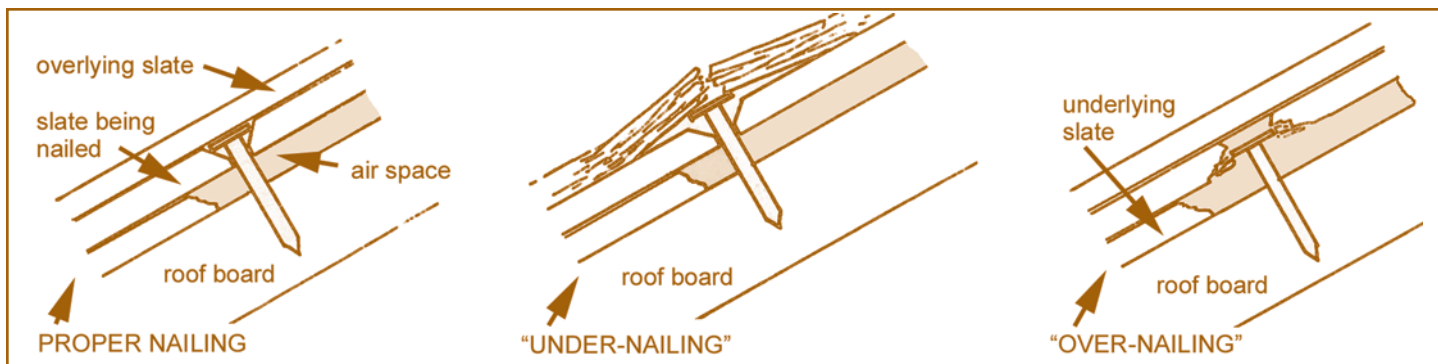
Figure 14 – A good slater has no problem nailing slates correctly. When properly nailed, the nailhead just sits down inside the slate. When undernailed, the protruding nailhead, over time, can damage the overlying slate. When overnailed, the slate being nailed will crack, break, or cock awkwardly on the roof.

Another common installation mistake is the overnailing and undernailing of the slates. Slate nail holes are meant to be crater shaped to allow the nail head to sit down inside the slate (*Figure 14*). Otherwise, the nail head will protrude and rub against the overlying shingle, eventually creating a hole (*Figure 15*). When the nail is not driven far enough, this is known as undernailing. Overnailing, on the other hand, is when the nail is driven too far and breaks through the slate. This leaves the slate hanging on one nail or sliding out altogether (*Figure 16*).

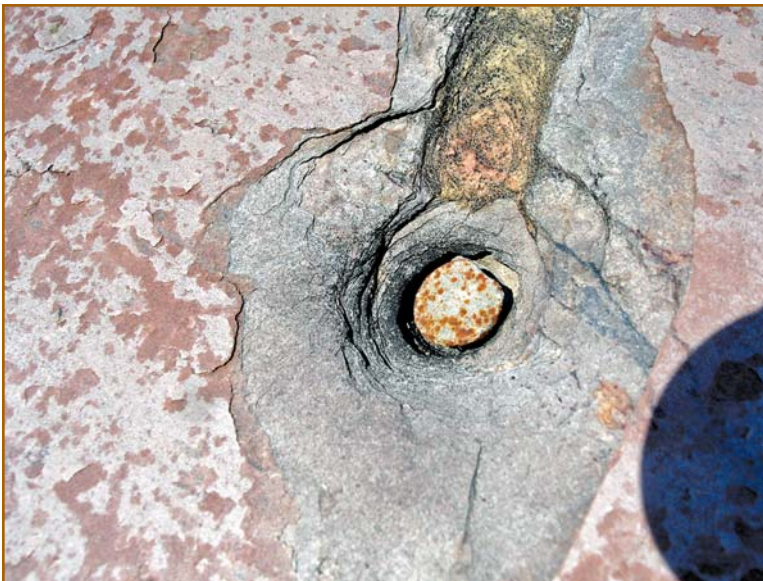
Figure 15 – A protruding nailhead can eventually wear a hole in the overlying slate.

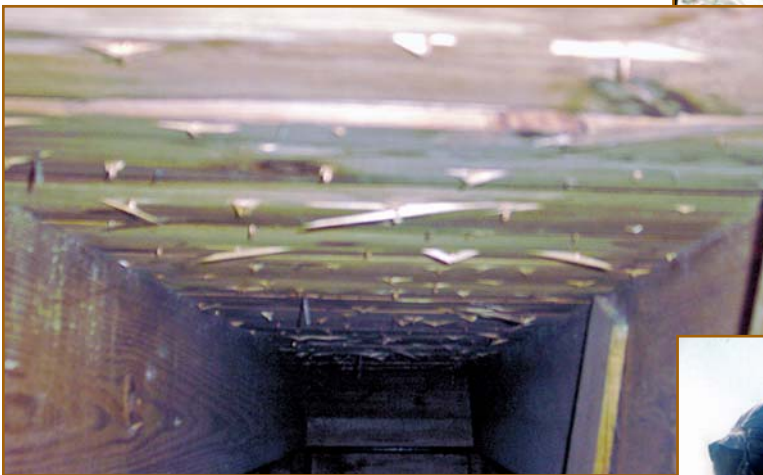
Figure 17 – When the slating nails are too long, the back of the roof decking breaks out. This reduces the effective holding power of the nail. A longer nail, therefore, does not mean more holding power. The best nail length just barely penetrates the roof deck.

Nail length is an issue that is commonly off the radar screen of the average roofing contractor. The slating nails should barely penetrate the roof deck boards. If the nails are too long, they break through the back of the boards and splinter out of the wood, reducing the board thickness where the nail is located and undermining the effective holding power of the nail (*Figure 17*).

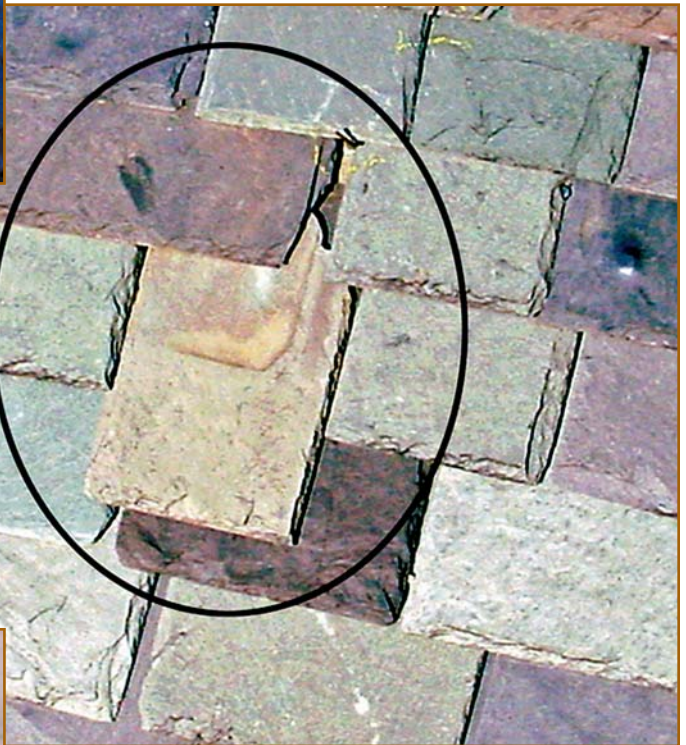
Figure 16 – This slate was nailed so tightly that the nails broke through the slate and the slate is now sliding out of place.

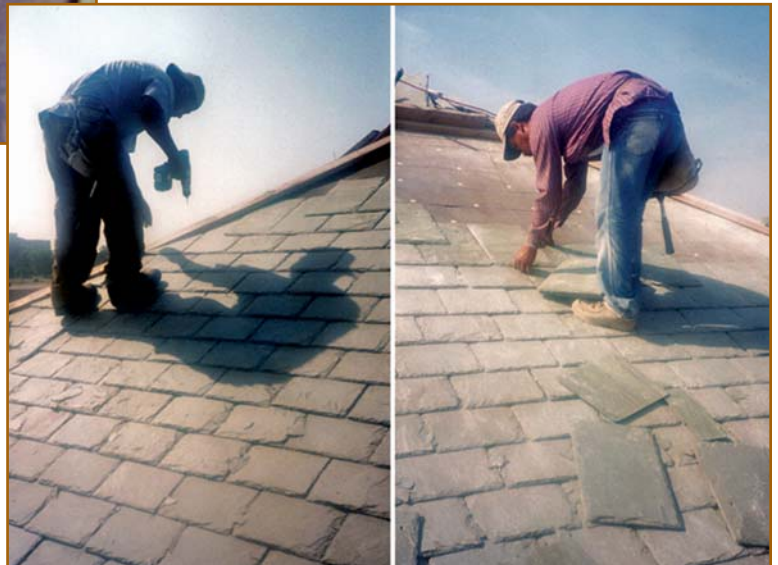
Figure 18 – It is a mistake to walk on a slate roof during installation.

A very common error with new slate roof installations is what I call the Bigfoot Syndrome – roofers walking on the slates during installation, as shown in *Figure 18* on a new bank building in Kansas. An experienced slating crew will make every effort to keep off the slates during installation by staging the roof correctly (*Figure 19*). When Bigfoot walks all over the slates, the shin-

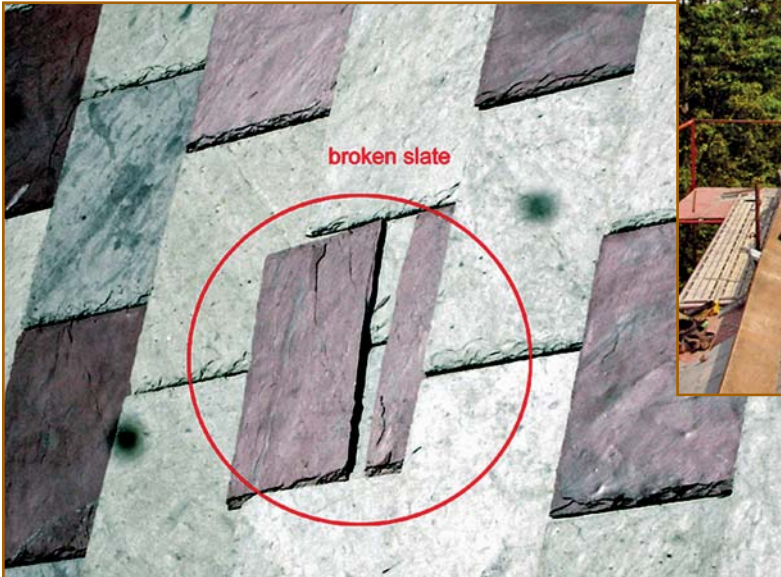
Figure 20 (left) – Slate roofs that are walked on during installation will shed slates after the roof has been installed, perhaps for years.

gles crack and break (Figure 20). They may not fall apart immediately, but I have seen a hundred slates fall off a new slate roof within five years of installation due to damage by foot traffic during installation.

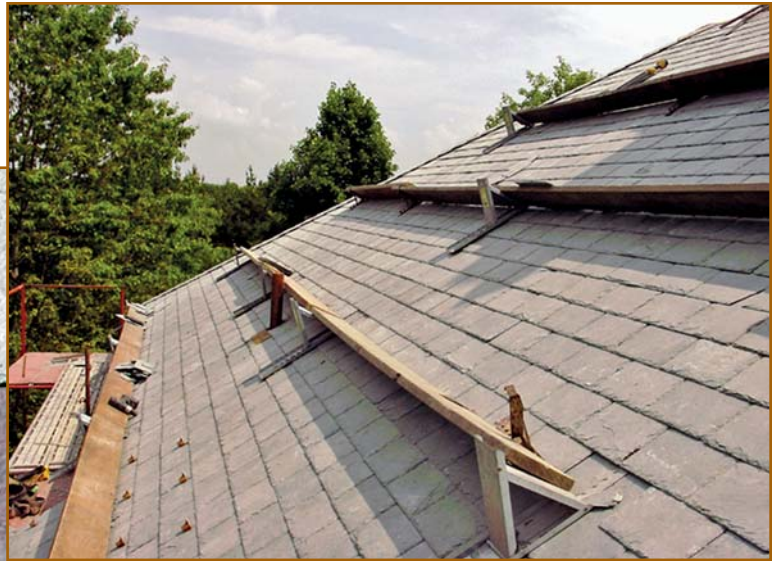
Figure 19 – A correctly staged slate roof will enable roofers to install the slate without needing to walk on the shingles.

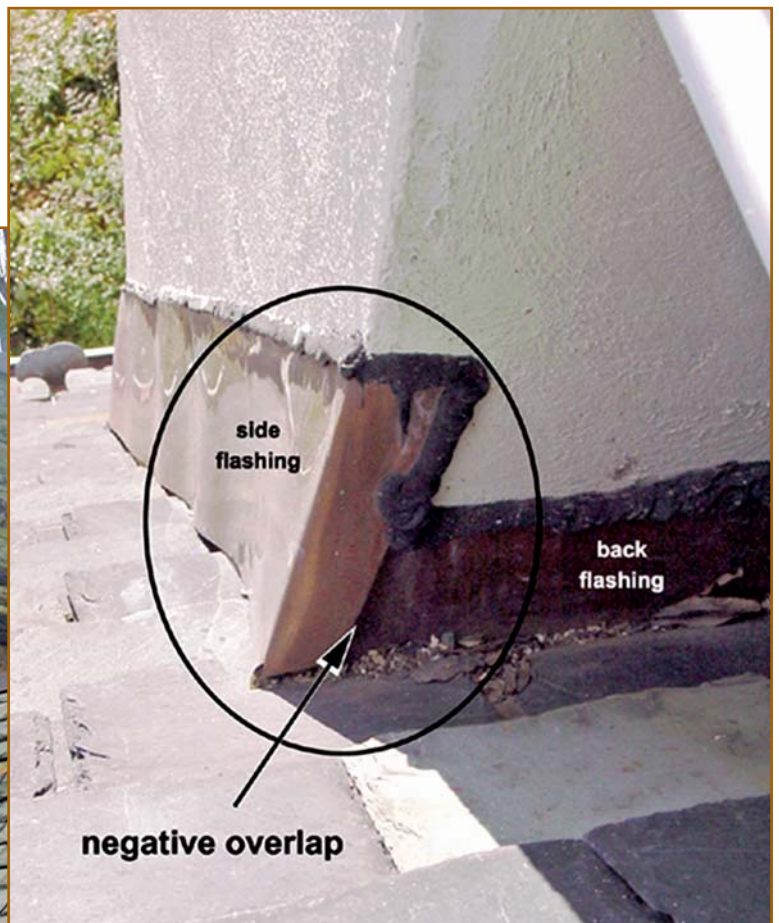
Figure 21 – Uphill flashing should always lap on top of downhill flashing. Negative overlap, as shown, will leak.

Flashings provide all sorts of opportunities for error. Negative overlap, for example, is sure to leak. Figure 21 provides an example of negative flashing overlap. Uphill flashing should always lap on top of downhill flashing. When lower flashings lap on top of higher flashings, water can enter the roof. Corner joints on roof penetrations are also commonly flashed incorrectly; chimneys provide a perfect example. The corner flashings must be either folded correctly or soldered in

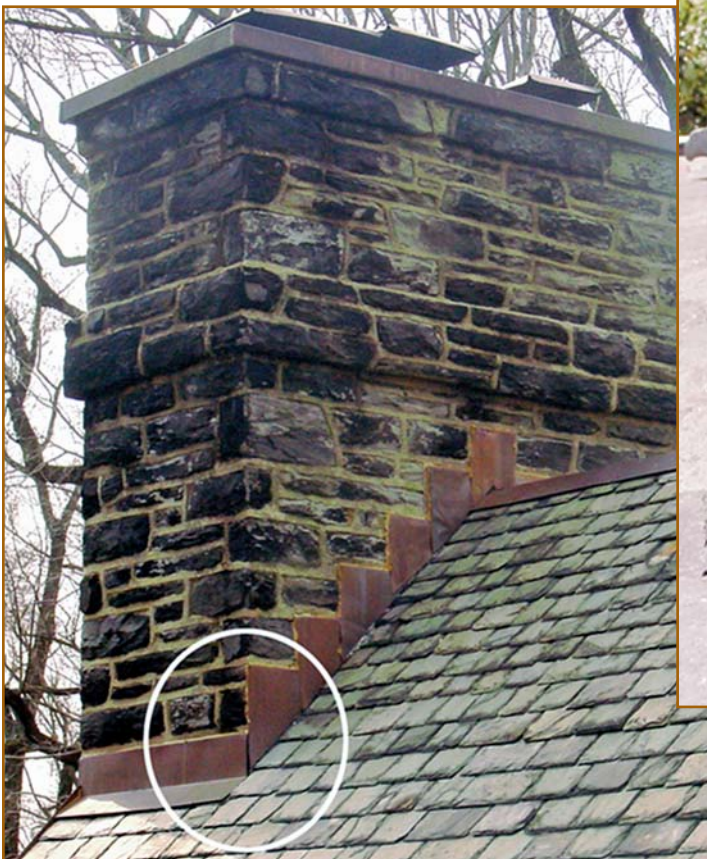
Figure 22 (left) – Chimney corner flashings should be either folded or soldered. If neither is evident, then the corner is either sealed with sealant or not at all. In either case, this is a leak waiting to happen.

order to prevent leakage through the corner. If a corner isn't folded or soldered, as shown in *Figure 22*, then the only thing keeping it from leaking is caulk or sealant, which do not have adequate longevity. An incorrectly folded chimney corner is illustrated in *Figure 23*. This is a leak waiting to happen. Dormers also often have corners that need to be flashed. Without folded or soldered corners, a dormer can be left wide open and waiting for the first good rainstorm (*Figure 24*).

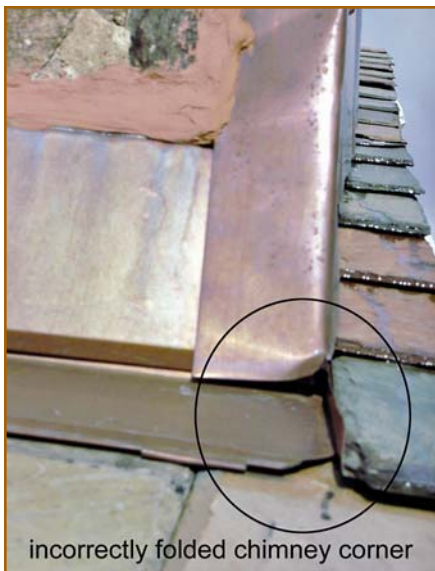
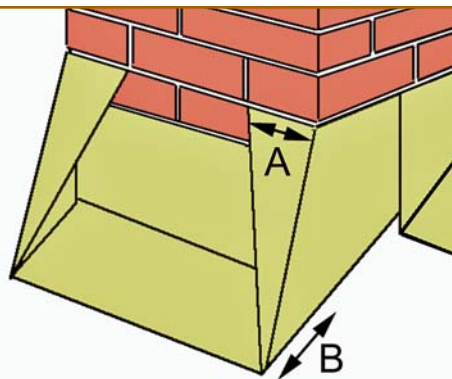
incorrectly folded chimney corner

A correctly folded chimney corner will ensure that A) water running down the chimney will not enter the corner, and B) water running down the roof will not enter the corner.

Figure 23 – This chimney corner flashing (left), although folded, was installed incorrectly and will surely leak. A properly folded corner flashing must account for the water that runs down the chimney as well as the water that runs down the roof. In effect, the flashing should create a “miniroof” over each corner.

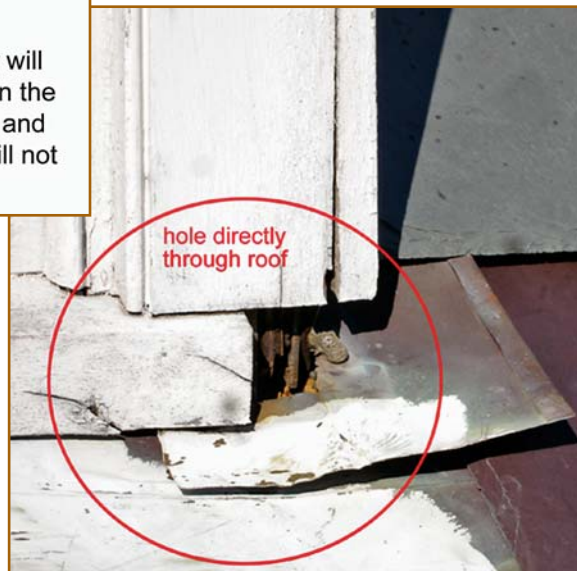
Figure 24 – This is a case in which the corner flashing is neither folded nor soldered, leaving a large hole in the roof and clearly showing how corners need special attention in order to prevent leakage.

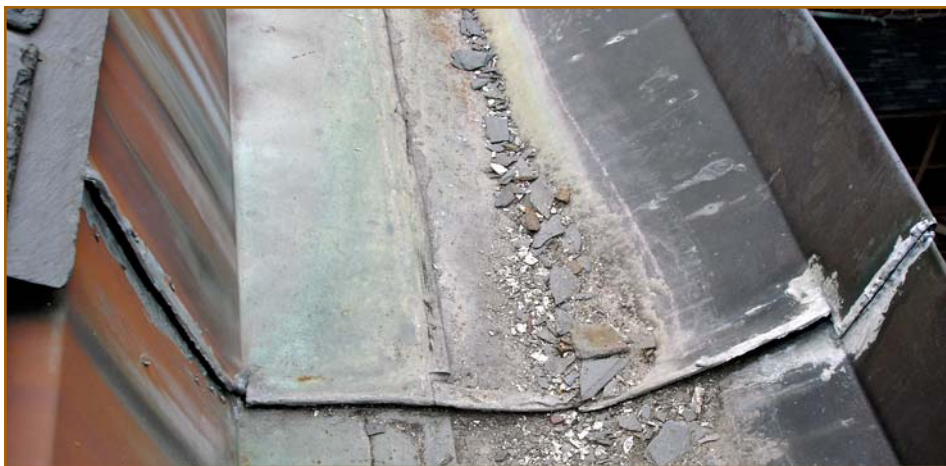
Figure 25 – This is a perfect example of a new built-in gutter showing failed solder joints because not a single expansion joint was installed in the gutter system.

Common on many slate roofs are built-in gutter systems. “Box gutters” require expansion joints, but they’re often installed without any allowance for expansion whatsoever. This becomes evident by the failure of the solder joints (Figure 25), which are then often roof-cemented after they start leaking in order

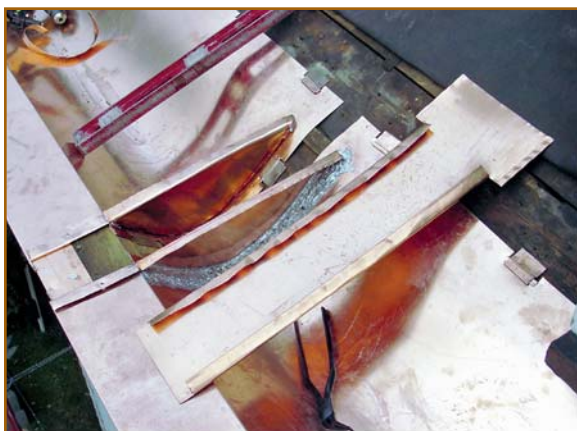
Figure 26 (above) – Box gutters have been patched at most joints, indicating leakage. The gutters should be relined.

to alleviate the water penetration (Figure 26). Expansion joints (Figure 27) can be added after the gutters are installed, but it's a lot easier to install the gutters correctly in the first place.

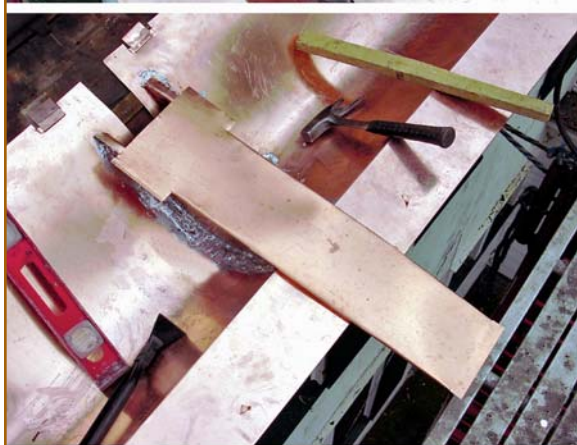
Figure 27 – Expansion joints allow built-in gutters to move when expanding and contracting, thereby relieving the stress on the solder joints and prolonging the life of the gutter.

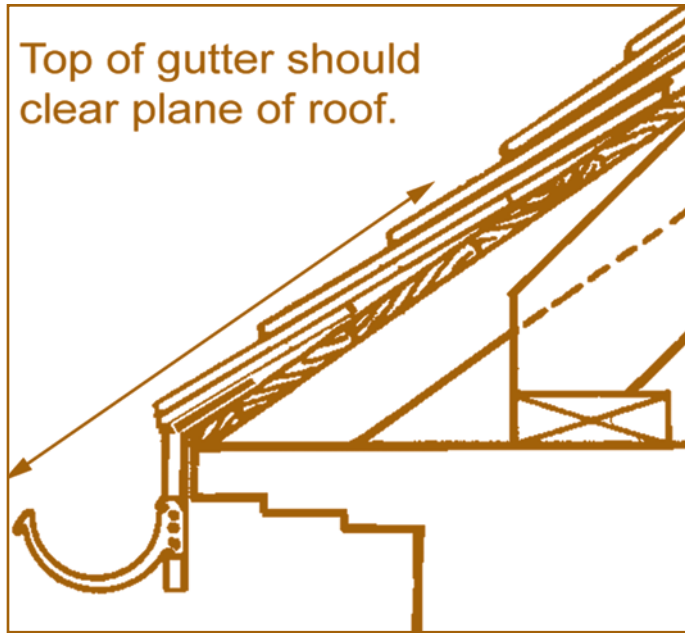
Top of gutter should
clear plane of roof.

Figure 29 – Ideally, the outer edge of external rain gutters should be hung below the plane of the roof to prevent damage to the gutters from sliding ice and snow.

Speaking of gutters, they're often hung too high. The outer edge of external gutters should be below the plane of the roof (Figure 29) if the gutters are in locations where snow or ice could slide down the roof and knock them off. The gutter in Figure 30, for example, will not last long.

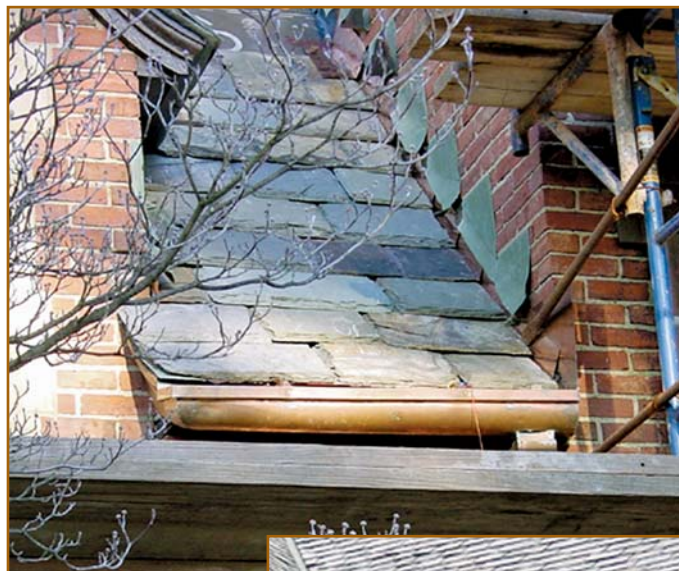
Figure 30 – This gutter is just waiting for a snow avalanche to knock it off.

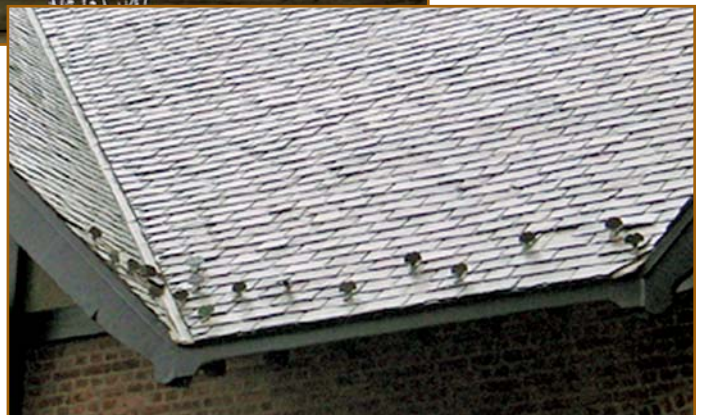
Figure 31 – Snowguards must be installed in adequate quantities, or they will get knocked off in the first bad ice storm, damaging the roof in the process.

Snow retention systems are another source of problems when they're installed incorrectly. One of the tricks for a proper snowguard installation is to use enough of them. Otherwise, they won't be able to hold the weight of the ice and snow and will rip out, taking slates with them. A poor snowguard installation is shown in Figure 31. Insufficient snowguards on this large roof

caused many of the devices to rip out during an icy winter. Follow the manufacturer's guidelines when installing these important slate roof elements.

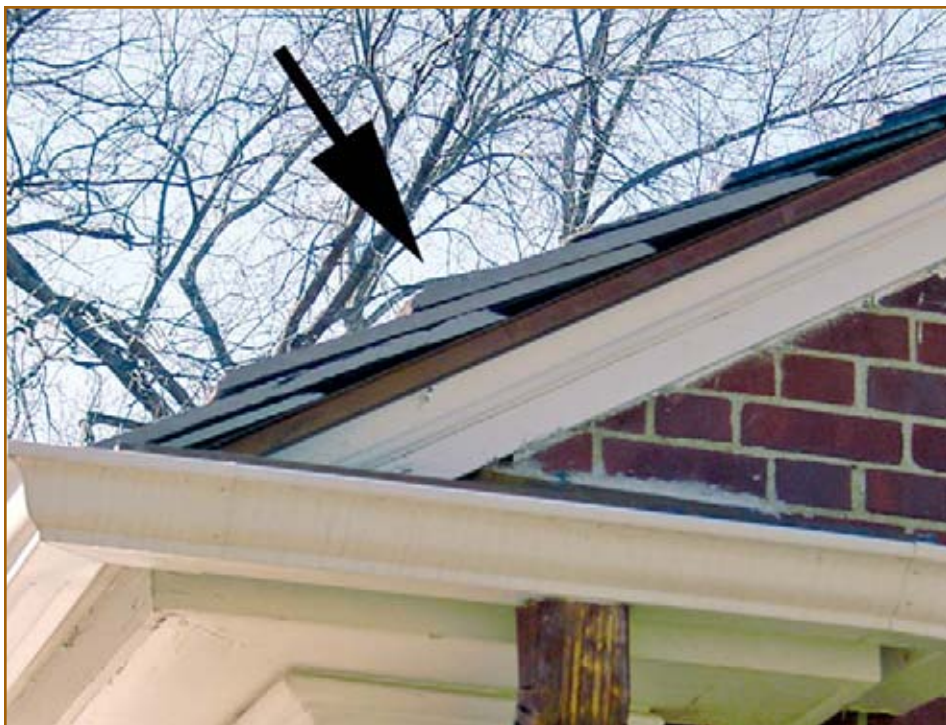
Figure 32 – Diamond blades cut a square edge on slates, making them stick out like a sore thumb.

Incorrect tools can be the downfall of many a would-be slater. Slate roofing has its own unique set of tools and equipment. For example, slates should be cut with – you guessed it – “slate cutters.” A slate cutter will leave a beveled edge on the shingle, thereby allowing it to match all the other shingles on the roof, all of which have beveled edges. If a diamond blade is used to cut the slates, a square edge remains, which can stick out like a sore thumb and get a roofer into big trouble if the property owner doesn't like the look of it. Figure 32 is

a perfect example of square edges exposed at the wrong place on a slate roof. These square edges could be dressed with a slate hammer and stake to give them the proper appearance, but one first must have these tools in the toolbox. When the proper cutter is not on hand, a roofer may resort to drastic measures to try to cut slates, as shown in *Figure 33*, where it looks like the slates were chewed off. This brand new roof, by the way, also had to be completely removed and reslated, causing the property owner much expense and grief.

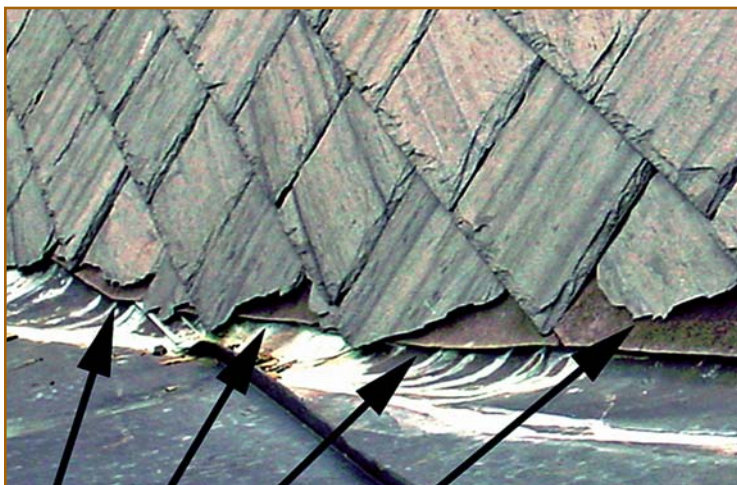
Figure 33 – Slate roofing requires the correct tools to do the job right. There is no excuse for the sort of work shown here.
