## THE PECULIARITIES OF HISTORIC SLATE ROOFS With Examples of Wrongful Condemnations

By Joseph Jenkins

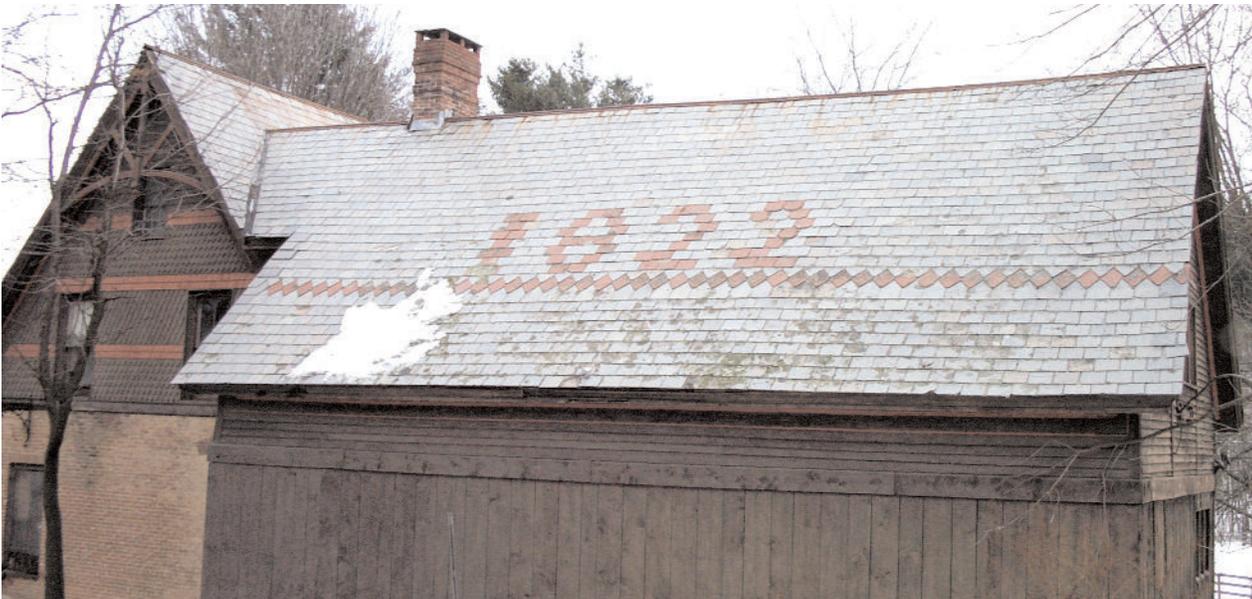
A recent photo of a barn in Vermont testifies to the potential longevity of a standard slate roof.

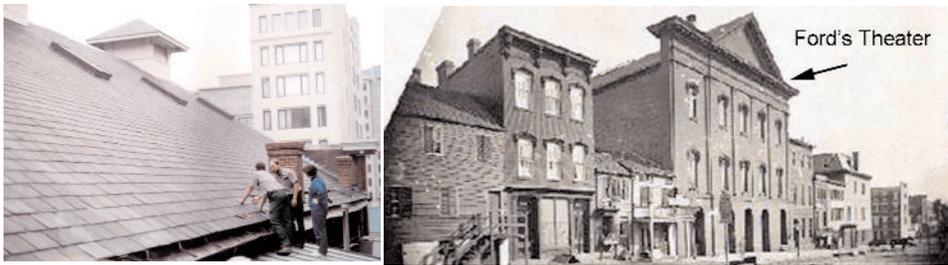
Ford's Theater

Left photo: This side of the roof looked old because the original 1865 slates were reused here when the roof was replaced around 1975. The right photo shows the front parapet wall. The arrow is pointing to the spot where the copper coping had split — right at the joint — a perfect funnel for rain water.

In short, the entire roof and all of the copper flashings had already been replaced and were about 25 years old — quite young for a Buckingham slate roof, which can be expected to last at least 125 years.

side, coincidentally at the only place where the roof could be easily inspected. It appeared from that vantage point as if the entire roof was still the original slate, but a closer inspection showed that 80% was new slate and only about 20% was original. Furthermore, no current worker at the theater had been there for 25 years and there was no written record of the roof having been replaced, so no one knew that it was already new. The leaks? The front parapet wall copper coping had split at a soldered seam and was channeling water directly into the building down the front wall. The other leak was caused by a defective flashing between the adjoining flat roof and the building wall. The roof itself didn't leak at all. From a slate perspective, it was still a new roof — but almost condemned.

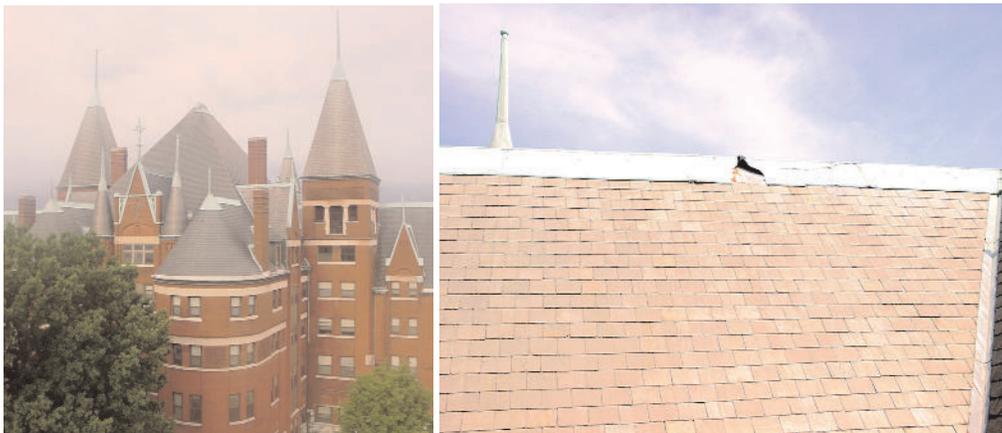
Left photo: This is only the entranceway to the huge building which has large wings emanating in three directions. The slate, at 120 years of age, is in excellent condition. Roofing contractors, however, would love to tear it off. Right photo: The minimal wind damage does not justify replacing the entire roof when the slate is still in good shape.

The Castle Park building near St. Louis is a huge, sprawling, five-story building with an 850 square slate roof built in 1882. The roof suffered hail and wind damage in the early 2000s and was subsequently condemned by contractors who offered to replace the roof with asphalt shingles for ten million dollars. The entire roof was original, flashings and all, and some leaking was occurring.

An inspection by the author revealed that the slates were a Buckingham or Peach Bottom variety of exceptional quality. There was essentially no wear visible on the slates after 120 years. The very steep slopes and the semi-dry conditions of the area had helped preserve the copper, most of which was original. The wind and hail damage on the roof was quite limited and all of it was repairable for less than 3% of the replacement cost. The slates themselves could be expected to last another century, although the copper flashings would have to be replaced eventually. The main leak was in a copper valley and was unrelated to the storm damage. Although this beautiful slate could last at least another century, contractors were earnestly attempting to permanently destroy it.

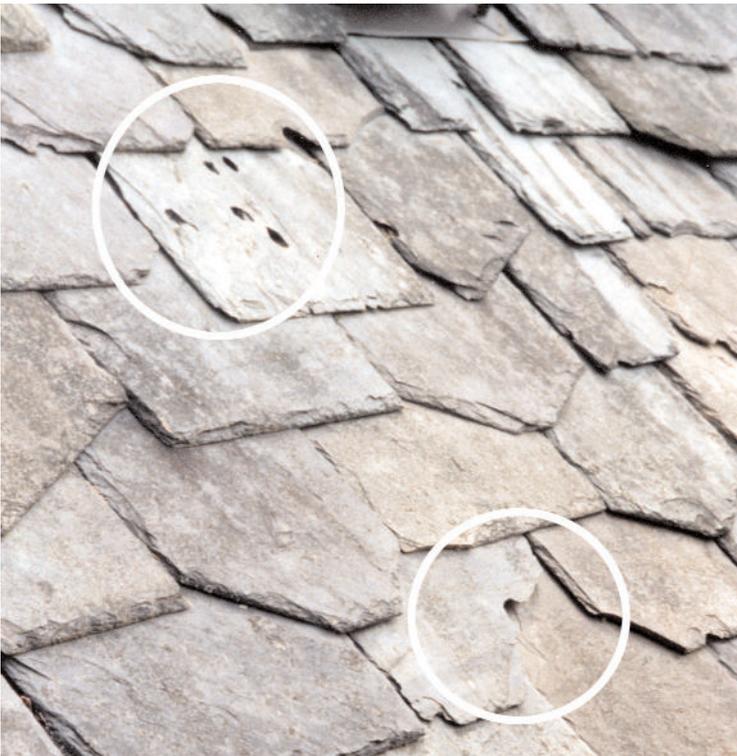
Hail damage of this nature as seen on Chicago area "ragged butt" slate roof is repairable by simply removing the damaged slates and replacing them. Most of the slates are undamaged.

A residence in an upscale Chicago neighborhood suffered hail damage to its unique “battered butt” style 75-year-old slate roof. Three firms looked at the roof and all three condemned it before the owner contacted the author for an impartial inspection. Hail damage to the mixed Vermont and Buckingham slate was certainly evident, but it was limited and all readily repairable

by any contractor with a minimum of slate roof restoration experience. The inspection revealed about 150 slates needing to be replaced — a couple days work for experienced professionals.

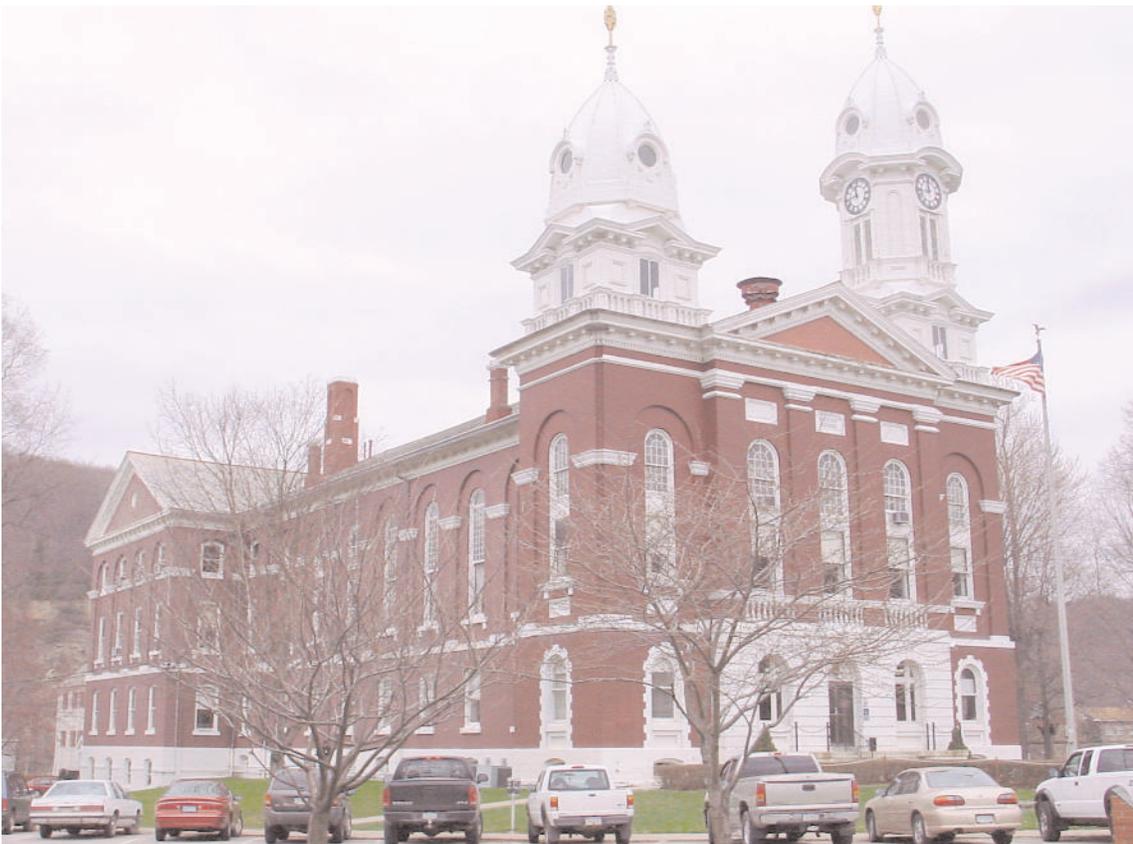
This courthouse roof was unnecessarily condemned and scheduled for replacement. The Vermont “sea green” slate roof is only 72 years old — about halfway through its life. Comprehensive restoration work on this roof will only cost about 10% of the cost for total replacement because the slates and fasteners are still in good condition. Most of the flashings, however, need to be replaced.

courthouse roof. The 130-square Vermont “sea green” slate roof was approximately 72 years old. A county engineer insisted that the roof was beyond repair and was “absolutely certain” it had to be completely replaced. The author’s inspection revealed that most of the problems with the roof were related to bad repairs in the past, all reversible. The slate itself was still good and could be expected to last at least another 50 years if not 75 or more. Replacement costs of \$358,451 were reduced to restoration costs of \$35,000, which included replacement of virtually all flashings with stainless steel — a savings to the cash-strapped county of over \$300,000.

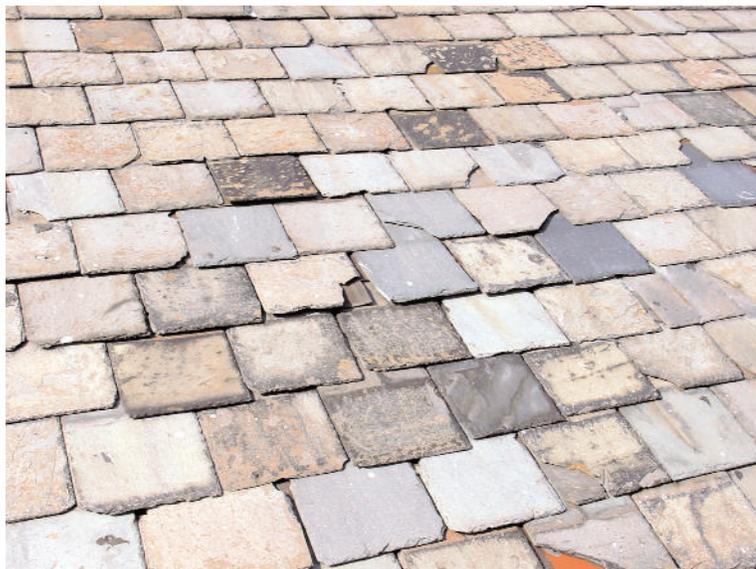
Venango County Courthouse

Most of the problems associated with the courthouse roof were caused by bad repair work over the years, an example of which is shown above. The wrong type and color of slates were used to repair this roof, indicating the repair contractor didn't understand proper restoration techniques. These will all need to be removed and replaced with slates that match the original roof. The author counted approximately 700 slates like this on the courthouse roof.

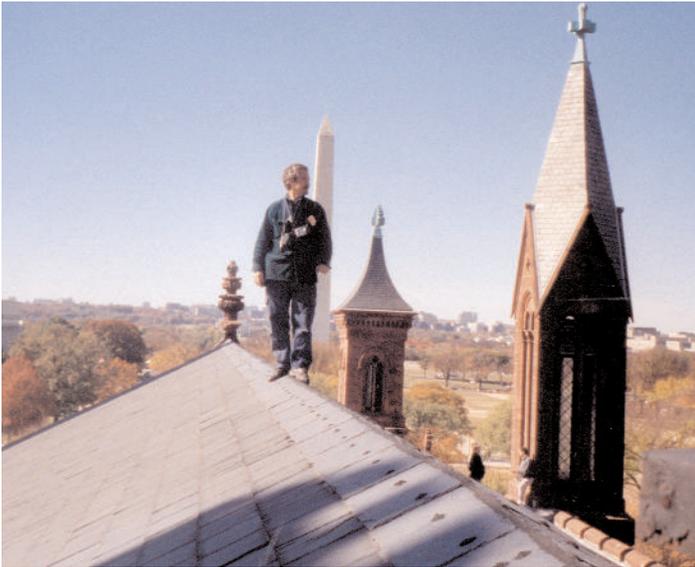
The Smithsonian Institution Building known as the Castle had already been replaced with new slate, but some of the original flashings had been left in place, and they leaked. The author is inspecting the roof in the photo above.

of replacement — a very expensive proposition. An inspection by the author revealed that the roof had recently been replaced — a scenario similar to Ford’s Theater. The slate roof on the Castle was only about 25 years old, having already been replaced with new Buckingham slates (although some of the original slates had been reused). The majority of the flashings had also been replaced with new copper.

Apparently, some of the more important historical buildings in our nation’s capital had been refurbished around the time of the bicentennial in 1976. At about that time, Ford’s Theater got a new roof and so did the Castle. For some unknown reason, however, not all of the Castle’s flashings had been replaced. Four main central valleys and the flashings along two parapet walls had been left as original, and they now leaked. Furthermore, the maintenance crew had the habit of tromping on the

slate roof in what appeared to be combat boots, crunching the slates underfoot, breaking them, and adding to the roof problems. The solutions were simple and relatively inexpensive: replace the old flashings with new copper and keep people off the roof who don't belong there.

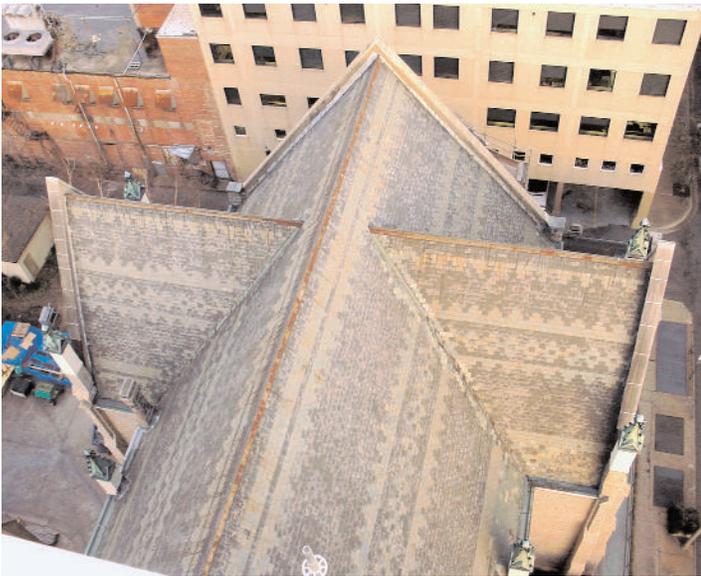
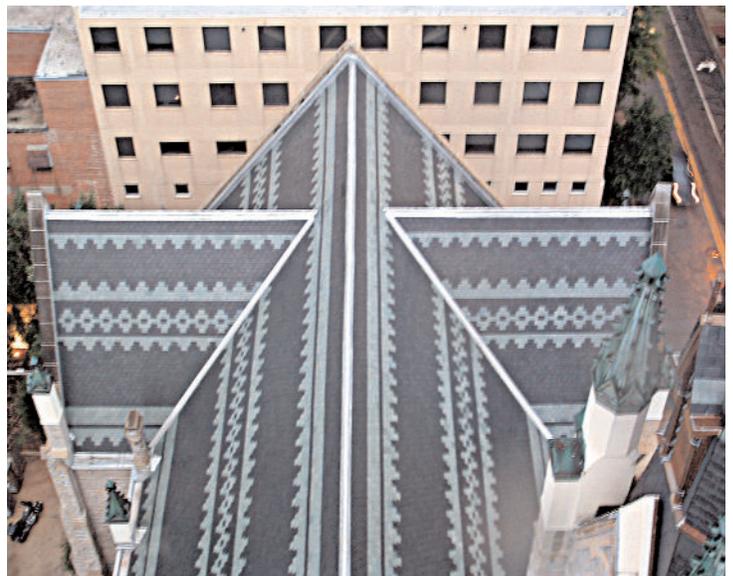
The Cathedral of St. Andrew in Little Rock, Arkansas, had worn out its black Pennsylvania slate after 120 years (above left). The Cathedral’s new roof, installed by Midland Engineering in 2003, is likely to last 150 years. Vermont unfading green slate mixed with Welsh black slate and terne-coated stainless steel flashings should out-perform the original roof.

A slate roof will wear out, of course, and at the end of its life, nothing can save it. This was the case with the Cathedral of St. Andrew in Arkansas. The Cathedral roof was made up of Pennsylvania black slates and Vermont unfading green slates mixed in an ornate pattern. At 120 years of age, the PA black slate had simply worn out — become soft, flaky and falling apart, especially on the south exposure and on the main body of the church. The Vermont unfading green slates showed almost no wear at all despite their age of 120 years.

The original roof was inspected by the author to determine its condition and to draw up specifications for replacement. The new slate roof was subsequently installed by Midland Engineering of South Bend, Indiana, to match the original roof. This time, however, Vermont unfading green slates were mixed with Welsh black slates from Cwt-y-Bugail. All of the copper flashings were replaced with terne coated stainless steel (some 4-lb. sheet lead was also used). The new slate roof is expected to last at least 150 years.

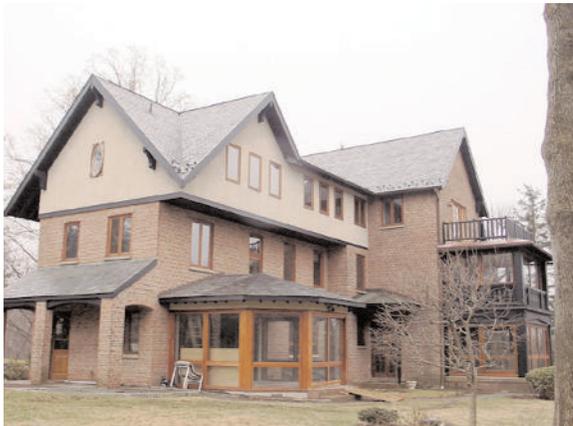
Ten year old slate roof on a private residence condemned by roofing contractors. The nominal snow guard damage, however, was covered by homeowner's insurance — the roof did not need to be replaced at all.

For what it's worth, even newer slate roofs fall prey to unscrupulous roofing contractors. A house just outside New York City had a ten-year-old Vermont mixed slate roof. In the spring of the year the owner found some slates on the ground, along with some snow guards. A local "third generation slate roofing expert" was called to the scene. He promptly condemned the 100 square roof and offered to replace it for \$450,000. The owner then called the author for a second opinion. The author's inspection revealed that the snow guards had let loose due to severe weather that winter combined with an inadequate number of snow guards for the size and slope of the roof. Each snow guard was hooked onto a slating nail causing a slate to be pulled out with the snow guard. The damages amounted to a maximum of \$10,000 and all of it was covered by homeowner's insurance. Otherwise, the roof was fine. So much for "experts."
