## What Home Inspectors Need to Know About

# SLATE ROOFS

Joseph Jenkins

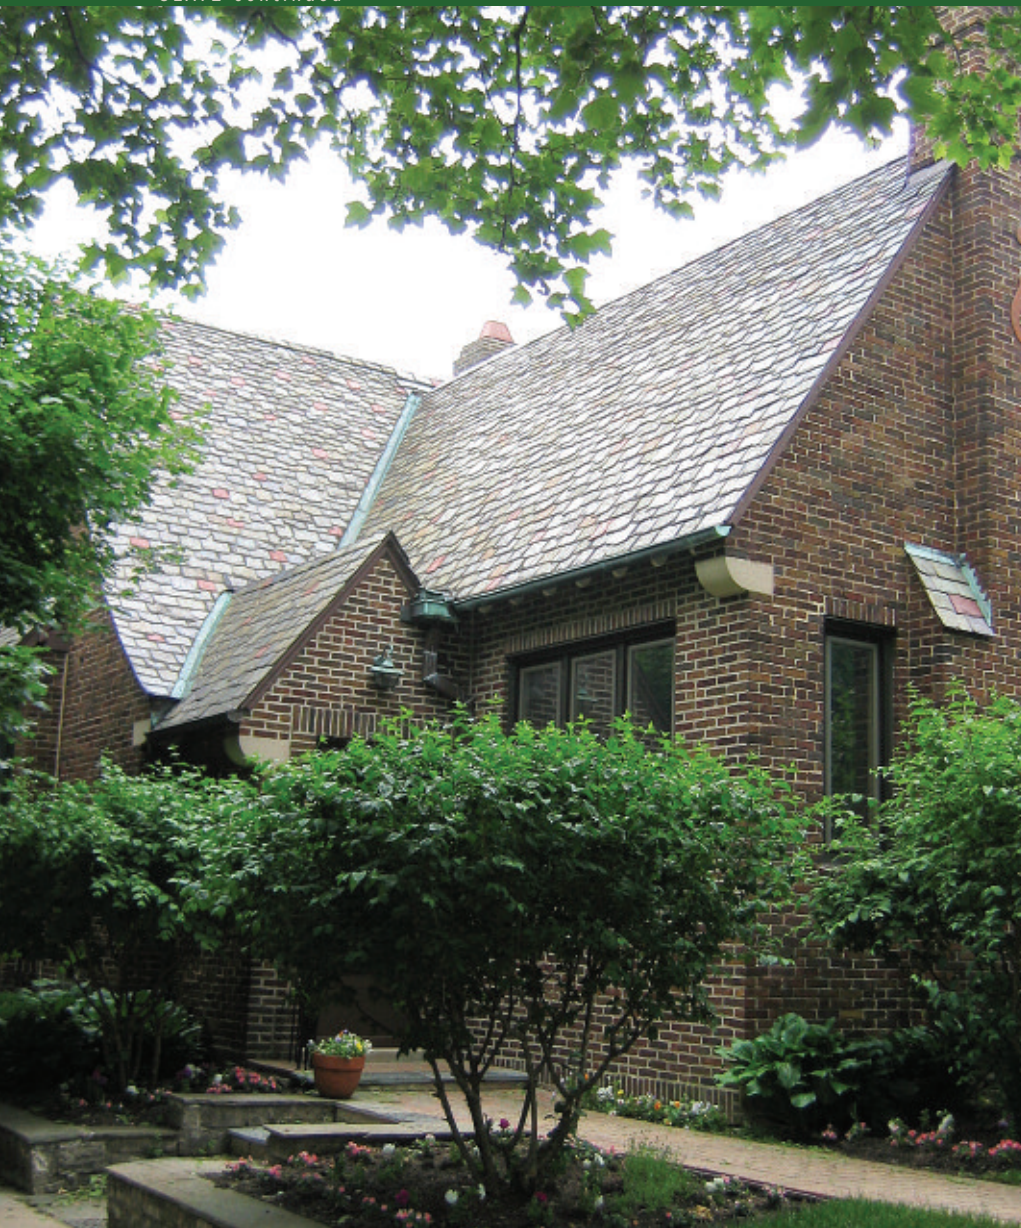
*Standard slate installation pattern, showing overlap, headlap, placement of nail holes, "face" and "head" of the slate. Course #3 overlaps course #1 by three inches. This is called the "headlap."*

In a standard slating pattern, each slate is the same length and width (although shapes may vary). Each slate is fastened to the roof with two nails along a chalk line that marks the top edge of the slate course, and each slate overlaps two courses below it. The standard headlap is three inches, but it can range from two to four inches. Without this headlap, the roof would leak like a sieve. Less headlap can lead to leakage, depending on the slope of the roof, however, two-inch headlap is not uncommon on older roofs with adequate slope (*see illustration at right*).

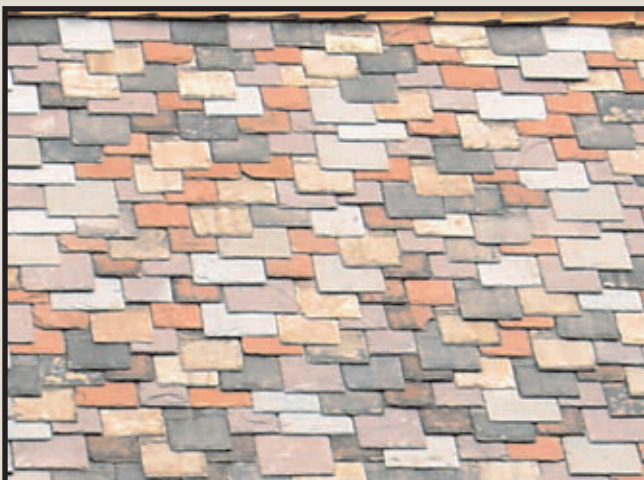
*Below: A new slate roof installed by the author is made with a variety of new and salvaged slates, clearly illustrating the striking contrasts in color and shade between common types of roofing slate. What you can't see is the longevity of each type of slate. Half of the slates on that roof are already 100 years old. The other half are new. It is likely this roof will last a century—well into 2100. Photo courtesy of the author.*

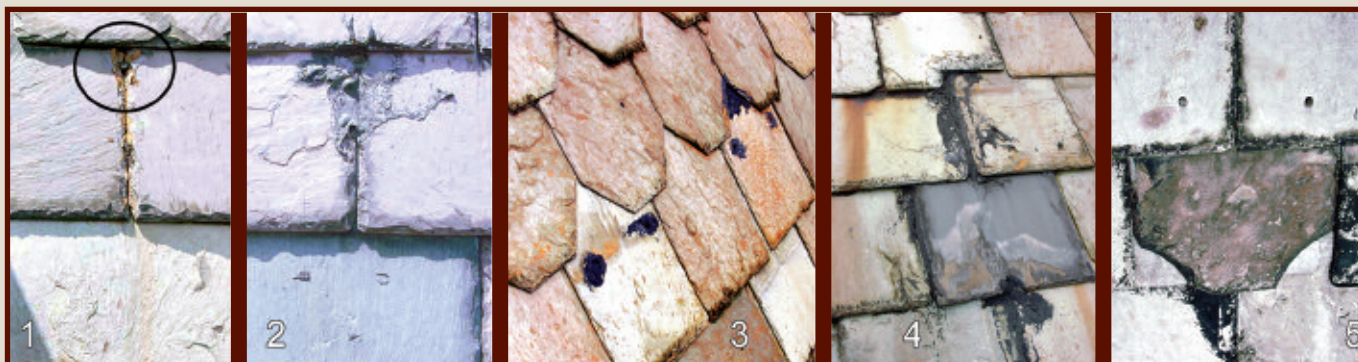
*Photos: Bad repairs can be found on almost any old slate roof. Some constitute “hidden leaks,” such as #1 below, where a nail has been driven into the top of the slot, caulked, then the caulk has worn off leaving an almost invisible hole in the roof. A bib flashing would have prevented this problem and will still solve the problem if inserted at this time. #2 illustrates the same problem, this time with roof cement rather than caulk. #3 shows “face nails” that have been tarred over — these are guaranteed leaks. #4 illustrates two obvious errors: wrong type of replacement slate and exposed roof cement. #5 is another example of a multiple error — face nails, wrong type of slate and wrong shape of slate. All of the above can be removed and the roof properly repaired.*

faulty repair work. Slate roof owners pay good money to have their roofs abused, then they have to pay more good money to have them repaired correctly. Abused roofs include the ones that are walked on by installers, the ones that are face-nailed, tarred, repaired with non-matching slates, coated, or reflashed incorrectly (*see photo below*).

It is improper to tar or coat the surfaces of slate roofs, or to use surface tar for repairs. Not only is this unsightly, but it doesn't stop leaks permanently, and it ruins the slates. Applying coatings to slate roofs creates problems that cannot be easily reversed.

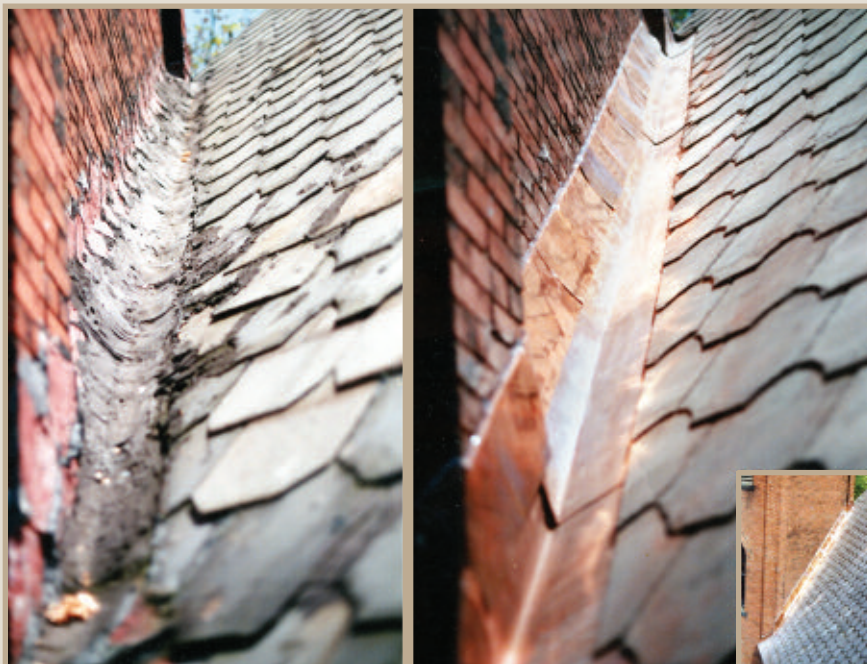
The first photo on the right shows a bell tower on a church that has been poorly repaired with roof cement, unfortunately a common sight on old slate roofs. The second photo on the right shows how a mess like that can be cleaned up and restored with new copper in one day by a professional slater and helper. The photo at the bottom illustrates a similar situation—valleys that were tarred repeatedly until the roof looked beyond hope (and, of course, still leaked). Nevertheless, one day's work by a professional slater, working alone, cleaned up the roof, giving it an almost miraculous new lease on life. Such is the art of slate roof restoration.

A lay person or a home inspector may look at either of the situations shown in these photos and be immediately convinced that the roof is shot and must be replaced. When a slate roof professional looks at the tarred mess, he sees a common sight that can be routinely repaired
